## MARINE CASUALTY REPORT

M/V ANGELINA LAURO (ITALIAN);  
FIRE ON BOARD WHILE DOCKED IN  
CHARLOTTE AMALIE HARBOR, ST.  
THOMAS, USVI, ON 30 MARCH 1979  
WITH NO LOSS OF LIFE

U.S. COAST GUARD  
MARINE BOARD OF INVESTIGATION REPORT

REPORT NO USCG 16732/01282

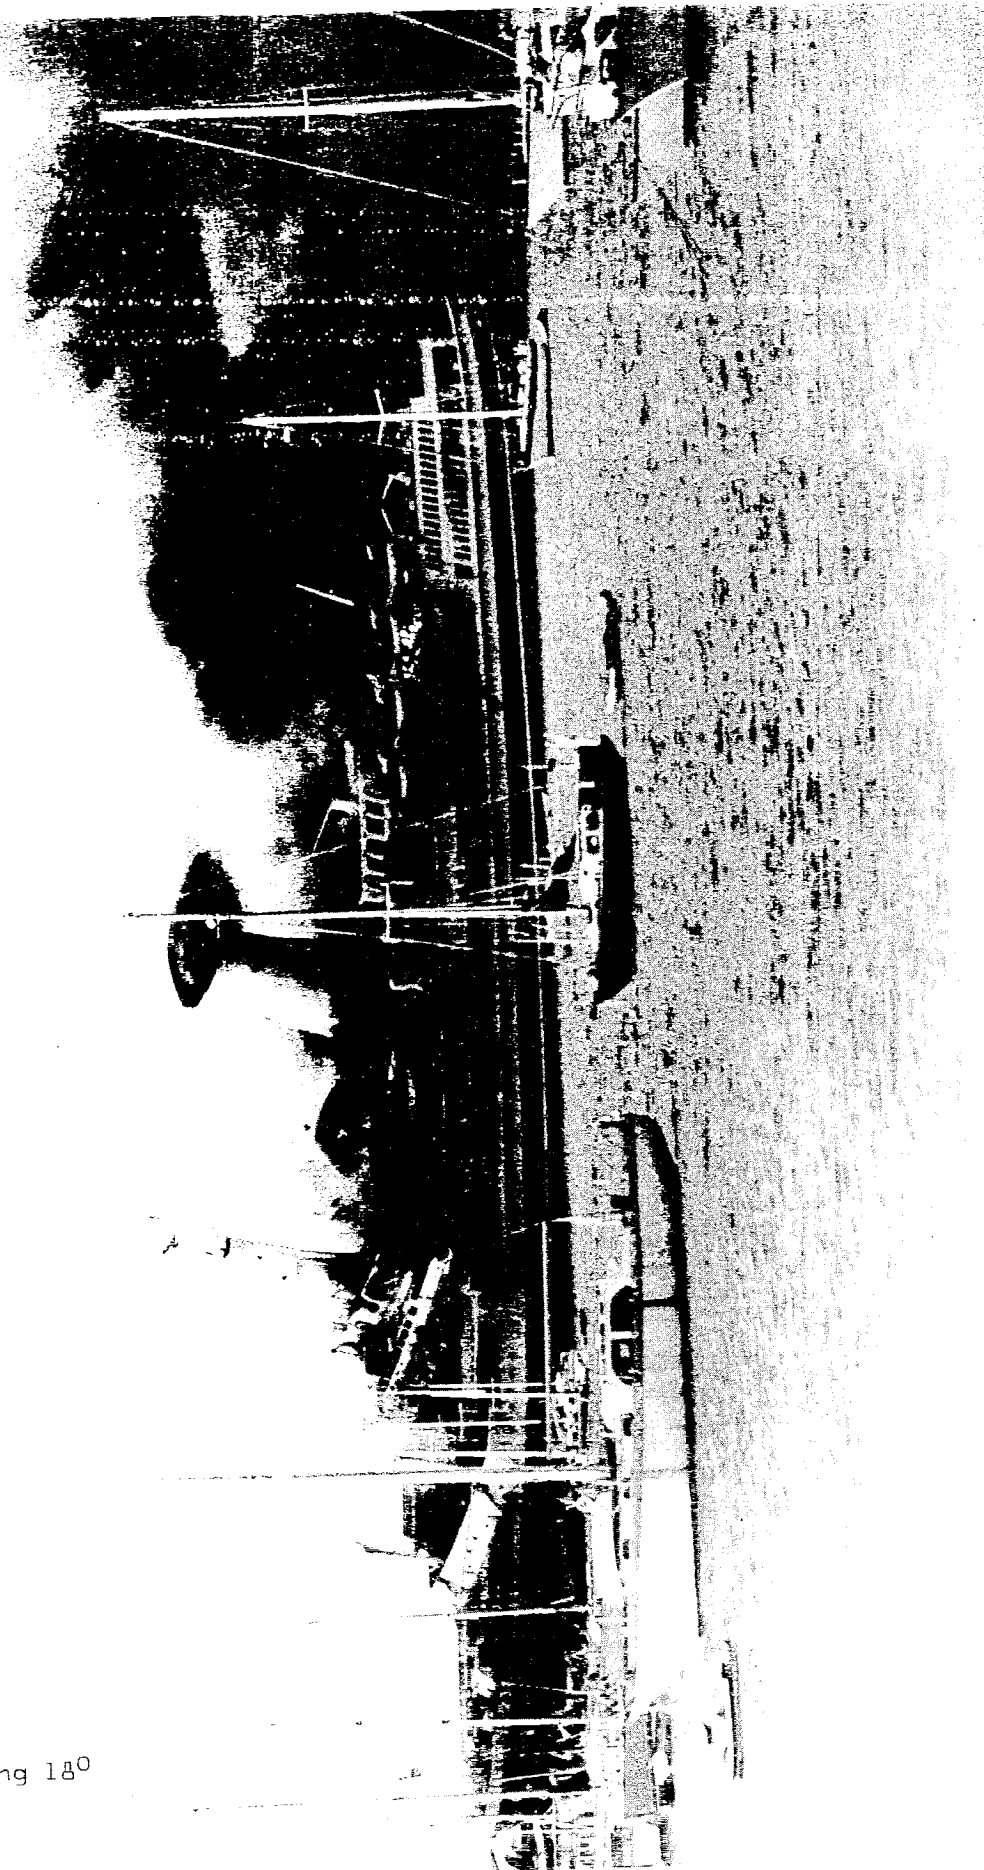
Figure 3  
Angelina Lauro  
On fire and listing 18°

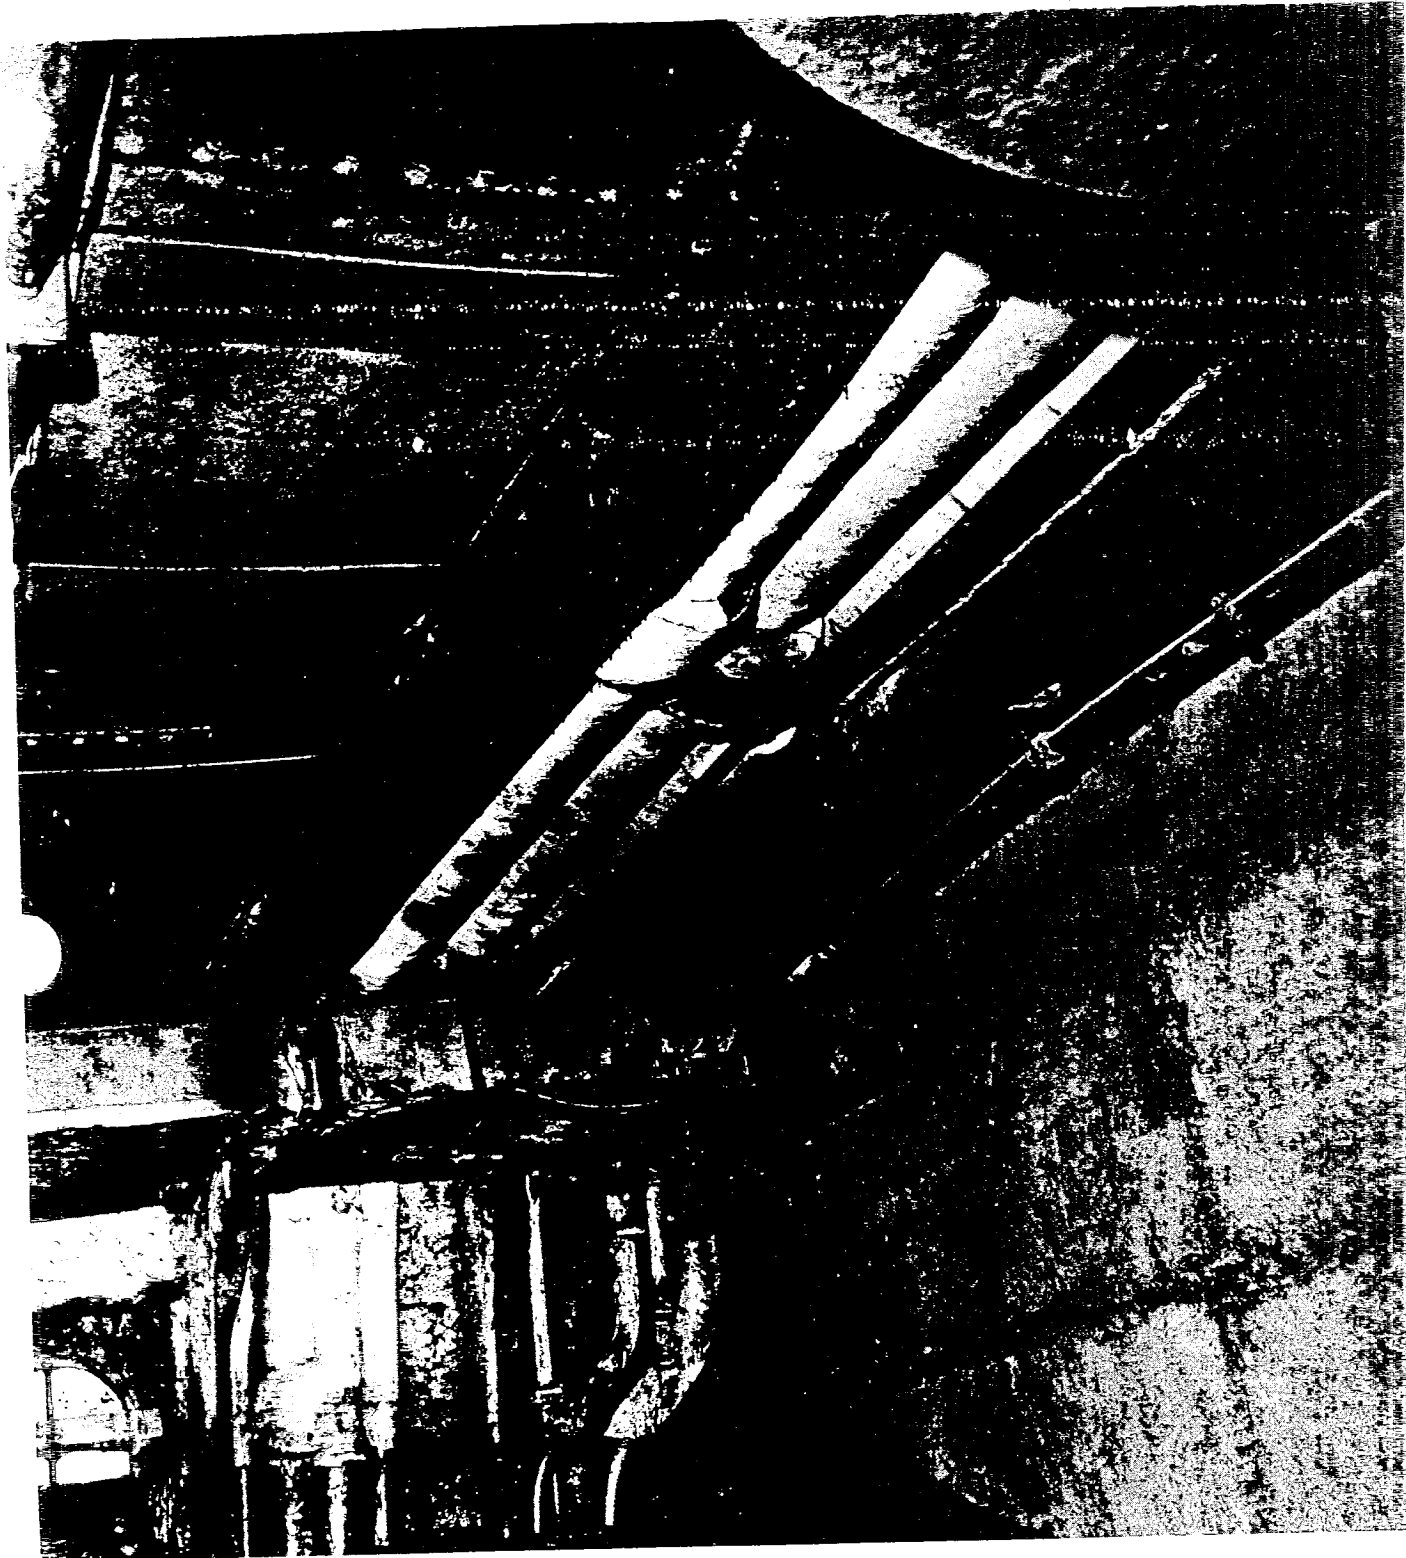
Figure 9  
Continental Dining Room  
View of the Crew Galley  
Exhaust Vent

35. Above the galley range and fryer/skillet was a steel exhaust hood which collected vapors from these appliances. Exhaust was extracted from the hood through a rectangular exhaust duct wrapped with fiberglass, 750mm x 200 mm in size. The exhaust duct passed horizontally through the main vertical zone at frame 166 and was routed through the Continental Dining Room aft to frame 151 where it turned 90 degrees and ran athwartship to the starboard corridor adjacent to the staintower on the centerline of the after end of the dining room. Here it turned 90 degrees and ran aft to frame 142 where it entered the staintower and was then routed vertically to the vessels forward stack. On the Stack Deck, the duct ran aft to frame 125 and terminated inside the after funnel. It was fitted with an electrically driven exhaust fan and a manually operated, blade type damper at this termination. Two automatic fire dampers were fitted in the hood exhaust duct, one

inside the galley and one inside the Continental Dining Room adjacent to the main vertical zone bulkhead. Both dampers were identical. They were constructed of 5mm thick steel. The blade was held in the open position by a fusible link designed to melt at 72 degrees centigrade and could be manually operated. The portion of the duct in the Continental Dining Room was covered with fiberglass. The ducts along with air conditioning ducts, sprinkler system piping and electrical wiring were hidden from view by a false ceiling composed of fiber panels supported by wood battings.

38. A post fire examination of the hood exhaust duct revealed that the damper on the galley side of the hood exhaust duct did not close, although the fusible link had melted. The damper on the dining room side had closed; however, it was severely warped. The inside of the duct had a heavy residue of burned grease, however; Chief Crew Cook CAPRICANO claimed that the vent was frequently cleaned and had been so as a matter of routine for as long as he was on the vessel. The hood was equipped with screens intended to catch and condense the grease vapors from cooking. Several witnesses said they were regularly changed, and CAPRICANO stated that this was a matter taken care of by the engineering department. The vent screens were changed on the 28th of March and normally changed once a week and examined by the ships engineers and by inspectors during Coast Guard examination. Also present in the hood was a steam smothering line. The line was traced where it comes out of the hood at the port side of the ship, down to the deck level, and then forward to the port corner of the galley, thence vertically where there was a manual valve at ceiling level for activation. This system was not used to fight the fire.
