SS BADGER STATE
EXPLOSION ABOARD AND EVENTUAL SINKING
IN THE NORTH PACIFIC OCEAN
DECEMBER 26, 1969

U.S. COAST GUARD
MARINE BOARD of INVESTIGATION REPORT
and COMMANDANT'S ACTION

ACTION BY
NATIONAL TRANSPORTATION SAFETY BOARD

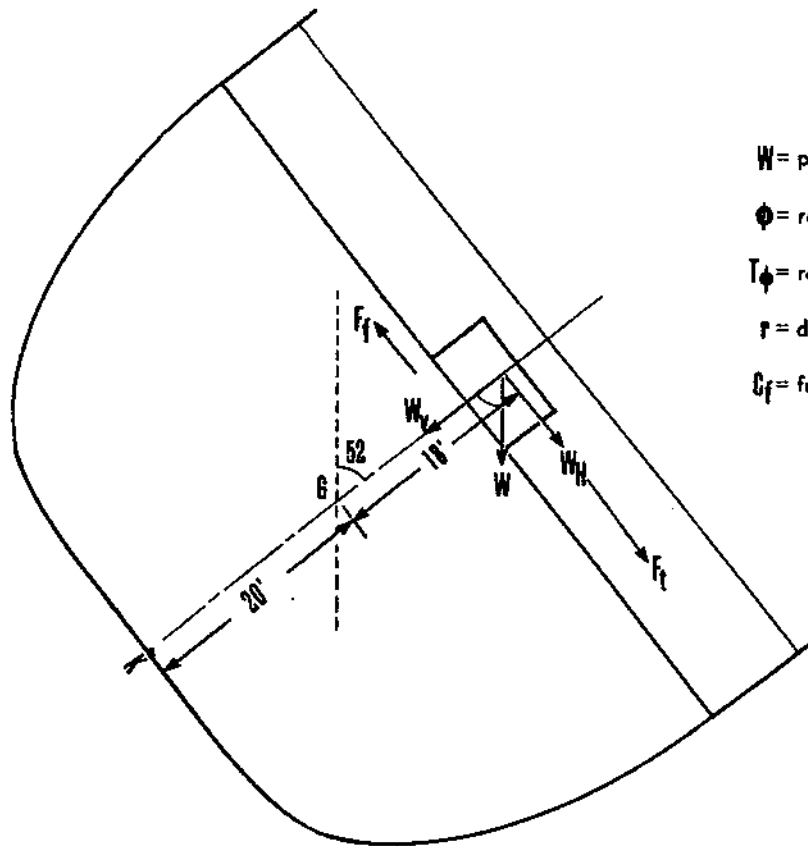
FIG. 1

W = pallet weight = 4075 lbs

Φ = roll angle = 52°

T_Φ = roll period = 11 sec.

The exact mechanism of the failure of the blocking and hull sheathing cannot be reconstructed. However, among the peak load points were those at the bomb nose blocking. With the bombs loaded nose to nose athwartship, the two outboard bomb noses had to carry the total load from the other bombs in that row at the maximum roll inclination. The bomb nose, with a diameter of 4.625 inches, had a centerline hole of 3.772 inches. This required the blocking, in contact with the two nose areas of one pallet, to support about 11,875 pounds over an area of about 11.8 square inches, with a resultant pressure of about 1,000 pounds per square inch. Another area of peak loading occurred where the hull curvature allowed only one bottom corner of the outboard pallet to press against the sheathing board and support the lateral forces of the entire row of bombs. Although some additional side support may have been added in the case of the BADGER STATE, even recent Navy-promulgated standards do not require any such additional side support for this "one-point technique of unit load positioning." Without additional support, the bearing surface of this technique is so small that the side forces encountered on the BADGER STATE would readily have crushed the sheathing support. Even additional support, in the form commonly used, probably would not have increased the bearing area on the sheathing and prevented crushing of the sheathing in this case. The compressive strength perpendicular to the grain fiber of Douglas fir varies with type, quality, and moisture content. Results of tests conducted on small clear specimens indicate that the coast-type Douglas fir has an average compressive strength of 440 p.s.i. in the "green" (38 percent moisture) condition to 870 p.s.i. in the air-dry (12 percent moisture) condition. Western hemlock, also reported as being used for dunnage has respective values of 390 and 680 p.s.i. Since the lumber used during loading was wet, the values applicable to the lumber aboard the BADGER STATE were probably near the lower values. Some of the stowage failures undoubtedly occurred because, at the large angles of roll, the dunnage was loaded beyond its compressive strength.
