# MARINE CASUALTY REPORT

FIRE AND EXPLOSIONS ON TANK BARGE MOS 106  
AT LA GRANGE, MISSOURI ON MISSISSIPPI RIVER,  
ON MAY 12, 1969

U.S. COAST GUARD  
MARINE BOARD of INVESTIGATION REPORT  
and COMMANDANT'S ACTION

ACTION BY  
NATIONAL TRANSPORTATION SAFETY BOARD

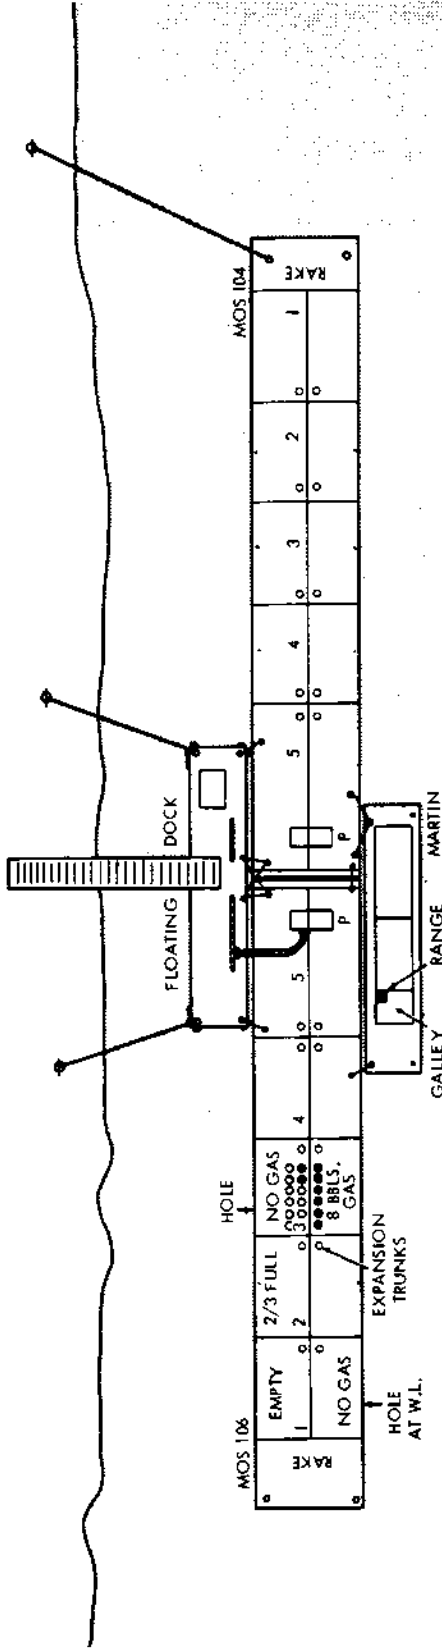
SHELL  
GAS  
STATION

WIND 6 mph  
AIR TEMP. 57°F

MISSISSIPPI RIVER  
WATER TEMP. 60°F  
CURRENT  
2 KNOTS
