MARINE CASUALTY REPORT

TANKSHIP PUERTO RICAN

**EXPLOSION AND FIRE
IN THE PACIFIC OCEAN,
ON 31 OCTOBER 1984**

REPORT NO. USCG 16732/0003 HQS 84

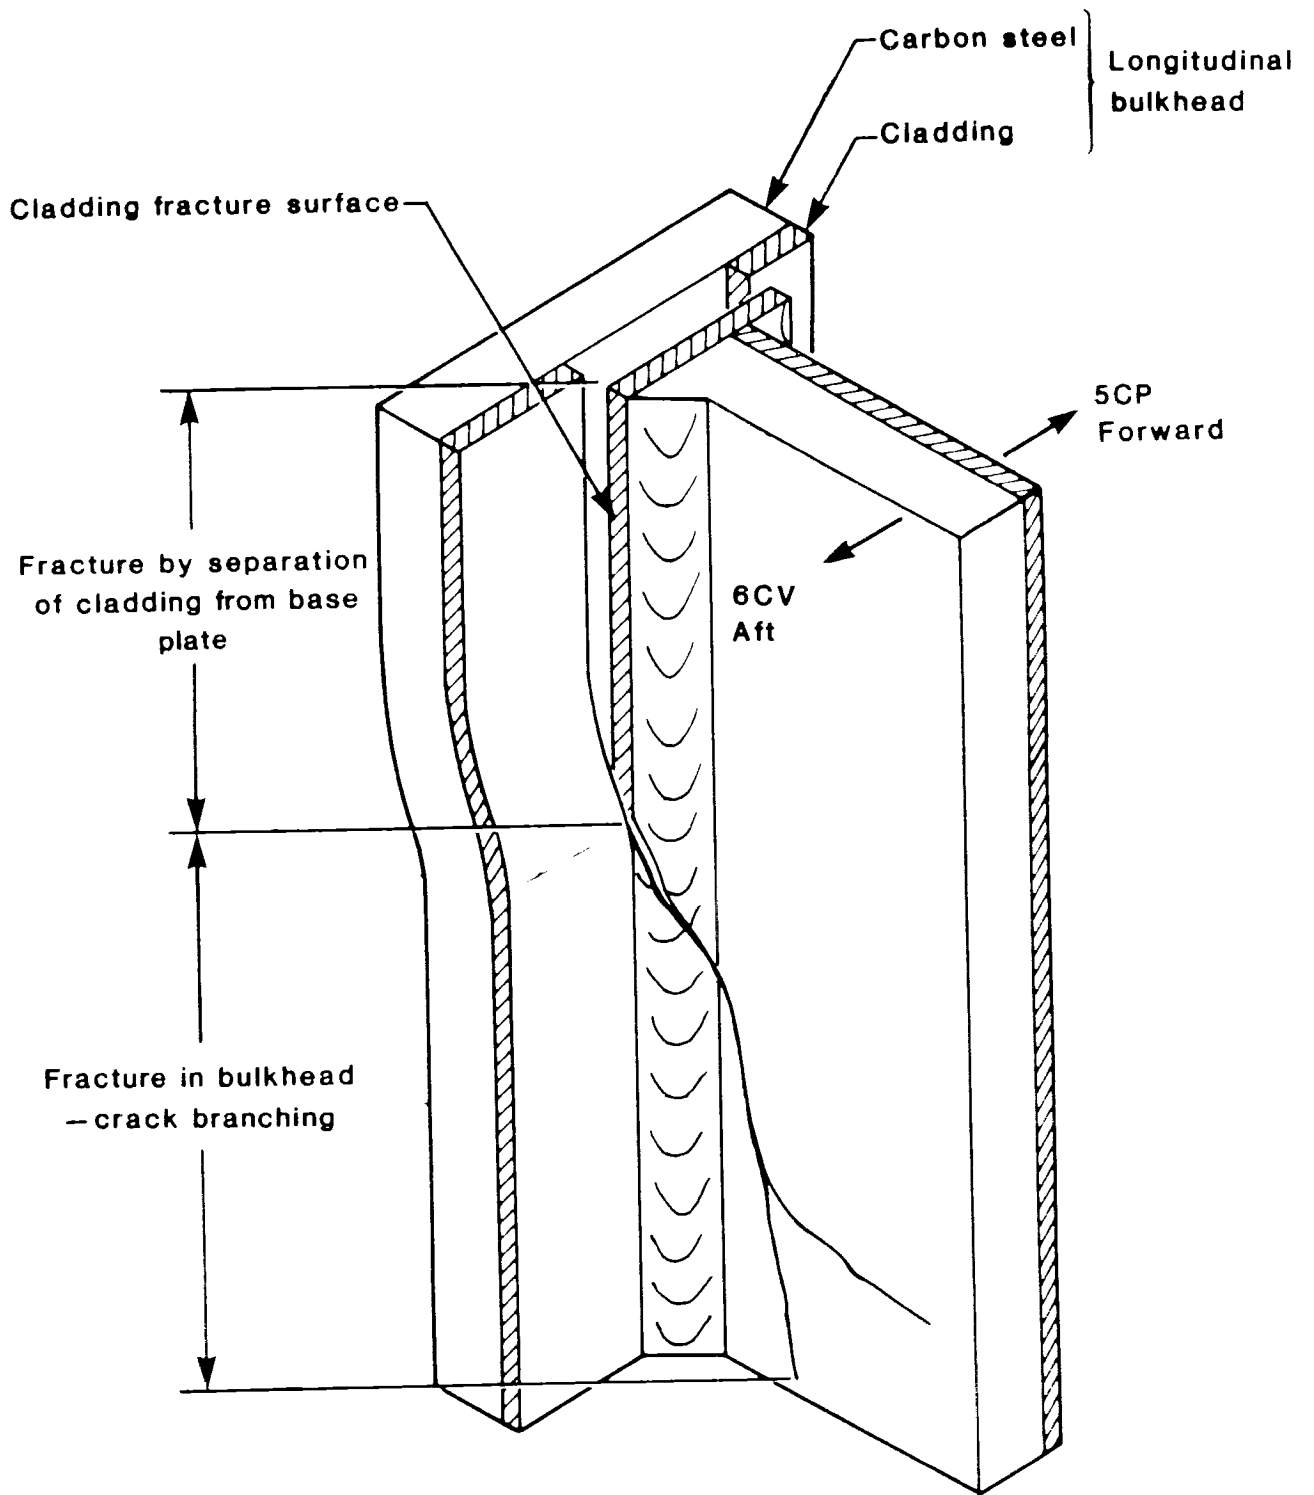
Figure 5. Sketch of different fracture paths in Cases 2 and 3.

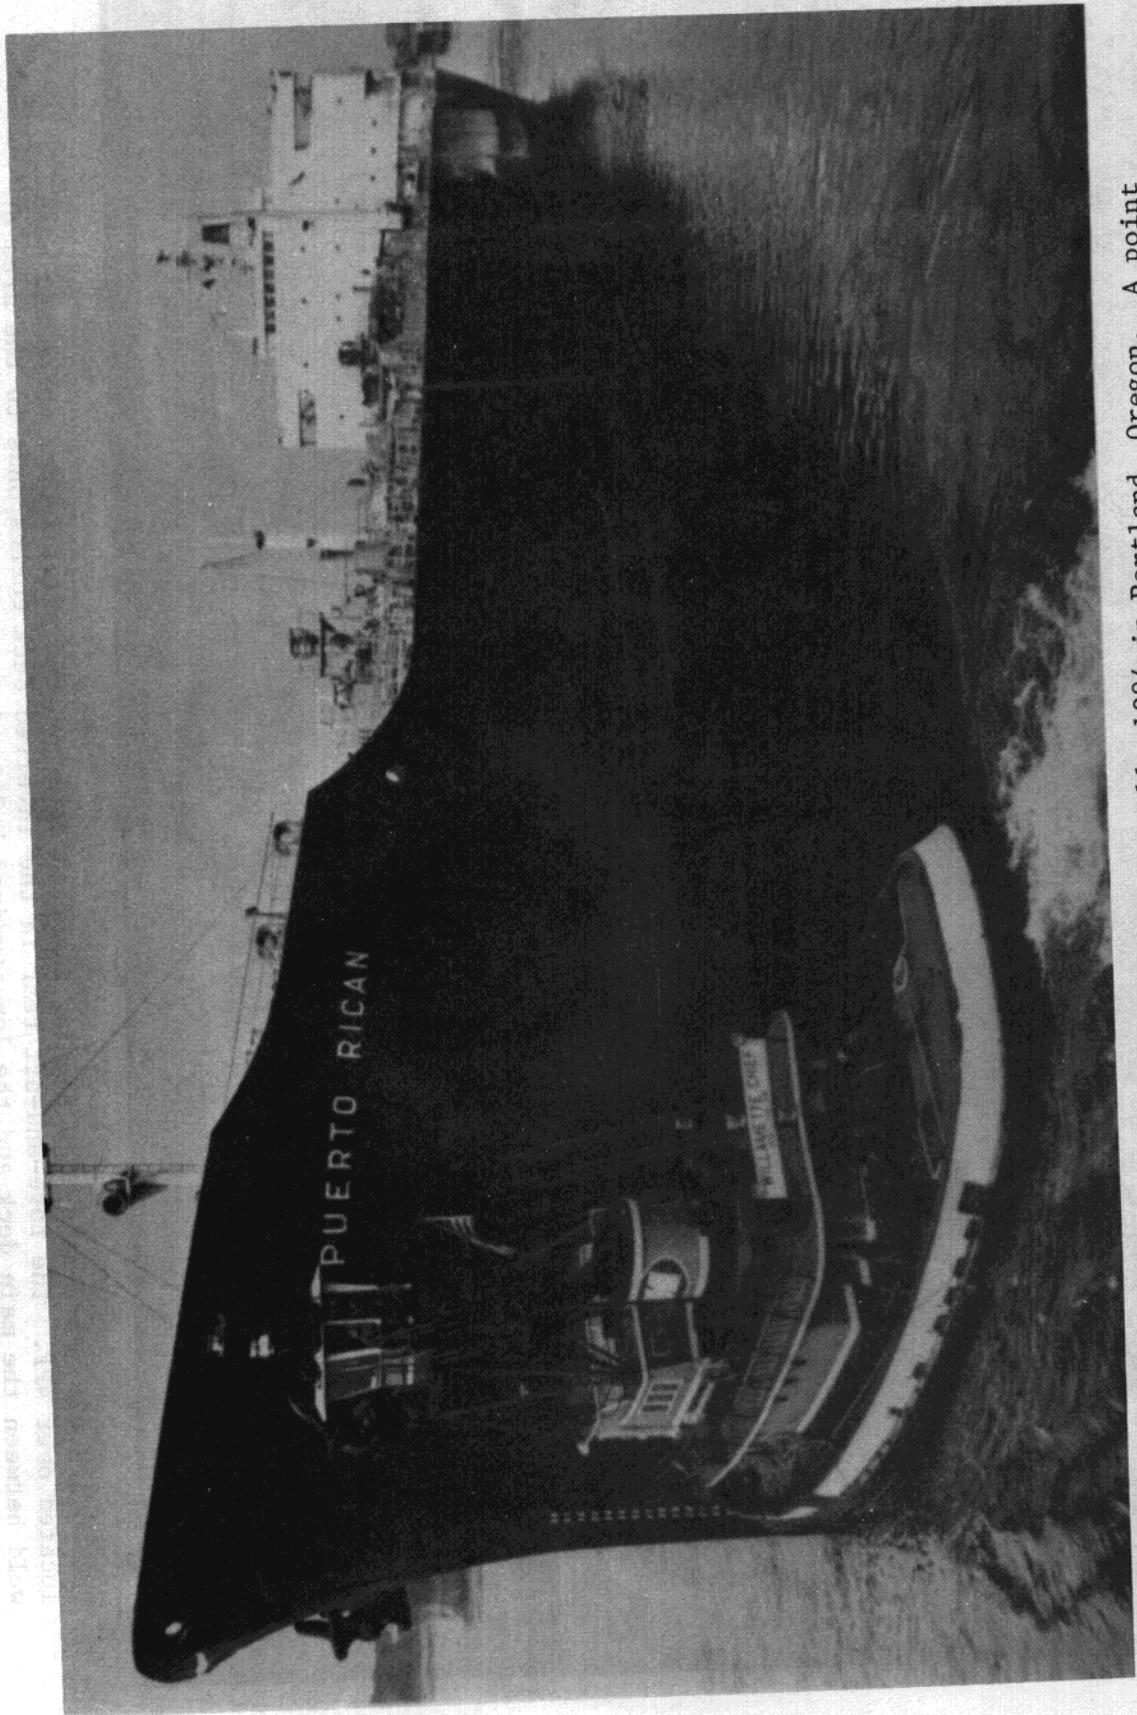
PHOTOGRAPH #1: The S.S. PUERTO RICAN on September 11, 1984 in Portland, Oregon. A point of interest is the light colored area on the hull aft of the kingpost. This appears to be in way of the number 4 port wing tanks. The Board could not determine the reason for this discoloration. (LAARS Photography Photo)

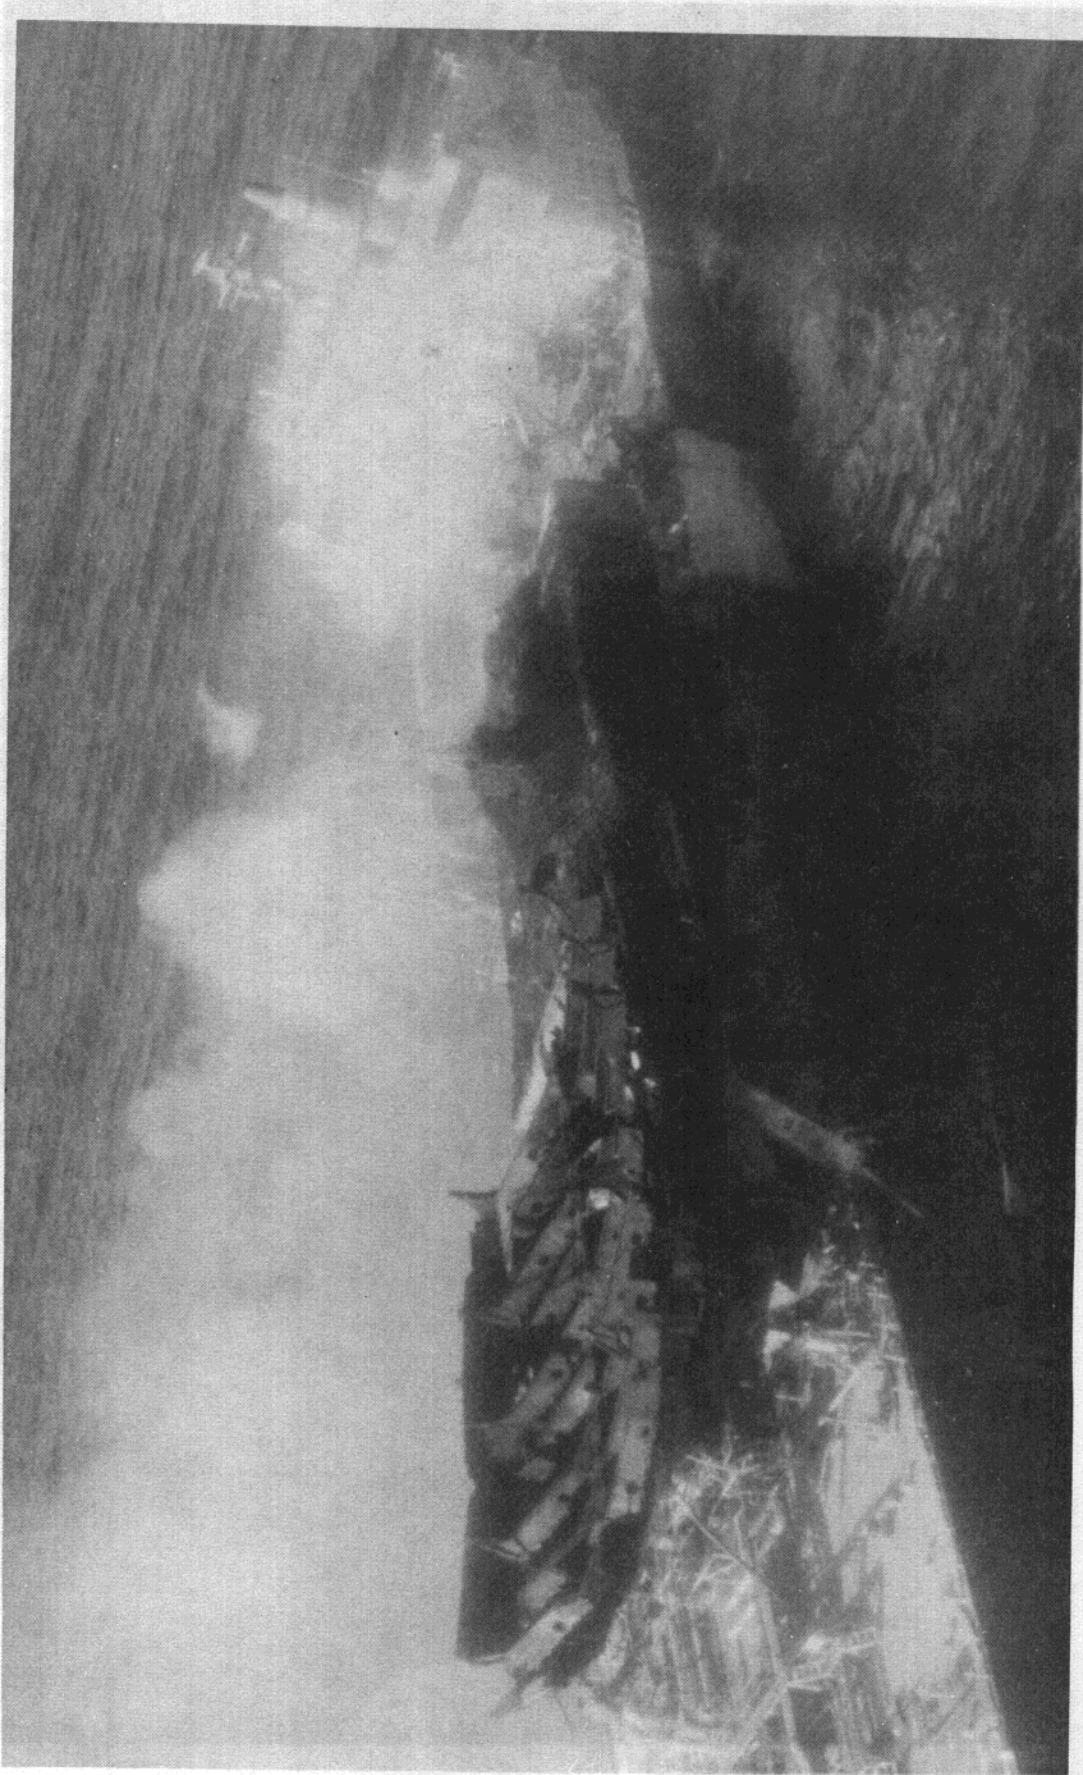
numbers 4 and 5 center tanks and the adjacent wing tanks. This condition is shown in photographs 3, 4, and 5.

PHOTOGRAPH #4: PUERTO RICAN under tow on October 31, 1984 at approximately 1030 in position approximately 15.5 miles and 250°T from Point Bonita. (USCG Photo)

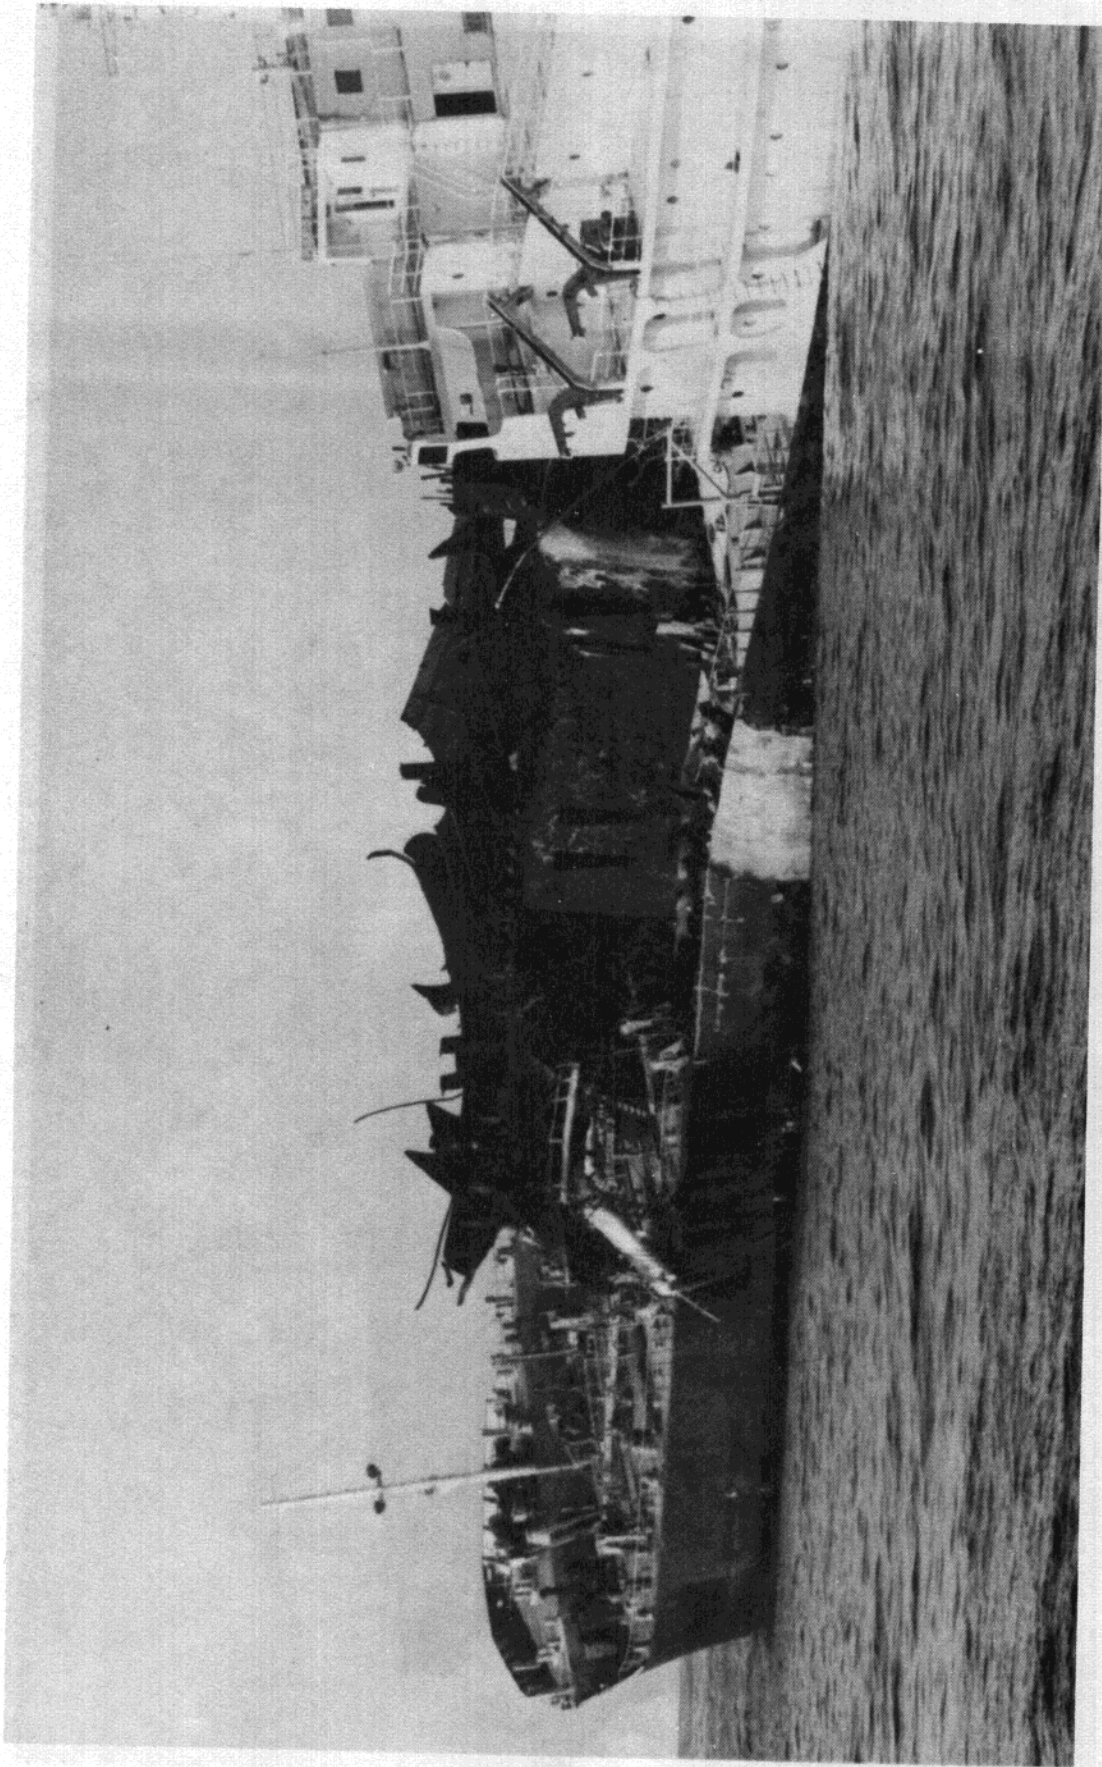
PHOTOGRAPH #8: PUERTO RICAN under tow on November 1, 1984 at approximately 0930 in position approximately 35.5 miles at 215°T from Point Bonita. The swell in the foreground gives the illusion that the stern is awash. The angular difference at the gunwale shows the area where the forebody separated from the stern on the port side at the main deck. (USCG Photo)
