MARINE CASUALTY REPORT

SS OMI YUKON, D.N. 5479 19

**EXPLOSIONS AND FIRE ON 28 OCTOBER 1986
IN THE PACIFIC OCEAN APPROXIMATELY
1000 MILES WEST OF HONOLULU, HAWAII
WITH MULTIPLE LOSS OF LIFE AND
PERSONNEL INJURIES**

Report No. USCG 16732/0002 HQS 88

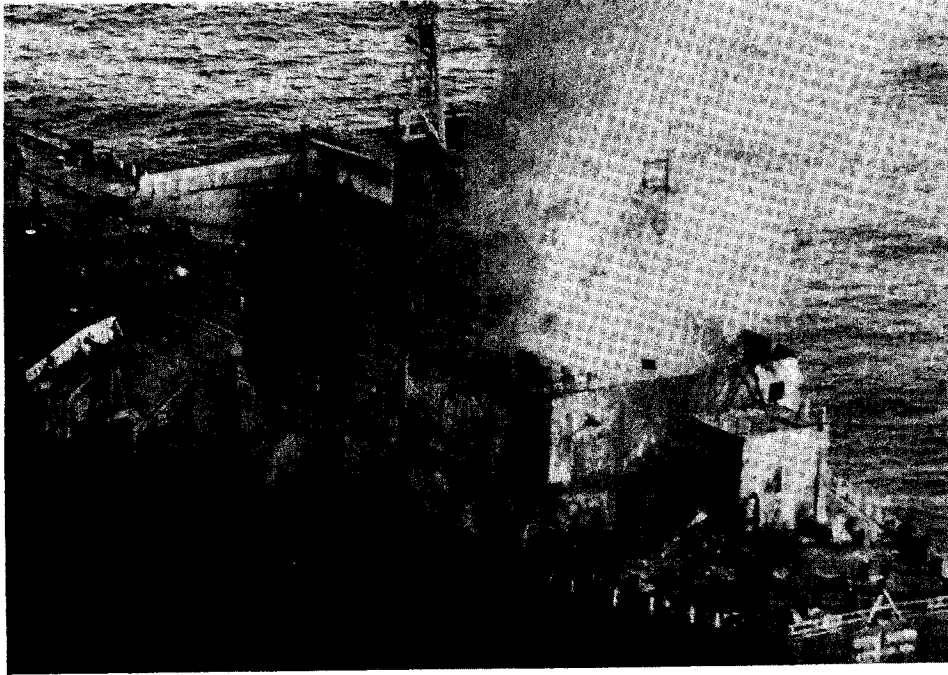
Photograph of the port side of the OMI YUKON taken on 29 October 1986 by LT. Kelly, USCG, C-130 pilot.

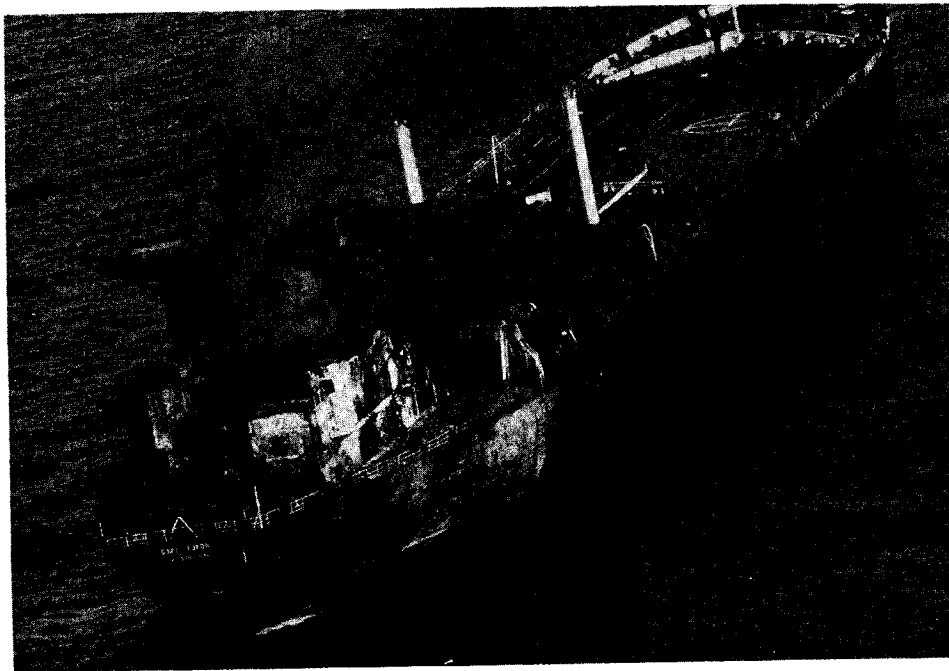
Photograph of the starboard side of the OMI YUKON taken on 29 October 1986 by LT. Kelly, USCG, C-130 pilot.

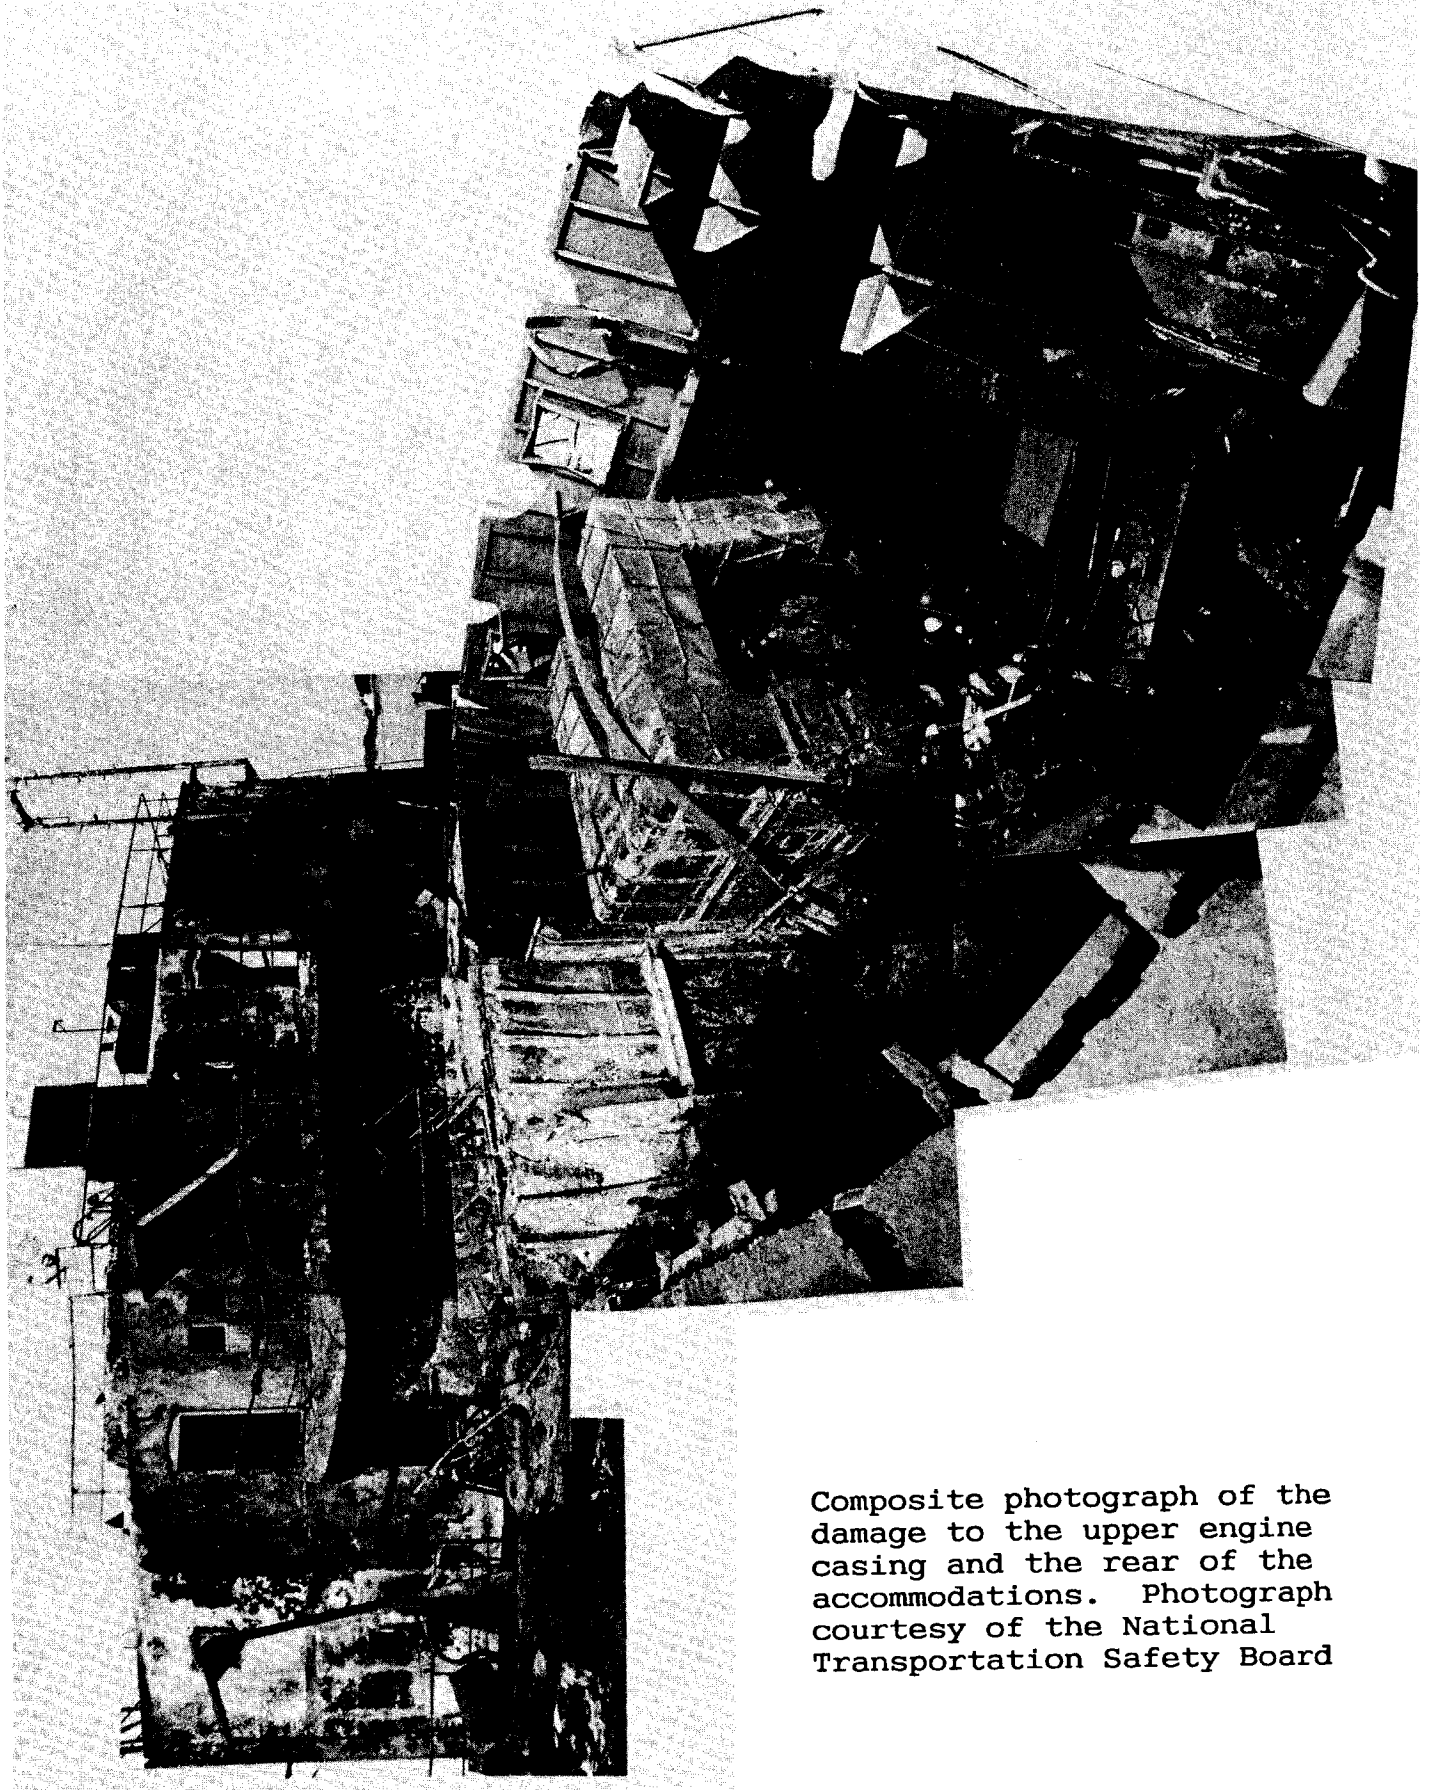
Composite photograph of the damage to the upper engine casing and the rear of the accommodations. Photograph courtesy of the National Transportation Safety Board

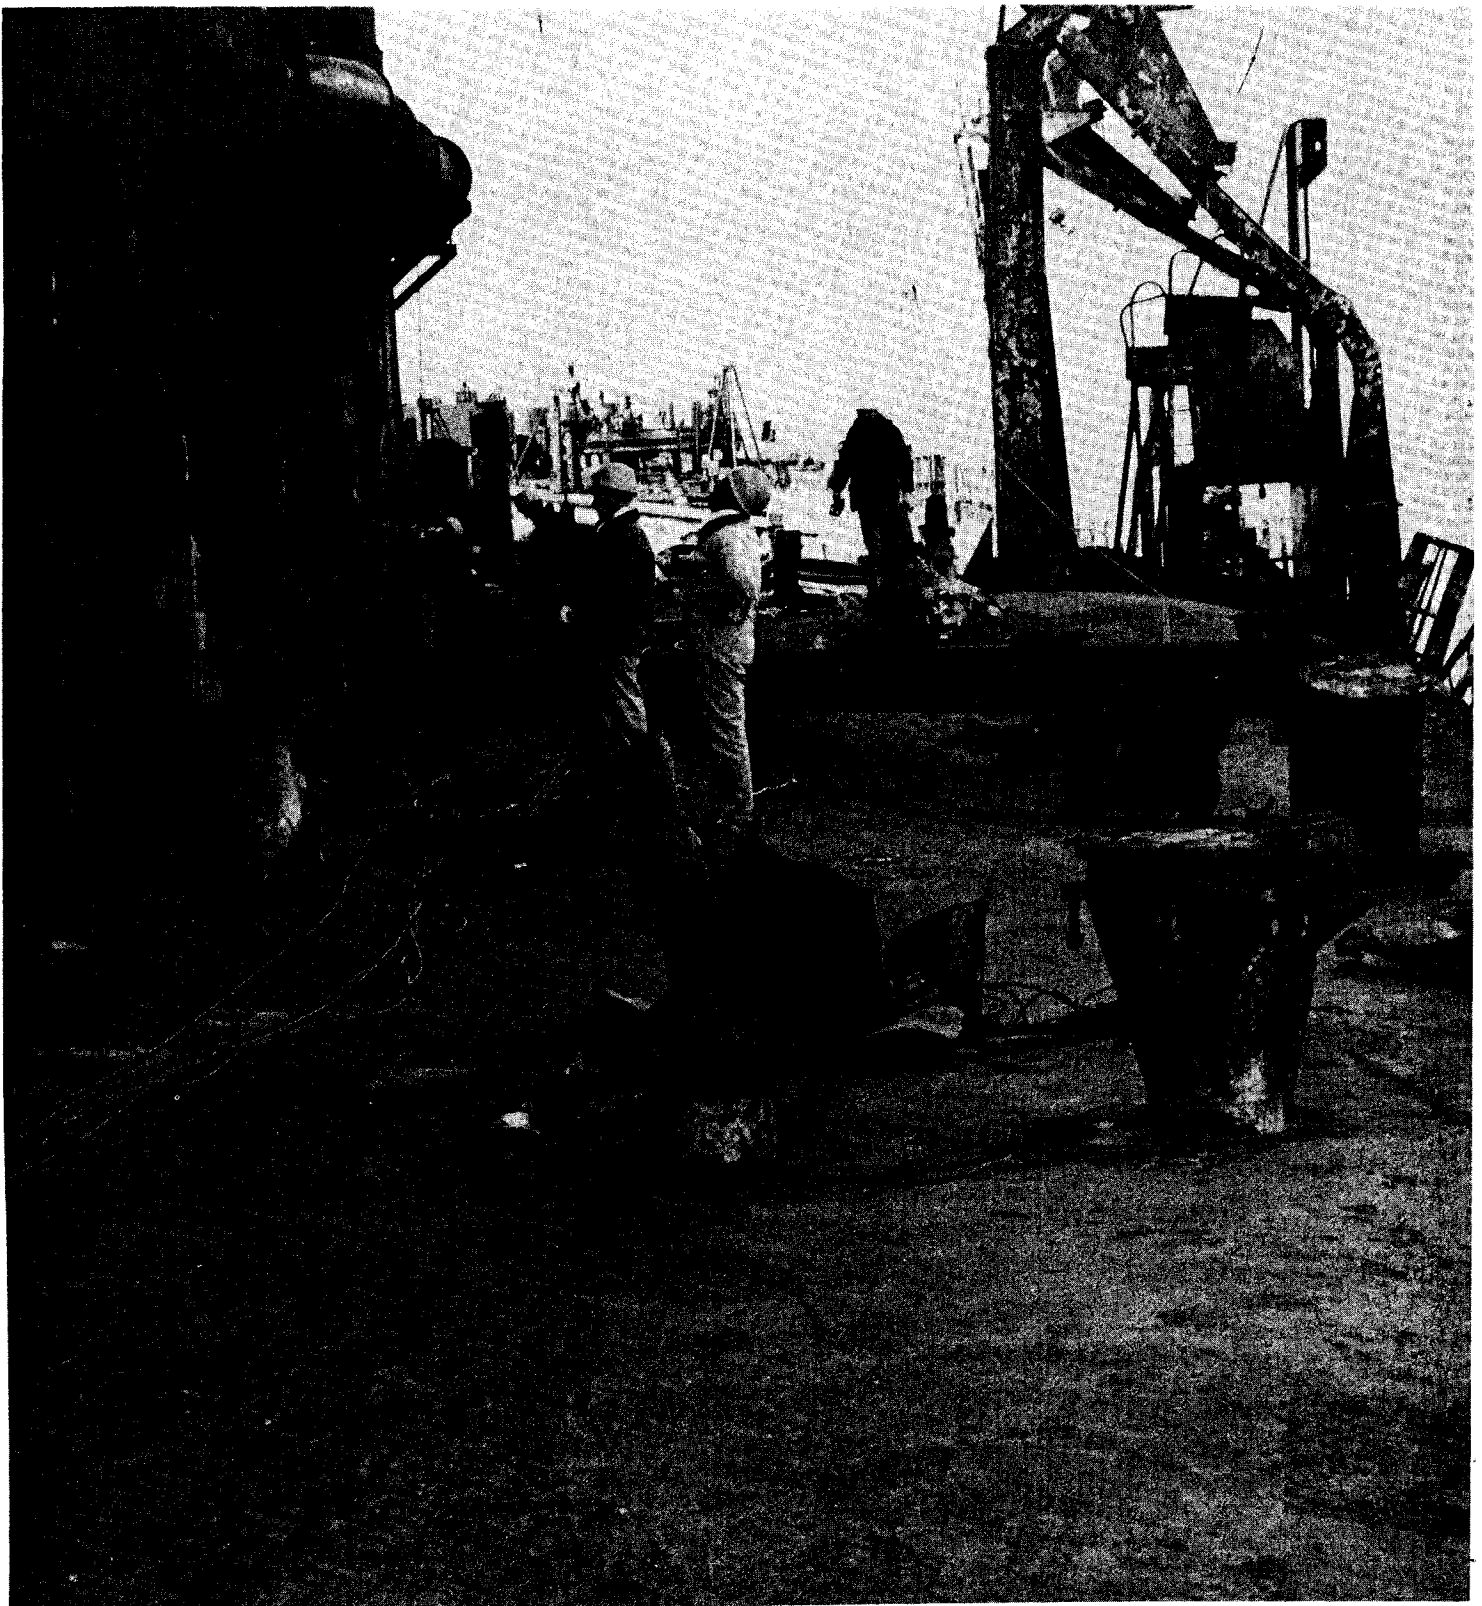
Photograph of the starboard side of the OMI YUKON depicting the damage to the main deck above the bunker tanks. The gooseneck vent in the foreground is the aft vent for the starboard fuel oil (bunker) storage tank. The object to the right of the vent is the garbage chute. The "I" beam laying on the deck diagonally is the fallen stores crane. Photograph courtesy of the National Transportation Safety Board

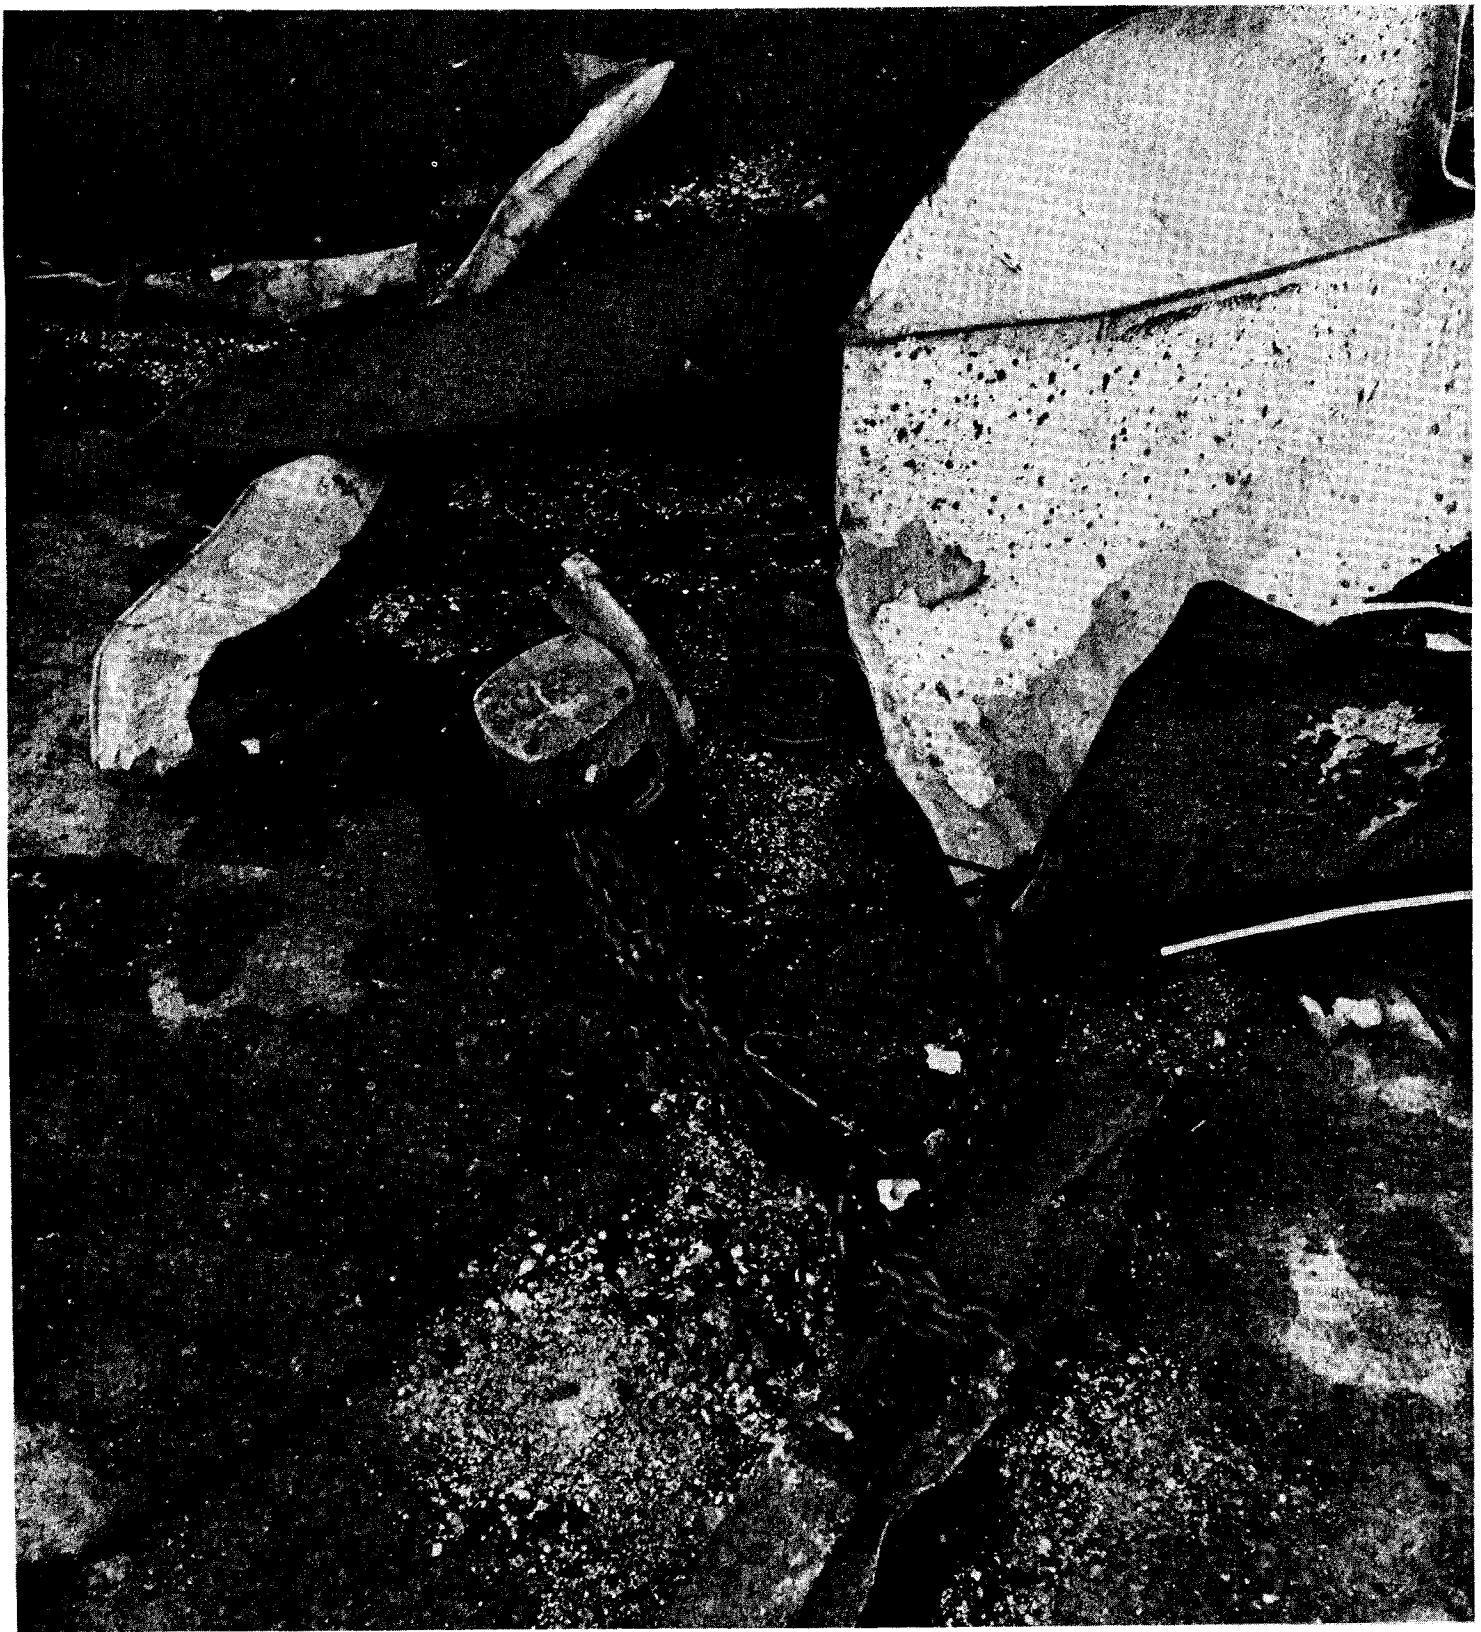
l. Debris found on the starboard aft deck in the immediate vicinity of the aft vent of the starboard fuel oil storage tank included: a burner's ignitor, sheet metal from vent louvers, the pin used for securing the storage boom to the side of the house, partially cut securing bracket for the stores boom, and small metal clamps and fittings used to connect section of oxyacetylene hoses. A section of portable electrical cord was found wrapped around a valve wheel on the accommodation house bulkhead in way of the forward hatch of the starboard storage tank.

m. The friction ignitor was found on the deck within ten feet of the aft vent for the starboard storage tank. The flint end of the ignitor was out of the cup. The ignitor was rusted and appeared to have been affected by heat.

Photograph of debris on the starboard main deck above the aft end of the starboard storage tank. The chain fall shown had been rigged to lower the stores boom during the removal process. A friction ignitor, with the flint end out of the cup, is in the center of the picture. Photograph courtesy of the National Transportation Safety Board.

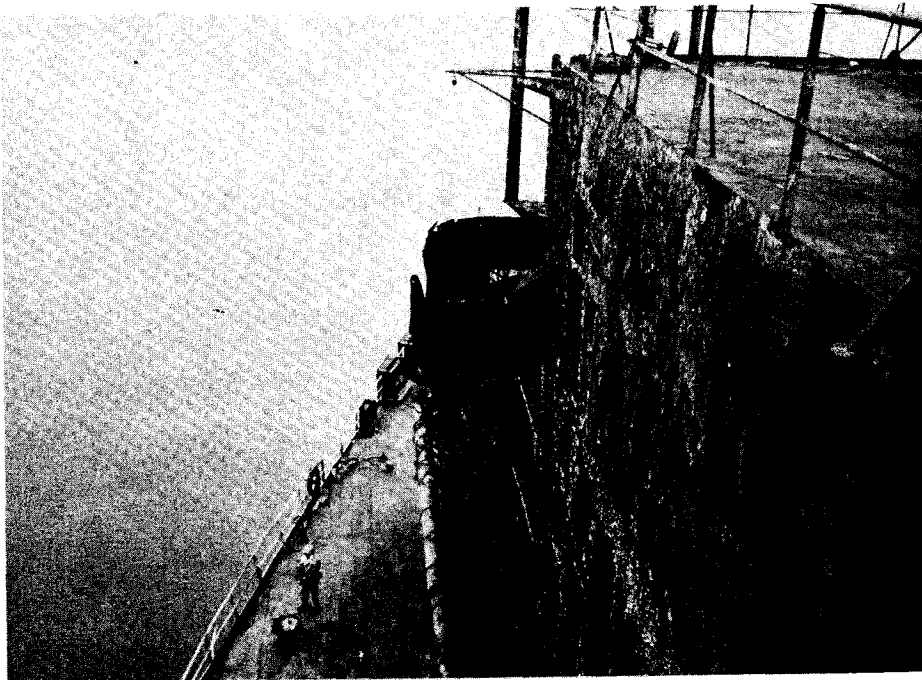
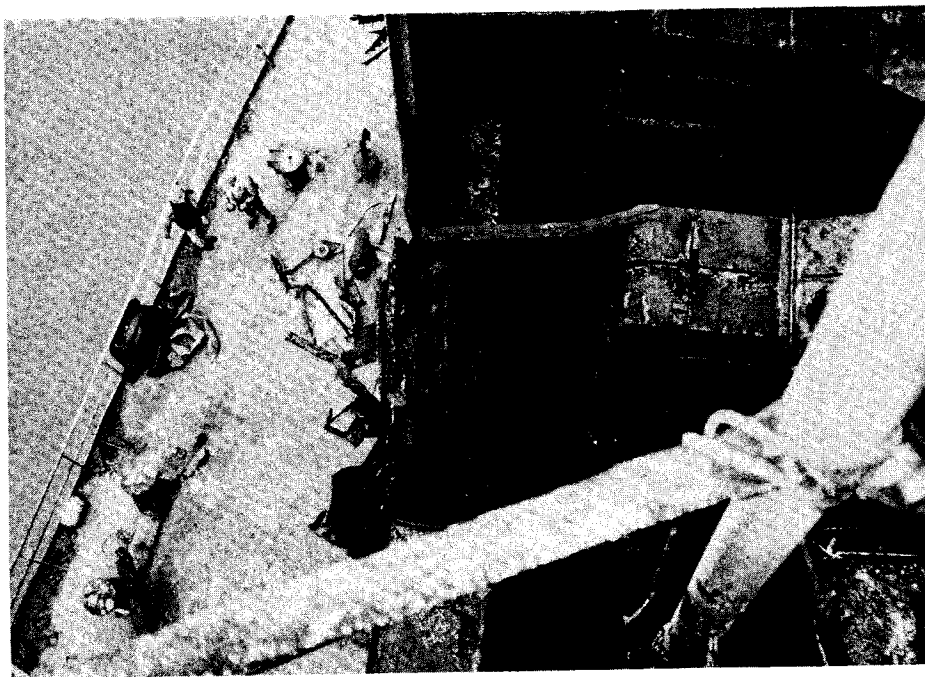
Photographs taken from the bridge deck of the OMI YUKON while the vessel was in Japan depicting an overview of the starboard storage tank. The top picture depicts two cables hanging down from the aft end of the starboard side of the accommodations house. Those cables were the stores boom support cables. The man in the top picture is standing aft of the garbage chute and the aft vent of the starboard storage tank. The lower picture gives a better perspective of the main deck above the starboard storage tank.

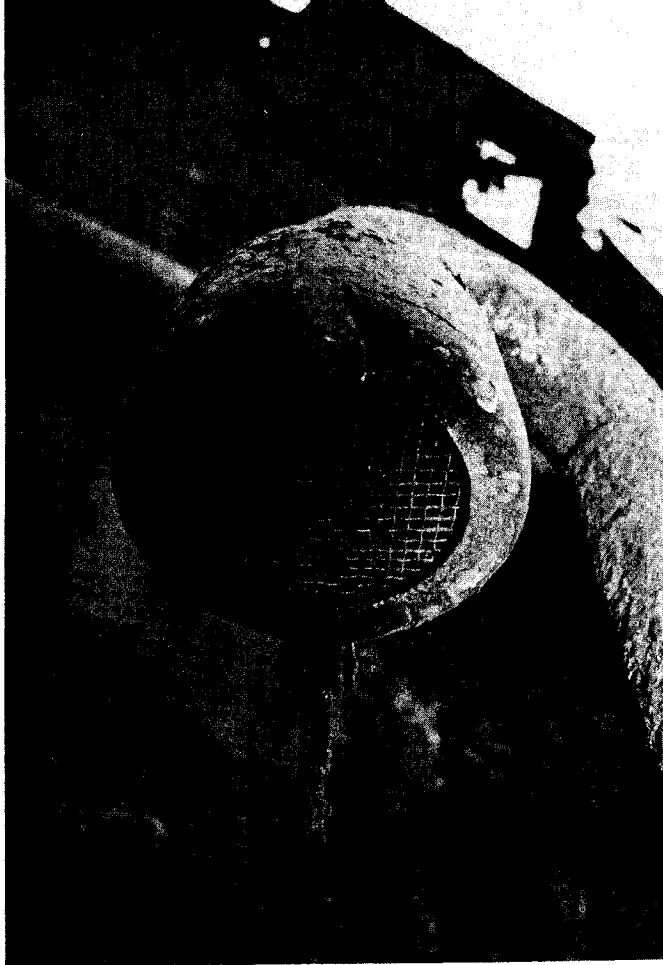
Picture of the aft vent for the starboard fuel oil (bunker) storage tank taken by a HIRI representative showing the gooseneck and flame screen assembly in place.

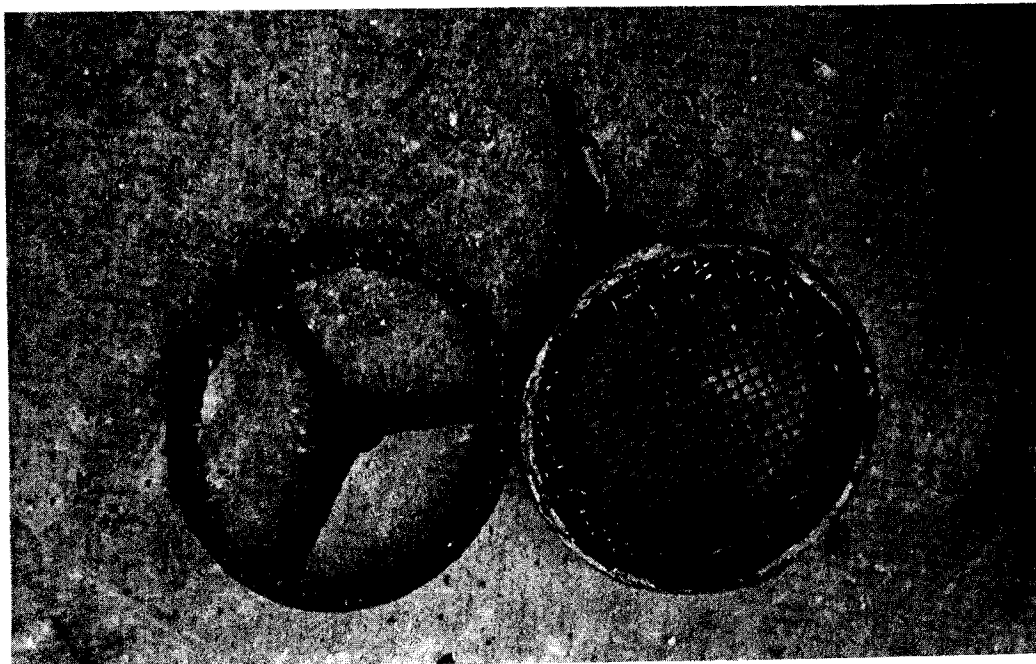
g. The gooseneck vent assembly for the aft vent on the starboard fuel oil storage tank was taken apart and there was no flame screen in the assembly. The course protective grid was intact. The ball check was split in half. On the circumference of the gooseneck mouth, above the flame screen assembly, there was an imprint in the paint residue of a previously installed flame screen.

Picture of the removed and taken apart flame screen assembly from the aft vent of the starboard storage tank. Above photographs taken by a HIRI representative.

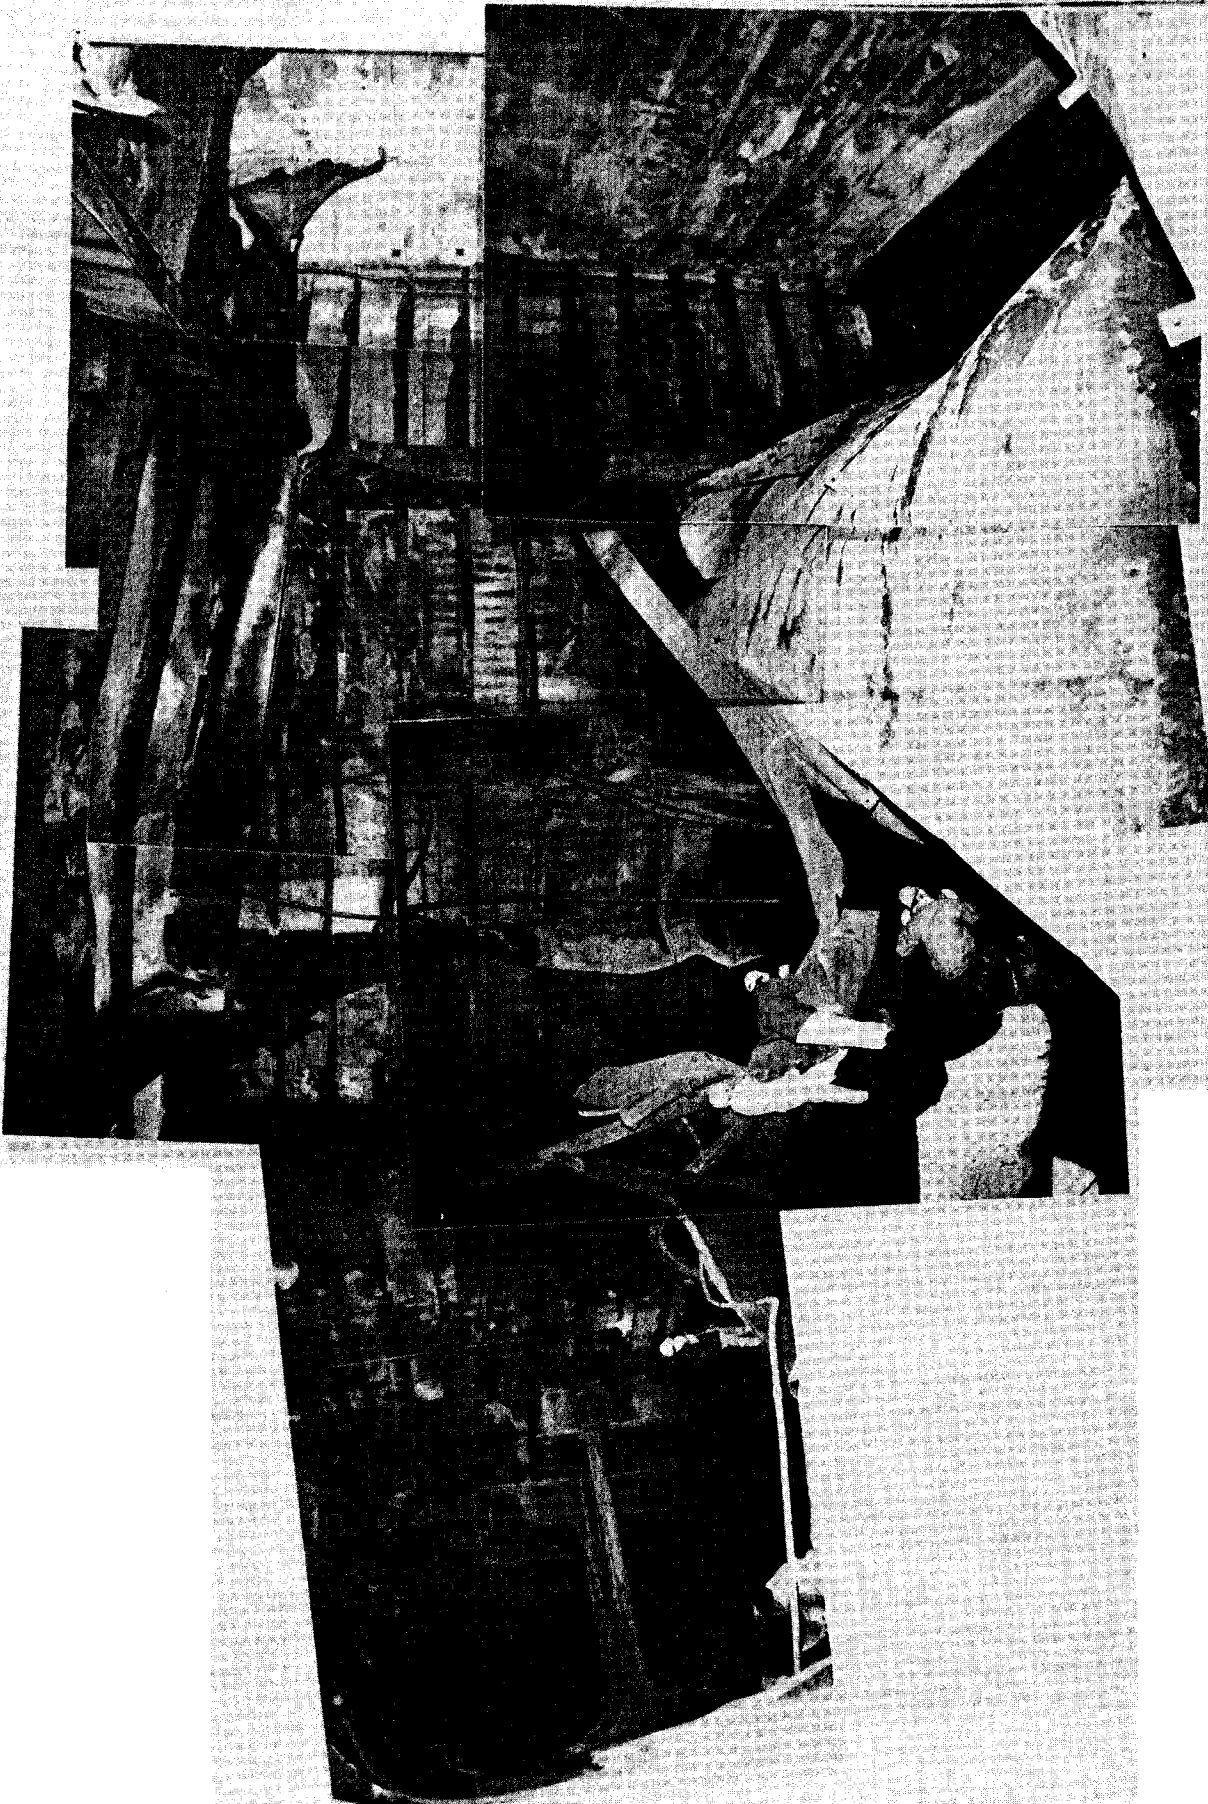
x. Internal examination of the starboard fuel oil storage tank revealed that the aft one of the two upper transverse web frames, located forward of the swash bulkhead was blown aft, where as the swash bulkhead originally located aft of this web was blown forward.

y. The starboard storage tank was opened to the sea when the swash bulkhead angle brackets ripped away from the side shell during the swash bulkheads movement forward as a result of the explosions. There were similar openings in the longitudinal bulkhead separating the engine room and the storage tank where the swash bulkhead was connected and ripped away during the explosions.

Composite photograph depicting the damage to the starboard settler, storage and transverse ballast tanks. The damaged transverse ballast tank starboard forward bulkhead is located at the far left of the picture. Photograph courtesy of the National Transportation Safety Board.

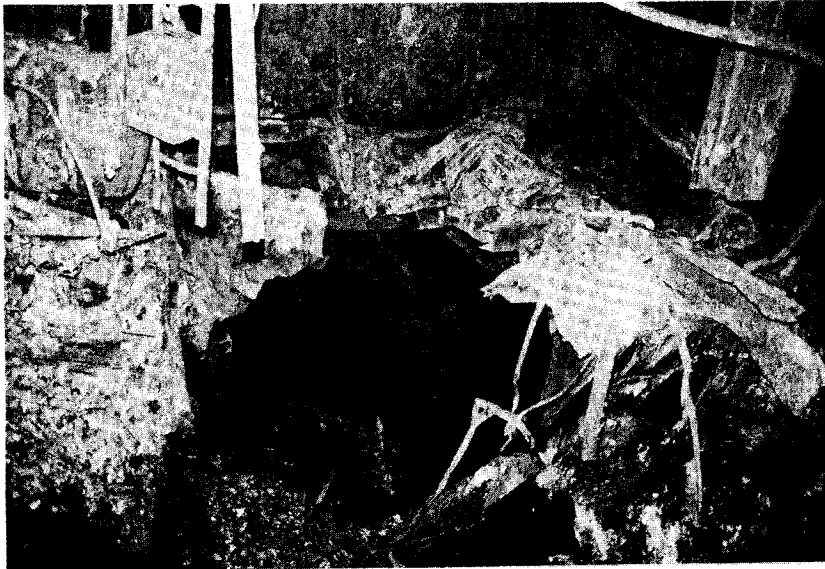
z. The bulkhead common with the engine room and the starboard storage tank had a significant breach large enough to drive a car through. The longitudinal bulkhead was blown into the engine room. The breach into the engine room was immediately forward of the original position of the transverse swash bulkhead in the storage tank.

aa. The major bulkhead penetration into the engine room created by the explosion within the starboard bunker tank was directly outboard of the control room and in way of the main electrical switchboard and automation console. The path of the explosion force which created this penetration was also directly in-line with the casing damage noted on the forward port corner of the boiler casing.

Photograph depicts the breach into the engine room from the starboard storage tank. The control room was located behind the debris in the right corner of the picture. Photograph courtesy of the Tsuneishi Shipyard, Tsuneishi, Japan.
