Golden Bridge: Engine room fatality, en-route to Newcastle, NSW – 10 December 2002

September 2003

Golden Bridge: Engine room fatality

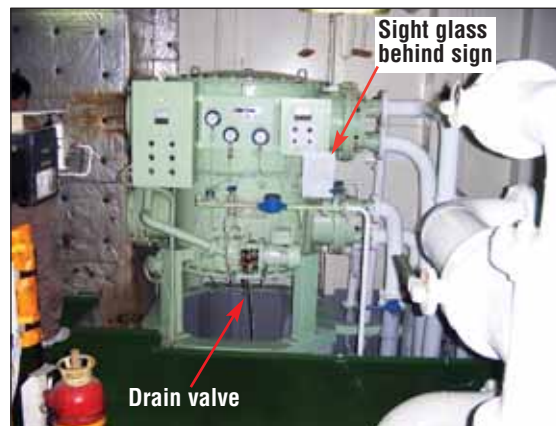
FIGURE 1: Photograph of fresh water generator

The fresh water generator on board *Golden Bridge* is a type WM-20H manufactured by Miura Company, Japan. It was supplied new when the ship was built.

A fresh water generator of this type makes fresh water using a flash distillation process. This is where seawater is heated in a vacuum until it 'flashes off' into vapour. The ensuing steam is then condensed to produce fresh water. During the process, the heater tubes in the evaporator (boiler) section eventually acquire a coating of calcium carbonate scale, which reduces the efficiency of the unit. This scale must be chemically removed periodically to bring the machine back to reasonable operating efficiency. An opening covered by a perspex sight glass is located on the side of the machine so that the operator can visually observe that the seawater is boiling. The sight glass is held in place by a steel retaining ring which is secured by eight bolts.

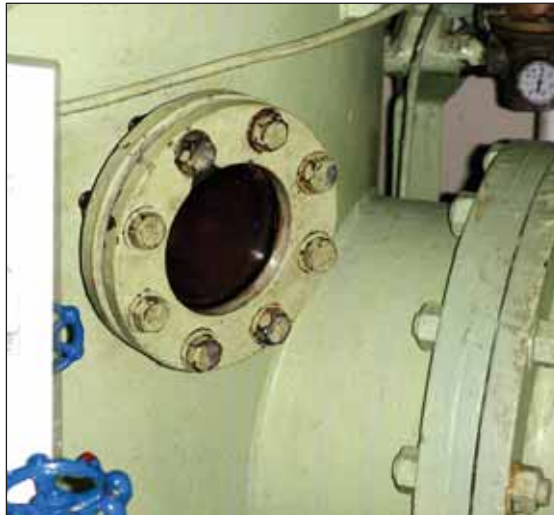
FIGURE 2: Close up of sight glass

evaporator section to aid in the removal of any built-up scale. Firstly, the sight glass (see photo) was removed. The chemical was then poured into the evaporator through the sight glass opening using a hose and funnel. To assist in the mixing and efficiency of the chemical, as prescribed by the chemical's manufacturer, air was bubbled through the descaling mixture. This air was supplied from the ship's service air system, at a pressure of 7.5kg/cm², via an air hose connected, using a ship manufactured fitting, to the drain valve on the base of the fresh water generator.

The third engineer was killed when he erroneously replaced the sight glass whilst the evaporator was still being supplied with service air. The pressure inside the fresh water generator built up until the sight glass burst. The sight glass was the weakest part of the pressure vessel and hence failed first while the third engineer was still standing in front of it refitting the retaining ring bolts.

1. The third engineer had replaced the sight glass whilst the service air was still being supplied to the evaporator causing an internal overpressure and eventual rupture of the sight glass.
2. The change of chemical being used for descaling required a procedure that had not been the subject of an on-board job safety analysis or a written procedure.
3. There were no written instructions and inadequate verbal instruction provided to the third engineer.
4. There was inadequate supervision of a relatively junior engineer.

Senior ship's officers should ensure that any new staff are adequately instructed and supervised during their initial stages on board a ship especially in procedures specific to that vessel where written procedures for ship specific operations are not available.

Ship staff should review their written procedures and job safety analysis to ensure that all 'critical shipboard tasks' have procedures written to detail the correct procedure for safe completion.

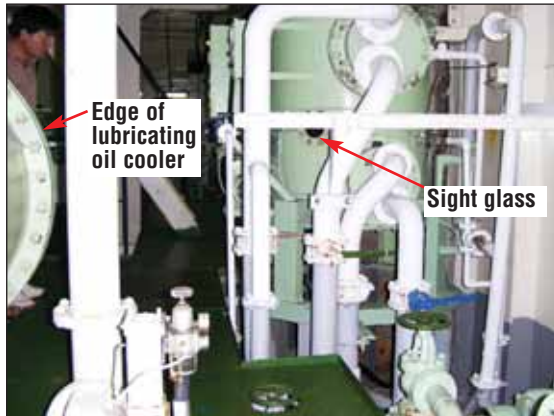
FIGURE 3: Photograph showing lubricating oil cooler

The chief engineer had witnessed the removal of the sight glass and the addition of the chemical before leaving the engine room. The third engineer had now only to wait for the chemical to do its job before flushing and reassembling the unit. Though this task is fairly straightforward, the third engineer's lack of experience, as well as lack of time on board, should have meant an enhanced level of supervision. He was supervised for part of the task but this did not extend to an explanation of the continuing dangers or precautions required. He had been in the process of replacing the sight glass (with the service air still being supplied to the vessel) when the glass had exploded due to the build up of pressure within the evaporator. The glass and air blast had hit him in the face causing him to be thrown backward against the lubricating oil cooler behind him (see photo). It was these head injuries which caused his death.
