Summary

The Australian registered tanker Australian Achiever, of 127,575 tonnes summer deadweight, cleared the New Zealand port of Whangarei for the port of Brisbane at 2030 on 7 November 1992. The ship had part discharged and retained on board about 35,000 tonnes of crude oil.

AUSTRALIAN ACHIEVER

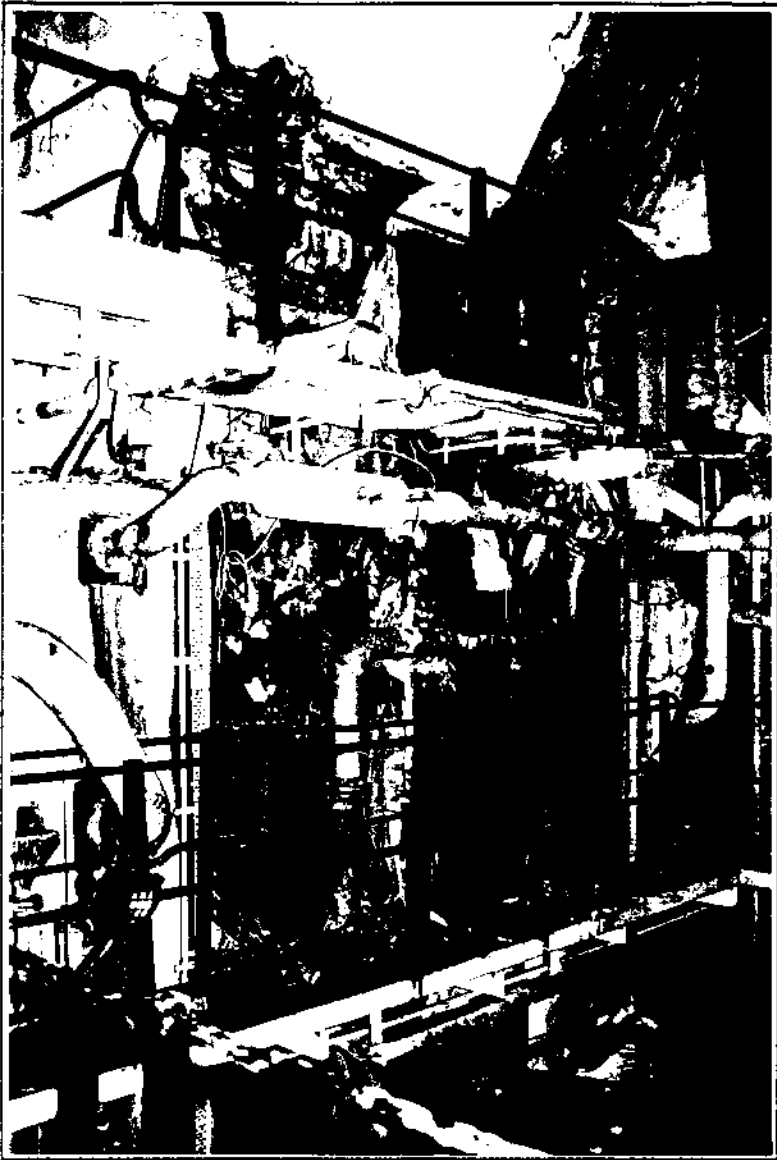
leaving a 50mm gap through which the gas could pass. Also, the tube banks within the unit were severely damaged. There was a hole, about 500mm in diameter, in the lower inboard casing and a further hole in

*Inboard side of
Waste-Heat unit top
and bottom manholes
are visible*
