Departmental investigation  
into a fire in the  
engine room aboard  
the Australian Antarctic  
Research and Supply Vessel  
**AURORA AUSTRALIS**  
off the coast of West Australia  
on 14 January 1999

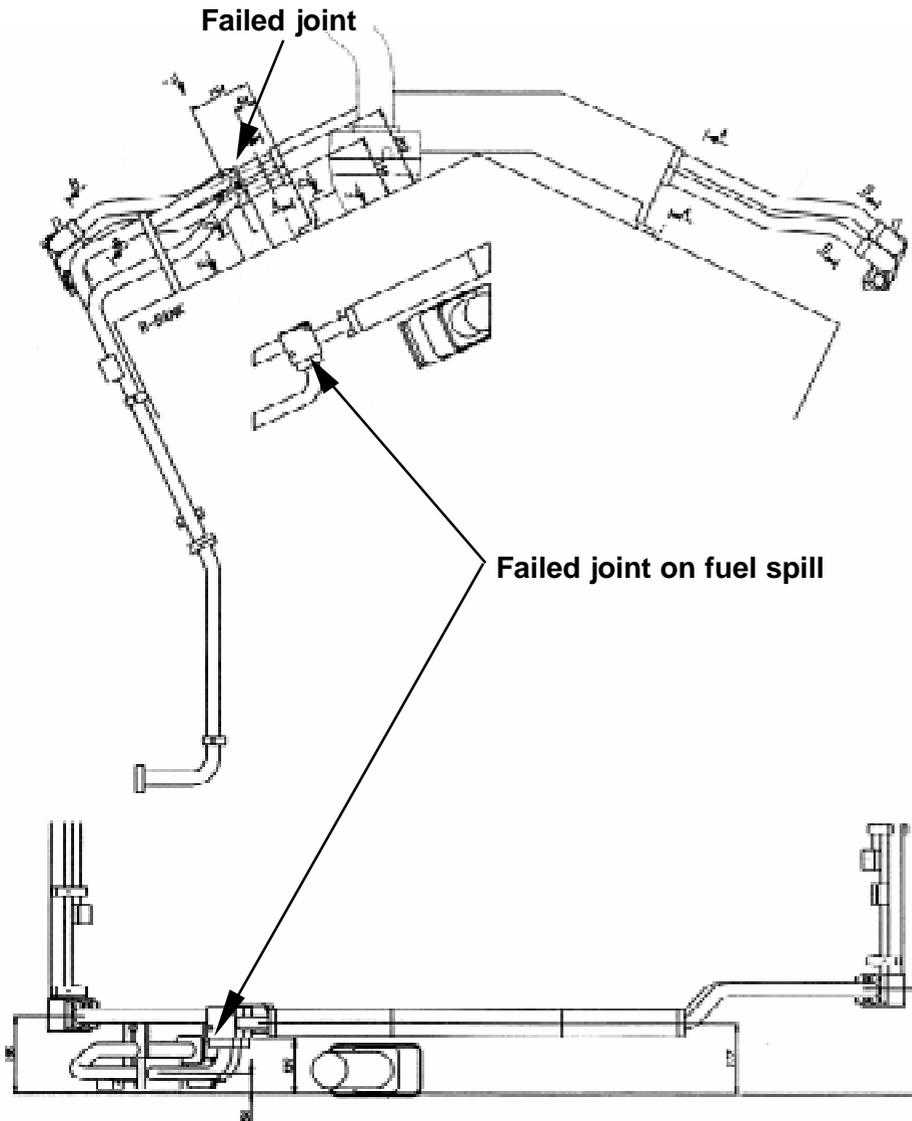
Elevation looking aft

When the cover was removed, it revealed a failure of the flanged joint on the fuel return pipe, adjacent to the forward end of B bank, where it branches across the engine to the hot box of A bank. See diagram page 19. Of the four screws securing the flange, the upper two had broken, the left lower screw was quite loose and the fourth had lost its preload. The pipe had sprung and the joint had opened up about 3 mm. During the investigation the engine room staff reported that difficulty had been experienced fitting the LP fuel pipework and this is borne out by the fact that the pipe sprung when the screws failed.

Failed joint on fuel spill

Fuel supply and spill pipework at forward end of VASA 32 engine

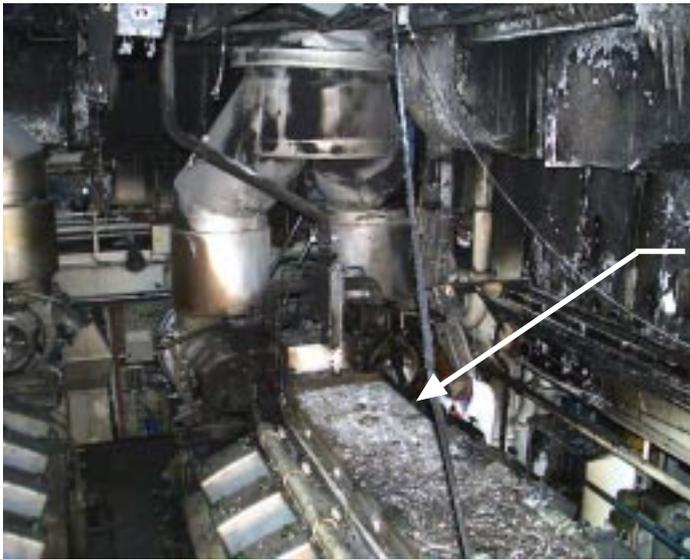
Fuel sprayed from this area

Fire damage around starboard main engine

Damage to the starboard main engine was limited mainly to rubber and plastic components such as cooling and vent pipes, some fittings and on-engine wiring.

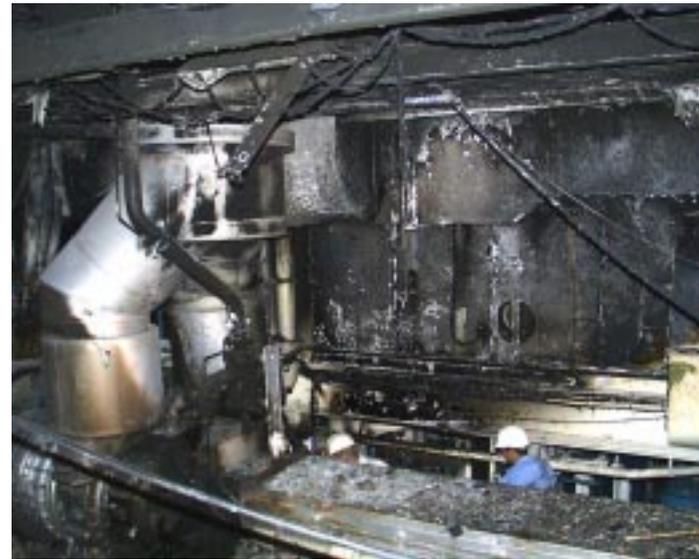
Fire damage around starboard main engine

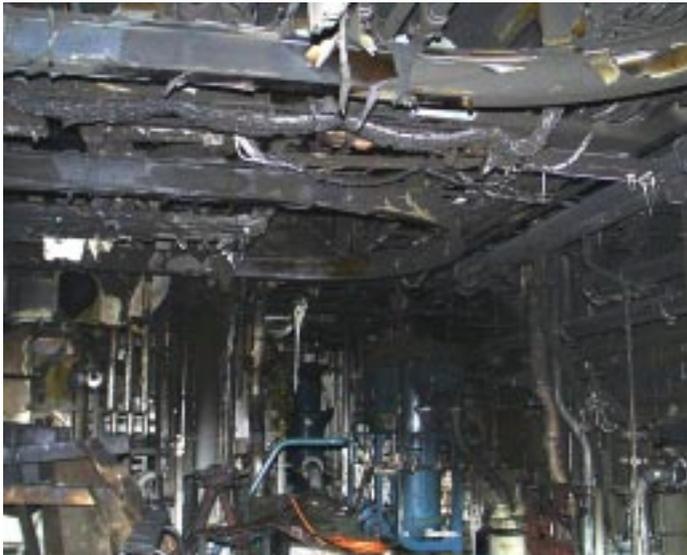
Damage to electrical cables under deckhead

It is usual, in incidents of this type, for even a relatively short-lived fire to produce enough hot gasses, which rise and become trapped against the deckhead, to rapidly cause severe heat damage to electrical cabling in cable trays. It was this effect that had caused the most serious and extensive damage. The fire damaged power cables, control and monitoring wiring and lighting throughout a large area of the engine room, both under the platform deck and the engine room deckhead. (See photos 20 ) It is also likely that charring of cable insulation caused most of the smoke which was generated during the incident.

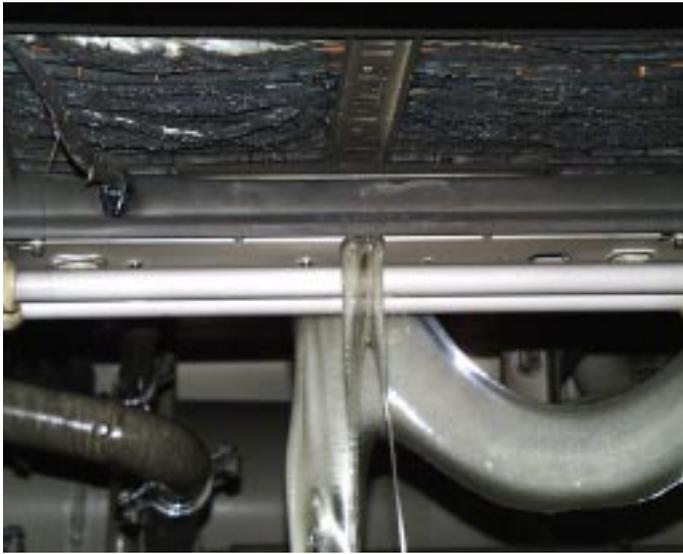
**Melted polycarbonate light diffuser**

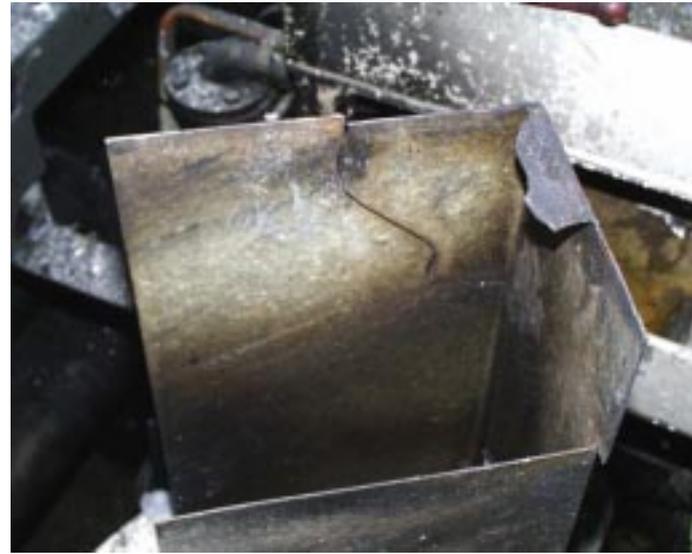
**Damaged sheet metal cover in situ over failed joint**

Wärtsilä VASA 32 engines are provided with sheet metal covers which shield the joints on the LP fuel systems outside the hot-boxes. The cover which was in place over the failed joint at the time of the fire, however, was not of Wärtsilä supply, but had been made up by shore contractors some two years earlier, as had the replacement cover adjacent to it. The cover was not a good fit, leaving a gap along the side adjacent to the engine. It was also badly cracked and had most of one end missing, the damage most likely having been caused by work-hardening from vibration. See photos, page 21

Other covers which were in place both on the starboard and the port main engines were well fitting, and showed no gaps such as existed at the aft side of the cover in question. The gap was exactly in line with the flanged joint which it was supposed to be protecting, with the result that the spray of leaking fuel issued directly through the gap.

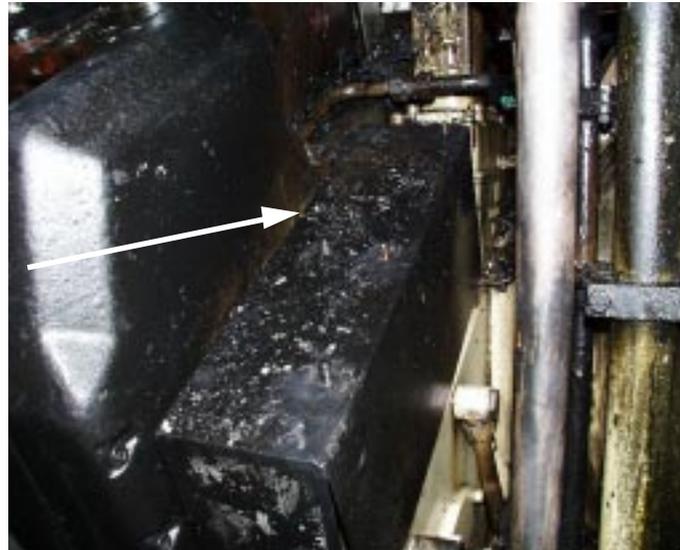
**Fuel sprayed through gap here**

**Damaged sheet metal cover removed from engine**

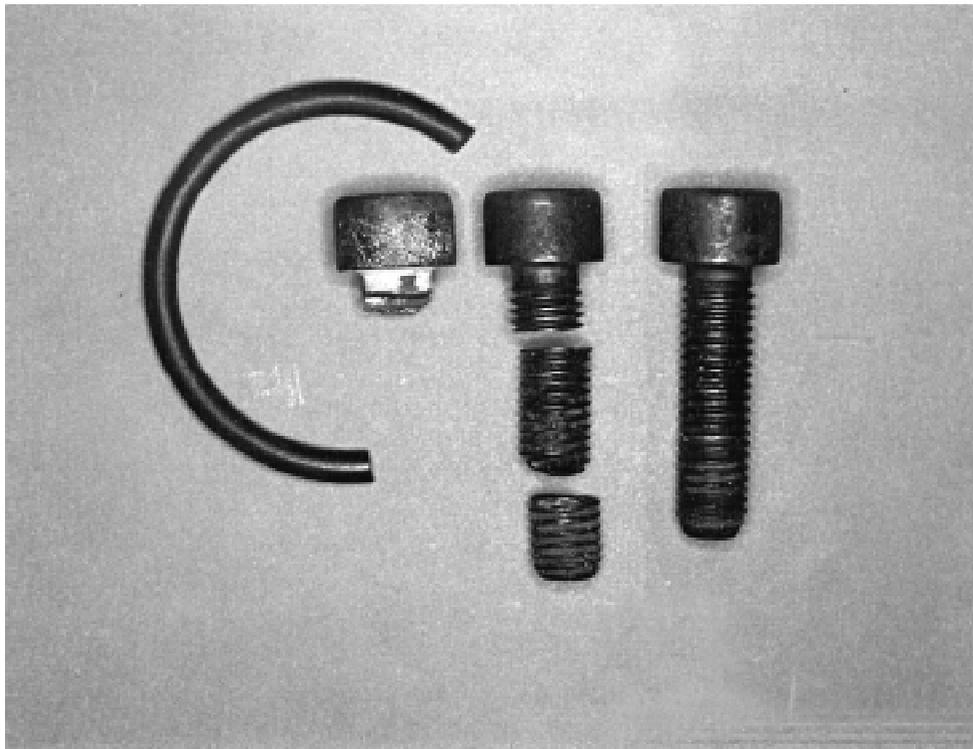
The shipowner supplied two complete screws and parts of two screws from the failed joint for metallurgical examination by ETRS. One screw head was missing. None of the three screw heads, with their small portion of attached thread, showed the reported distortion in the thread. See photos next page.

The O-ring was also examined and it was found that, as the rubber was firm with no visible degradation or cracking, it had not contributed to the failure.

**Screws and O-ring from failed flange joint, as supplied for examination**

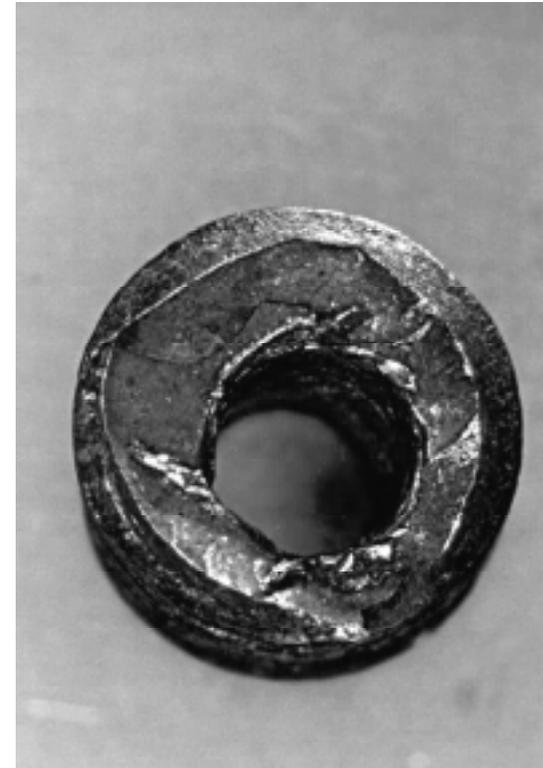
The report, commissioned by the shipowner, on the examination of the screws which were provided, contained no conclusions but in discussion stated that one screw, which had failed in high-cycle, low-stress, fatigue, had failed first. The other screw had started to fail in fatigue, but when the first had failed, this one had then suffered a fast fracture. The two intact screws from the flange showed no sign of over-tightening or fatigue.

**Fracture surface of one of the failed screws (drilled for removal from tapped hole)**
