SUMMARY OF EVENTS

The offshore supply vessel M.V. Maersk Handler suffered a serious fire in the engine room on 7th April 1984, whilst on passage from the rig Maersk Valiant to Port Hedland, WA.

M.V. MAERSK HANDLER

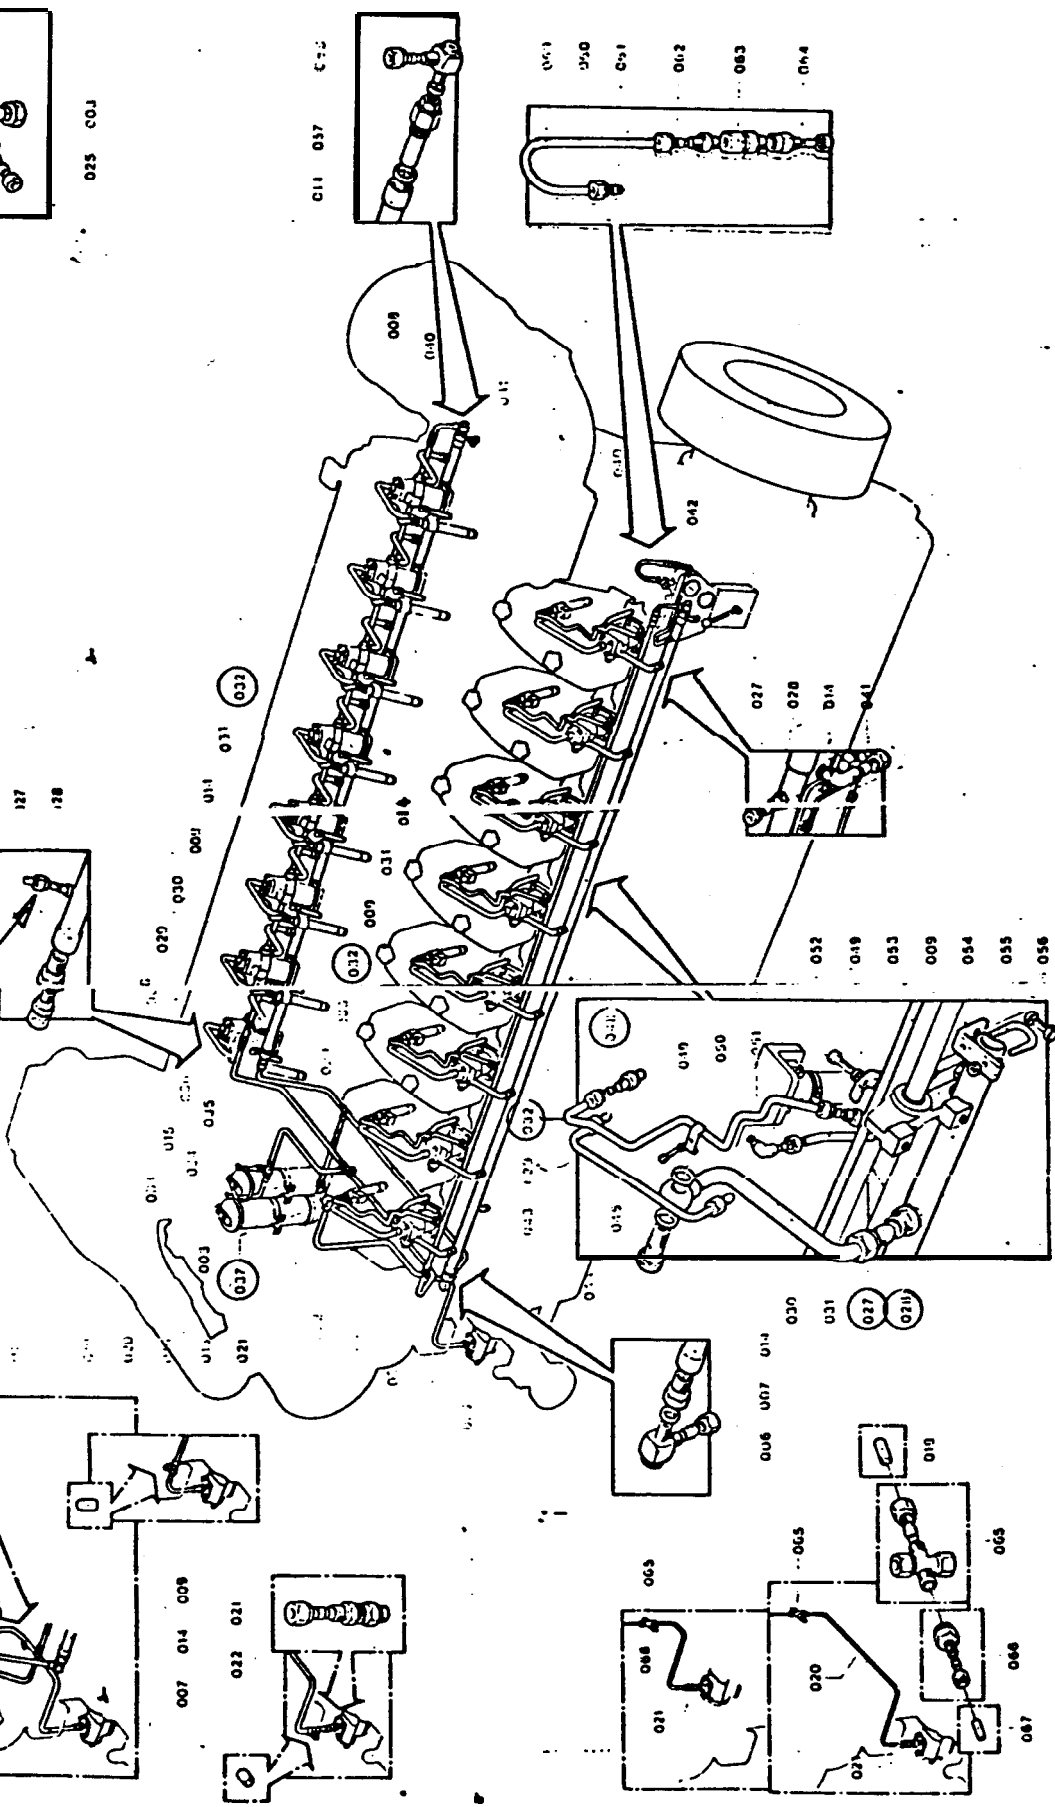
Fig. 1105

Each engine was served by two identical fuel rails, one down each side, a pressure gauge being fitted on a tapping on the port rail of each engine and the tapping on the starboard side being blanked off. The cause of the fire was discovered to be the failure of the blanked tapping on the starboard side of the starboard engine, which then released fuel onto the engine where it ignited. There was one of these blanks on each engine and they were only shown in the engine spare parts book, not in the operation manual. They were not provided with any locking devices.

nipple on the rail, a shaped olive of non-ferrous alloy, and a cap. This fitting was the same, but of smaller size than the other fuel pipe connections, except in this case a solid rod piece was inserted instead of a pipe. When a conventional pipe is inserted in this type of fitting, although the olive is of a softer metal than the pipe, the compression effect of the cap on the olive causes the pipe wall to distort slightly. This has the effect of locking the pipe into the olive. However, by using a piece of solid rod, instead of a pipe, this distortion could not occur and the rod would only be held in place against the pressure of the fuel in the pipe by friction. A sketch of the engine showing the blanked fuel line nipple is attached.

The cause of the fire was the loss of the blank on the superfluous nipple on the starboard engine starboard fuel rail. The diesel fuel which escaped as a result of this loss, forced out under pressure by the low pressure booster pump, ignited when it came into contact with the hot areas of the cylinder head and exhaust manifold.

The engineers stated that they were unaware of the existence of this blank. When the rod piece blank was discovered to be missing the tightness of the compression cap nut was checked and discovered to be quite firm. The missing piece of rod, which is 20mm long and 6mm diameter, was not recovered but the olive was intact. It appears that for some reason the friction bond between the rod and the olive failed.

The fact that the cap was found to be still hard up after the loss of the blank, showed up a deficiency in the design of the blank. The adoption of such a blank is considered to have been very poor design practice.

BLANKED FUEL LINE
NIPPERS
023 (07) 011 026

A modified blank was manufactured and fitted. This dispensed with the olive and piece of rod, and the modified blank was fitted under the screwed cap. Its overall diameter was such that it would be impossible for it to pass through the hole in the cap.

The new blanks, which were manufactured for the Maersk Handler, are a much more reliable fixture. However, on an engine running continuously at between 400 and 800 rpm it can be expected that any unlocked screwed coupling could loosen in time due vibration. Accordingly new blanks should be secured mechanically in some way to prevent the fuel leak which would occur if they became slack.
