Iron Flinders general arrangement

Summary

Shortly after berthing at West Swanson dock, Melbourne, on 24 September 1993 the 13280 g.r.t. container and general cargo vessel "Iron Flinders", on charter to BHP Ltd., suffered a fire in the waste-heat unit (economiser) which is situated in the main engine exhaust trunking at the base of the funnel.

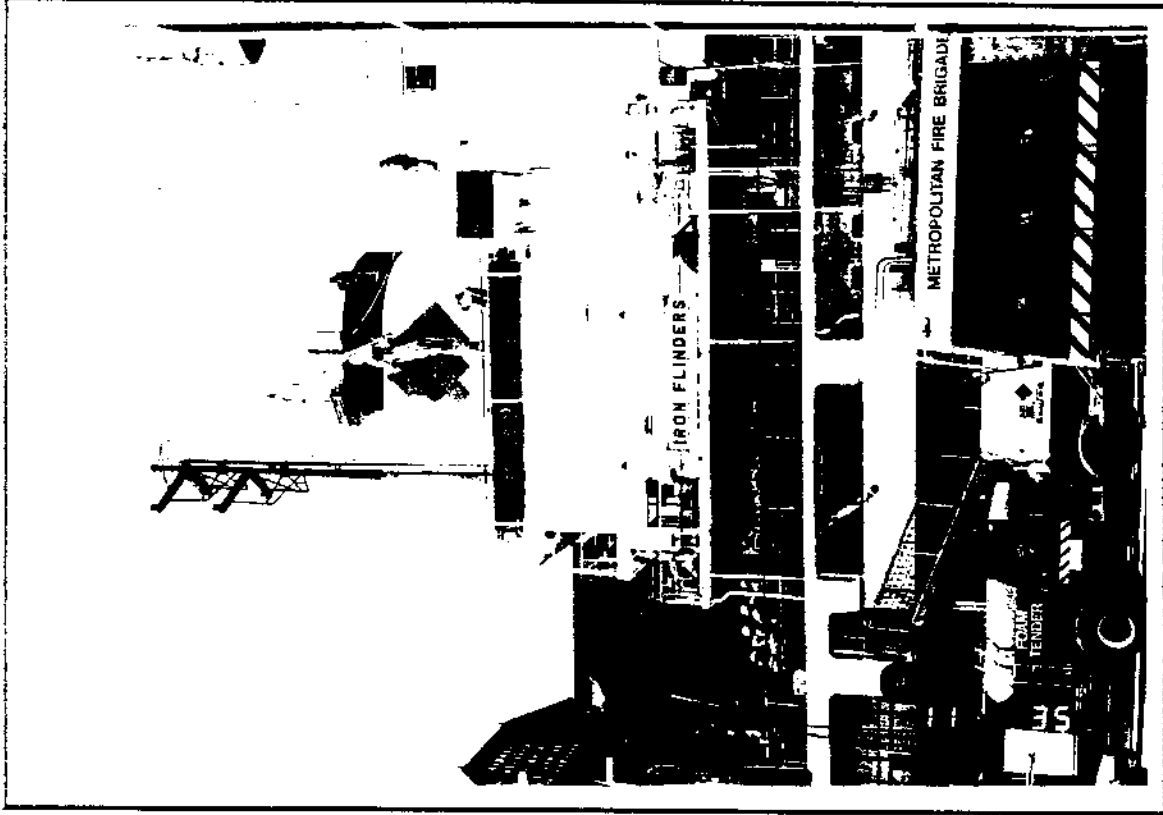
Fire blanket and pallet "plug" being positioned over the funnel, approx. noon 24 September 1993

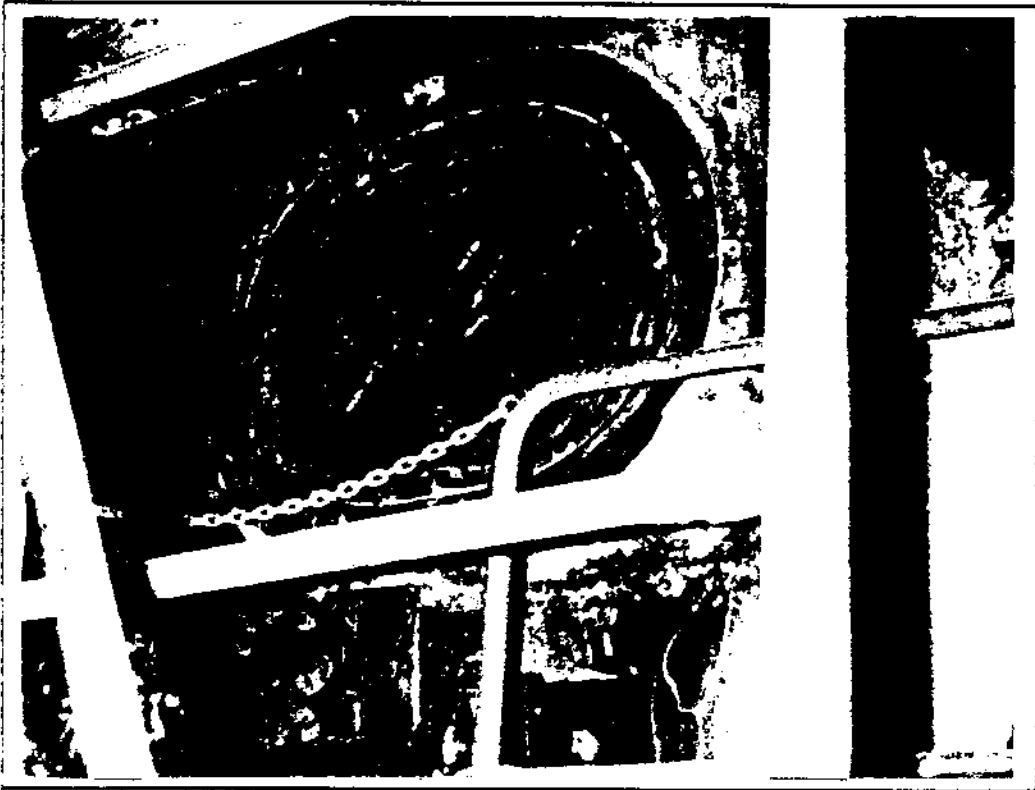
Waste heat unit lower inspection access (door removed)
