MARINE SAFETY INVESTIGATION
REPORT 174

Independent investigation into
the ballast tank explosion and subsequent fatalities
on board the Hong Kong registered bulk carrier

Nego Kim

Report No 174
October 2002

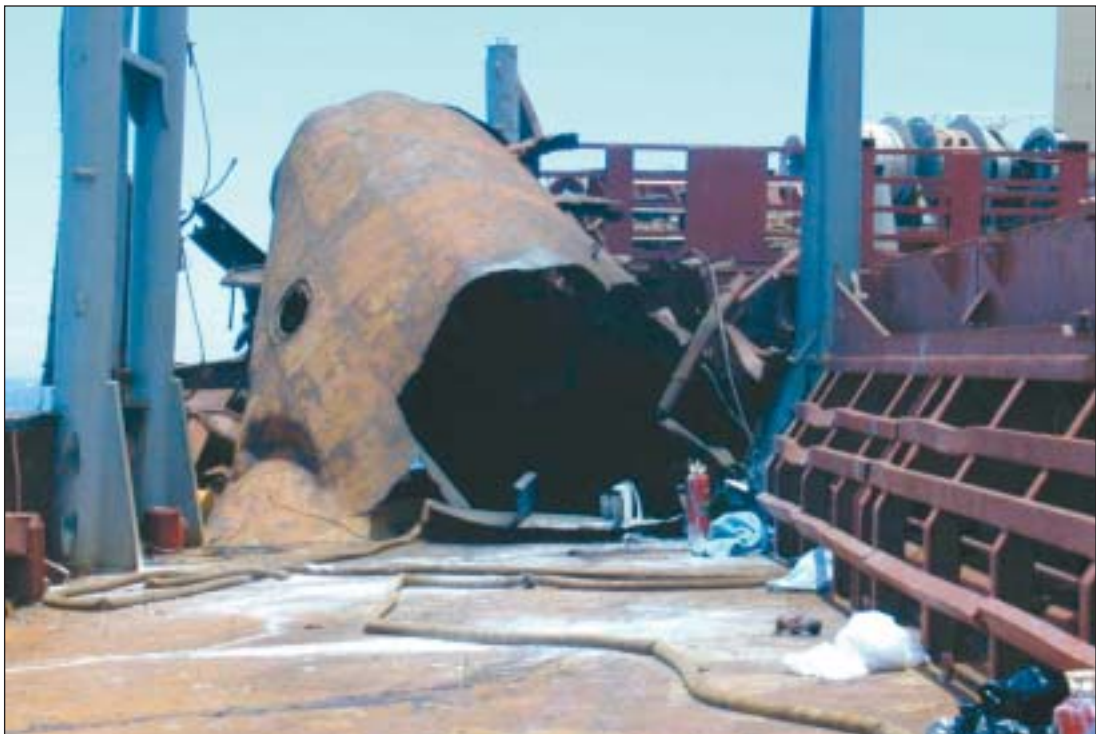
FIGURE 2:
Ruptured tank on *Nego Kim*

At about 1640 a large explosion ripped through the tank. The tank ruptured and three men were blown down the length of the main deck, killing them all instantly. The explosion also blew four other men over the ship's side. One man, who had been inside the tank, was still alive although severely burned. He was assisted out of the tank, through the ruptured maindeck plating, and later airlifted ashore. Eighteen days later he died in hospital as a result of his burns and other injuries.

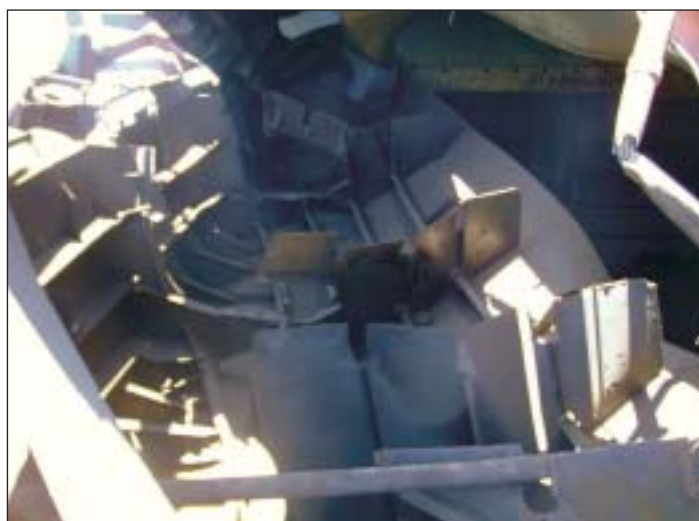
FIGURE 7:
Interior of port topside ballast tank after the explosion

Inspection of the tank by investigators found very little mud or ballast residue, which was consistent with the work order covering the planned maintenance of the tank. A small quantity of water in the tank was probably the result of firefighting immediately after the explosion.

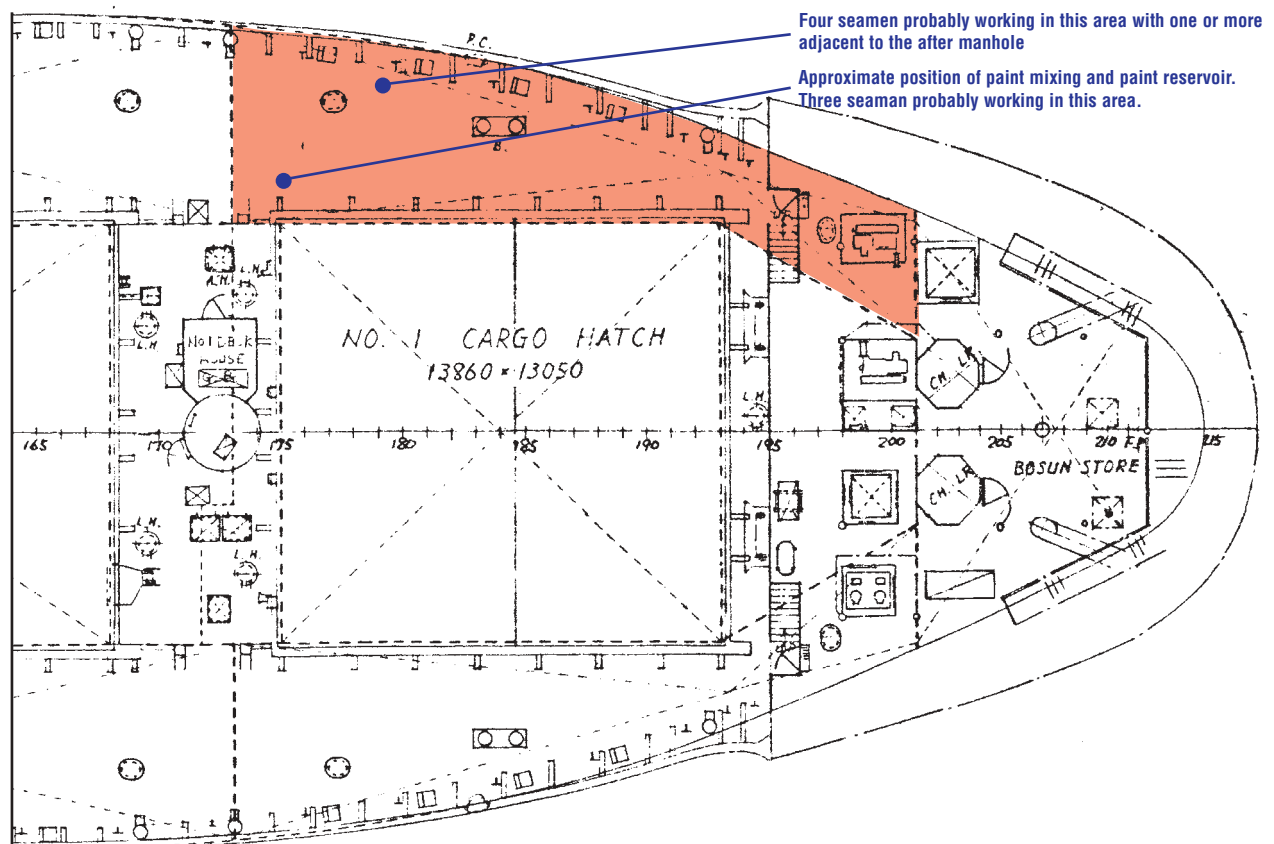
FIGURE 8:
Upper deck of *Nego Kim* - over port topside ballast tank (shown shaded)

The post mortem examination would suggest that the three seamen who were killed on the deck of *Nego Kim* were standing aft of frame 175 over no.2 topside tank. The crewman whose body was recovered from the water had probably been standing between frame 175 and frame 190, over no.1 TBT. The other missing seamen were also probably standing over the area of deck that had violently ruptured.

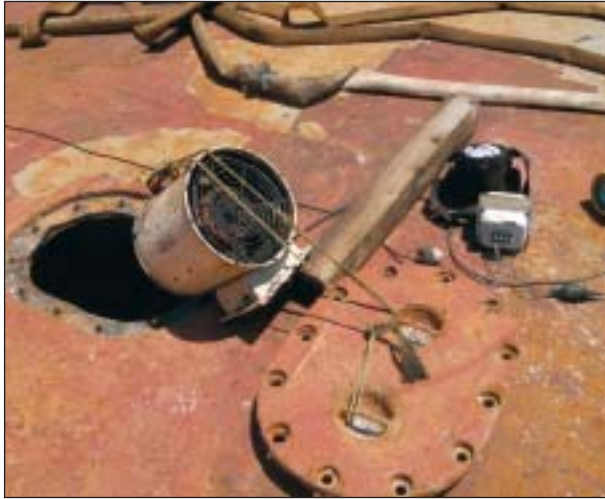
FIGURE 10:
Similar fan rigged on 21 November

The fan was set to supply air (blow into) the tank rather than exhaust the atmosphere from within the tank as recommended in the paint manufacturer's instructions. When using a supply fan, a trunking should be used to deliver the supply air to the bottom of the space rather than just to the upper area. Not only was the fan set to supply air to the tank without a trunking, but it was set at an angle to the manhole thus rendering a calculation of the volume of air supplied to the tank highly problematic.

The probability is that the actual airflow rate into the tank was far less than 40 m³/min and the concentration of volatile thinner added was significantly higher than 5 per cent, the maximum volume recommended. The evidence is that, with these combined factors, an explosive atmosphere accumulated within the 2 hours and 10 minutes which elapsed from 1430, when painting was resumed, to the time of the explosion.

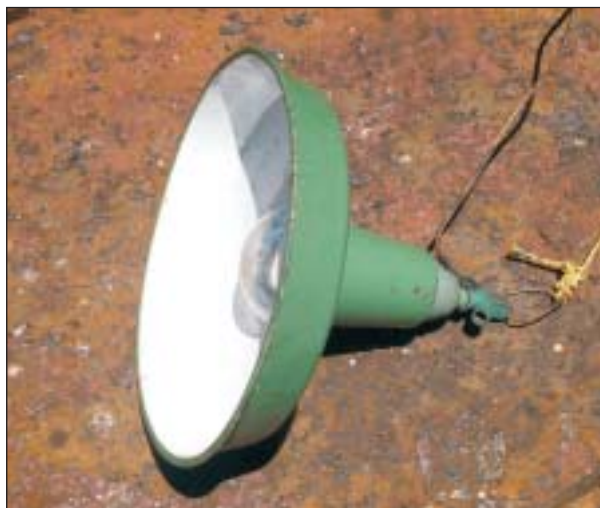
FIGURE 11:
Cargo light assembly

- the deterioration of the cement holding the glass globe, particularly with a globe at the limit of its life, could allow vapour to come into contact with the incandescent filament;
- poor connection between the screw cap and the lamp holder fitting, particularly in an atmosphere prone to corrosion which can lead to high resistance or sparking;
- had the light been dropped and the bulb shattered, the incandescent filament would have momentarily provided such an ignition source.

The most probable point of ignition was the light assembly, either through a spark in the electrical system, or by being dropped and the bulb breaking, introducing the very hot incandescent filament into a vapour concentration within the flammable range. The latter is supported by the discovery of the light assembly's protective mesh and the light socket at the bottom of the tank, directly below the manhole, while the light shade was recovered from the deck. This indicates that the point of ignition was probably below the shade which was blown out of the tank, possibly through the after manhole or through the ruptured deck plating.
