Departmental investigation  
into a fire in the  
engine room aboard  
the Netherlands Dredger  
Leonardo Da Vinci  
off the port of  
Dampier, WA  
on the 11 June 1998

investigation into a fire in the engine room aboard

LEONARDO DA VINCI

off the port of Dampier, W.A. on 11 June 1998

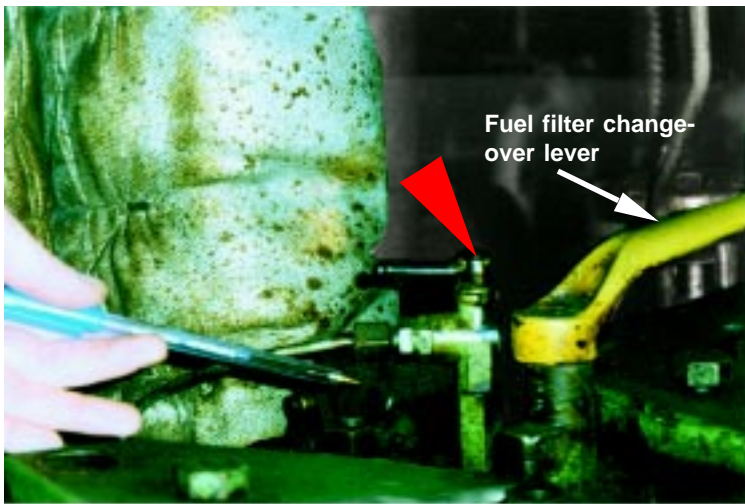
Fuel filter change-over lever

No 3 shut-off cock handle in place

No 2 shut-off cock handle missing

The handle was also found to be missing from No. 2 diesel filter differential pressure indicator shut-off cock, however in that instance the spindle bonnet was seated tightly. According to those interviewed, the handle

During the investigation it also became apparent that, although it had not contributed to the fire, there had been a slight fuel oil leak from the spindle of the No. 1 diesel engine fuel filter change-over lever. This had first been recorded in the Chief Engineer's workbook seven days before the fire, with subsequent daily entries indicating new "O" rings were required. The time required to change the "O" rings is about one hour, but the Chief Engineer did not consider the leak of sufficient significance to stop the dredging operation in order to effect the change.

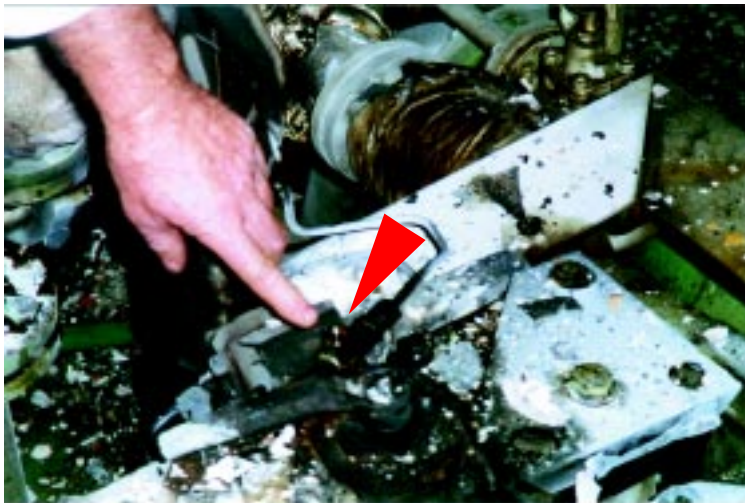
No 1 shut-off cock spindle bonnet missing

On investigation, the handle and spindle bonnet of the shut-off cock to No. 1 diesel filter differential pressure indicator were found to be missing. This had allowed diesel fuel, under 8 bar pressure, to spray upwards, on to the hot exhaust trunking of the engine, the heat of which had ignited the oil.

The handle, which is attached by a screw to the top of the spindle, also serves as a keep, or locking device, securing the spindle bonnet. During the course of the investigation it transpired that the handle had been missing for some considerable time. It is apparent that with the handle (the locking device) removed, the threaded bonnet had vibrated loose.

The shut-off cocks are normally left in the open position, only being changed to the closed position when maintenance work, such as changing the diaphragm, is necessary on the differential pressure indicator. The shut-off cock had not been operated, and had therefore been undisturbed, for some months. It was not possible for the investigation to determine how long it had taken for the spindle bonnet to vibrate loose and to become unscrewed.

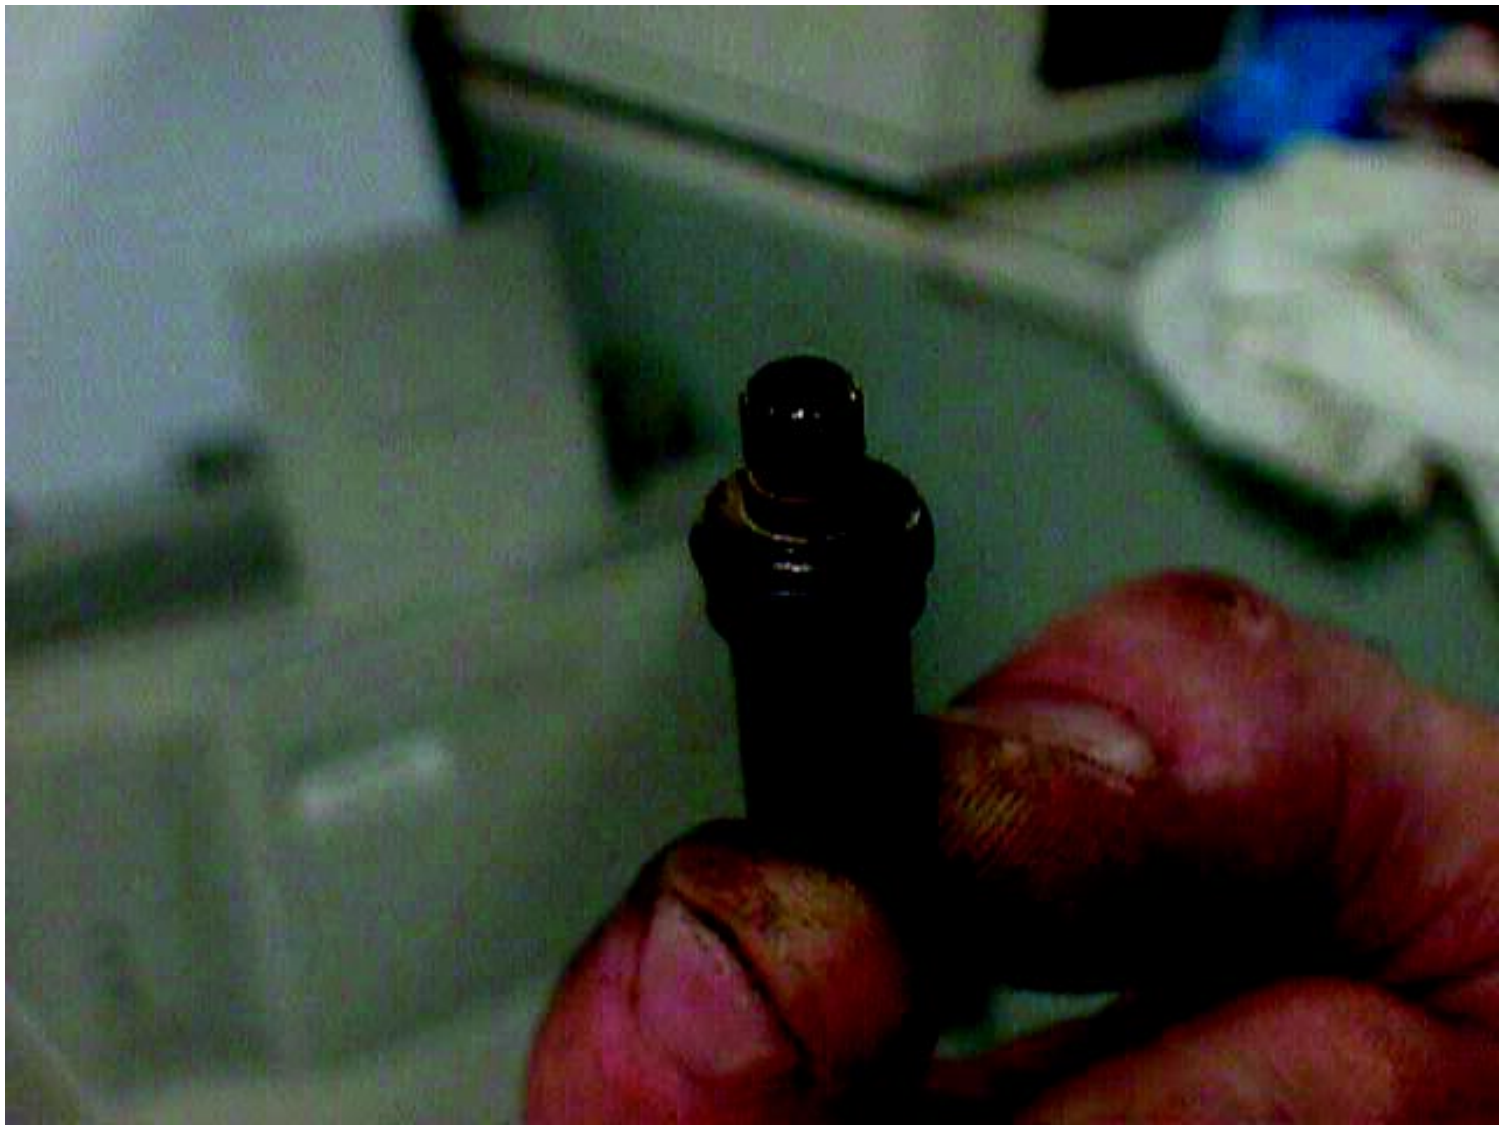
The spindle was found in the bilge, beneath the engine, clean and undamaged. The body of the shut-off cock was also undamaged.

**Spindle from No1 bonnet**
