UNION SHIPPING NEW ZEALAND LTD
 M.V. "UNION ROTOMA"

On 19 April 1994 the New Zealand flag ro-ro vessel Union Rotoma was on passage from Nelson in New Zealand to Port Botany in NSW when, at 1835, alarms were sounded by the vessel's automatic fire detection system indicating a fire in the engine room. The duty engineer quickly reported that the aft end of the port main engine was on fire. The fire was spreading very rapidly and the decision was taken to evacuate the engine room and to flood it with the ship's fixed carbon dioxide extinguishing system. A "Mayday" message was transmitted by Inmarsat C and was acknowledged by the Maritime Rescue Coordination Centre in Canberra.

CAMSHAFT END BEARING HOUSING (THRUST BEARING) ASSEMBLY BOLT FAILURES

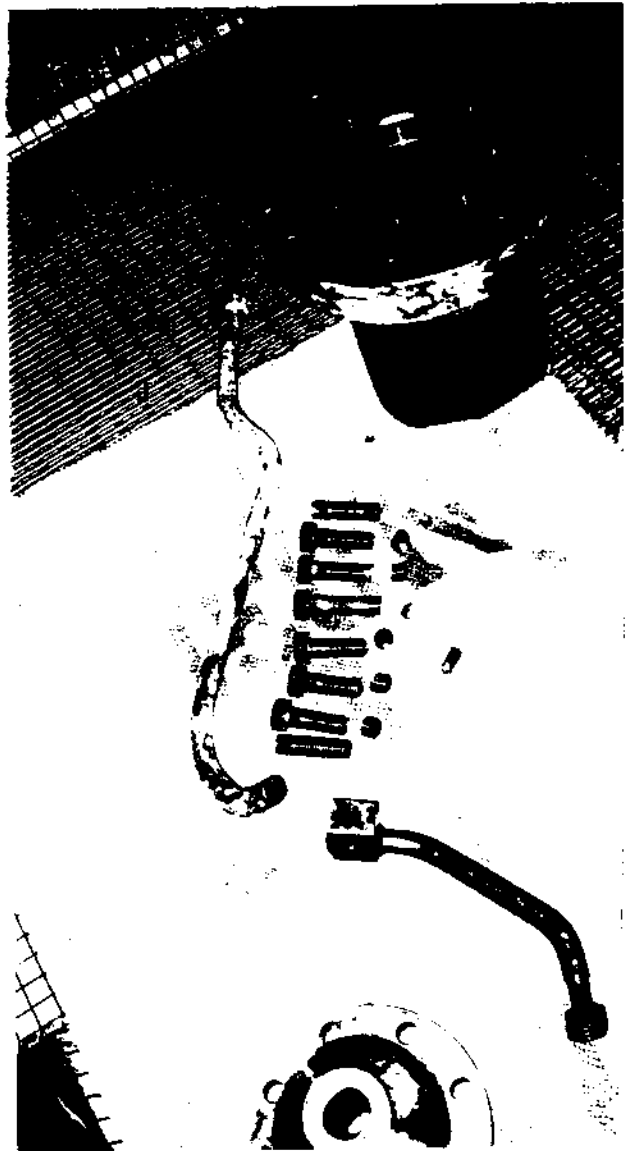
Camshaft anchor bearing housing
from starboard engine with fractured
lubricating oil pipe and sheared
securing bolts

Starboard engine entablature
with camshaft anchor bearing
housing removed

When first inspected after the fire, the bearing housing was found to be sitting 2 to 3mm out of the entablature with seven of the eight bolts, which had been securing it in the entablature, sheared. The other set bolt had vibrated free in intact condition. One of the locating dowel pins had been sheared by the movement of the housing.

2. The lubricating oil pipe was fractured when the housing for the camshaft anchor bearing worked its way out of the entablature, consequent upon the failure of the eight securing set bolts.

3. The set bolts which secured the bearing housing in the entablature had no form of locking and should have had cross-drilled heads and been laced with locking wire.

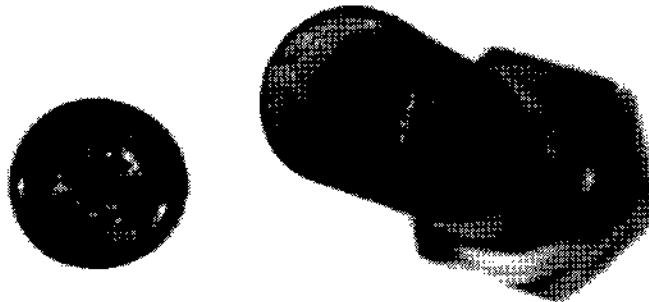
A total of eight bolts, nominal diameter 20mm, from the camshaft end bearing housing were examined. Of the eight bolts, one bolt was intact, two had fractured under the head of the bolt, and the remaining five had fractured at a location approximately between 12 to 15 mm from the end of the bolt (at a point which appears to coincide with the extent of thread engagement into the engine entablature), see figures 1 and 2.

Figure 1. Bolt from the camshaft end bearing housing, as received.

In each case bolt fracture was caused by fatigue. The location of the fatigue fractures coincides with sites of stress concentration, under the head of the bolt and at the limit of thread engagement in the entablature.

The orientation of the plane of crack growth with respect to the axis of the bolt indicates that alternating axial loads were responsible for fatigue crack initiation and growth.

Resistance to fatigue cracking depends on the creation of the correct level of preload, with respect to the magnitude of the applied alternating loading condition, in the body of the bolts. The application of a torque lower than that recommended by the manufacturer, during assembly, may result in the development of fatigue cracks in the bolts.

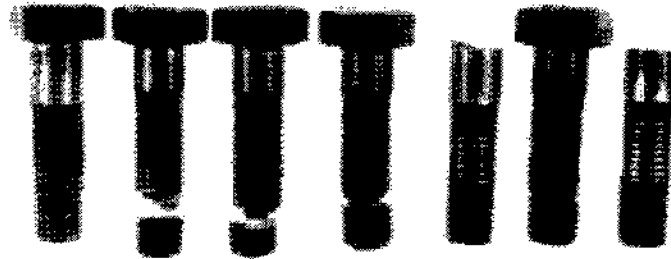
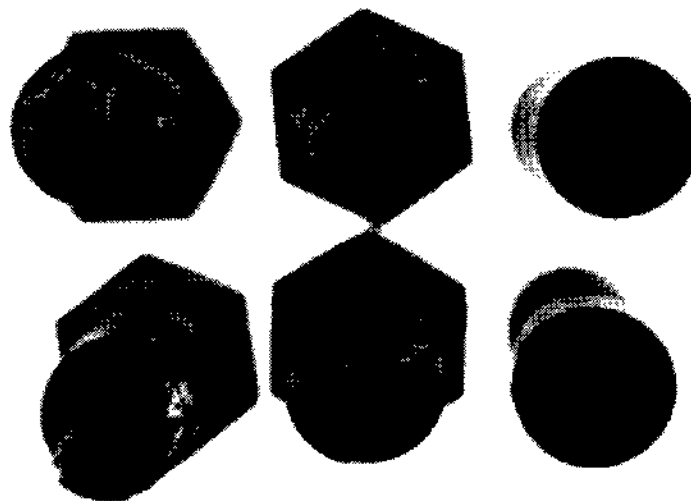
Figure 2. The remainder of the bolts from the camshaft end bearing housing, as received.

Eight bolts from the camshaft end bearing were examined. Seven of the eight bolts had fractured. In each case fracture was caused by fatigue crack growth. The orientation of the plane of crack growth indicated that the alternating loads responsible for fatigue were aligned with the axes of the bolts. The region of thread wear on the remaining intact bolt indicated that it had been loose.

Recommendations regarding corrective action should also consider the following alternatives. If the bolts had been tightened according to specification and the magnitude of the alternating loading condition imposed on the bolts is associated with "normal" operation, then consideration should be given to increasing the torque applied to the bolts during assembly in order to prevent further failures. Or, if the loading condition is associated with "abnormal" operation, then action should be taken to address the cause of the loading condition in order to prevent further failures.
