Departmental investigation
into the fire aboard the
Australian flag oil tanker
TASMAN
in the port of Melbourne,
Victoria on
19 December 1998

Navigation Act 1912 Navigation (Marine Casualty) Regulations investigation into the fire aboard the Australian flag oil tanker *TASMAN* in the port of Melbourne, Victoria on 19 December 1998

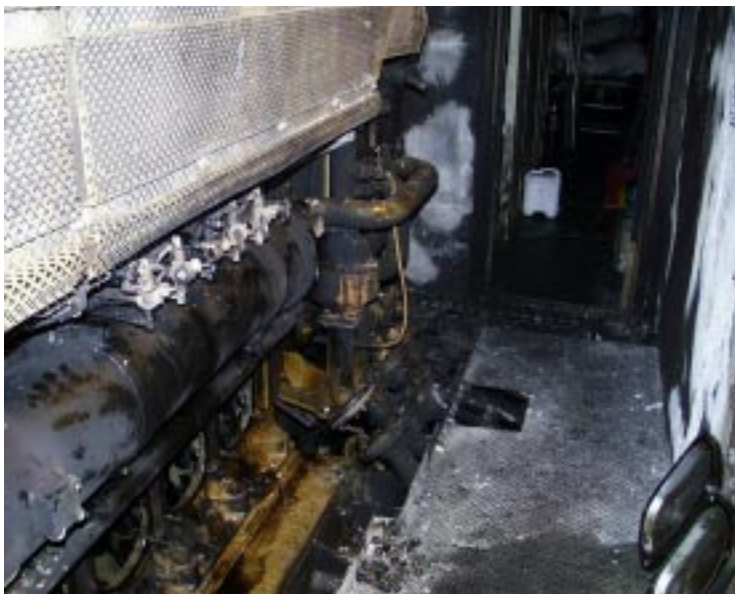
Examination of the fire scene after the incident showed that the area of most intense heat damage was in the port aft corner of the generator room, consistent with the observations of those involved with firefighting. The point of lowest burn was in the bilge in this port aft corner (fig. 2 & 3) and from here, damage extended up the aft end of, and up the port side of, no. 1 generator.

FIGURE 2
Port aft corner of generator space – bilge fire occurred here

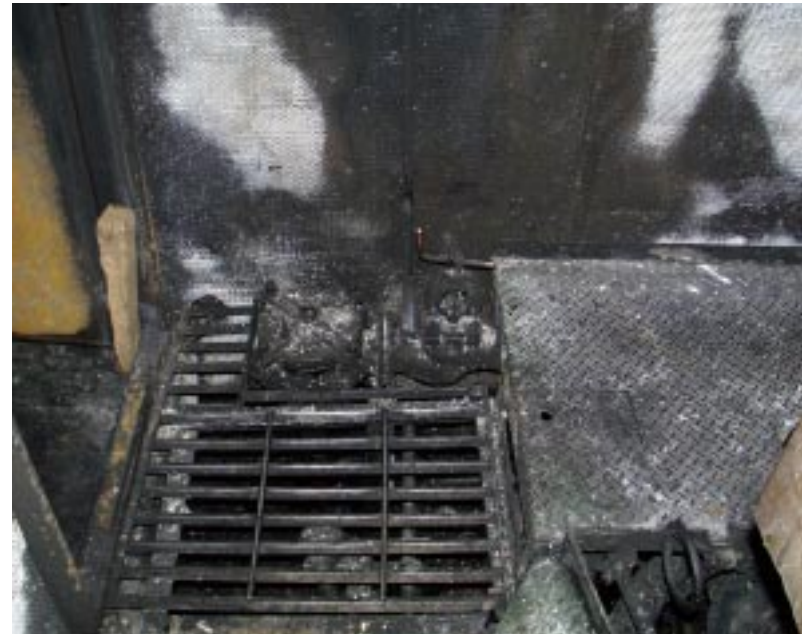
Flames rising from the bilge up the port bulkhead of the space had melted the perforated aluminium sheet cladding which covers the rockwool insulation. Although the rockwool itself would not burn, indications are that it had acted as a wick, drawing oil, or oily water, up from the bilge. Pools of solidified aluminium were found on the steel deckplates forming the walkway along the port side of the engine. Heat and smoke, trapped beneath the deck plating, had extended across the width of the aft end of the generator room, blistering paintwork on pipes below the plates.

FIGURE 3
View of port side of generator space – looking aft to steering flat

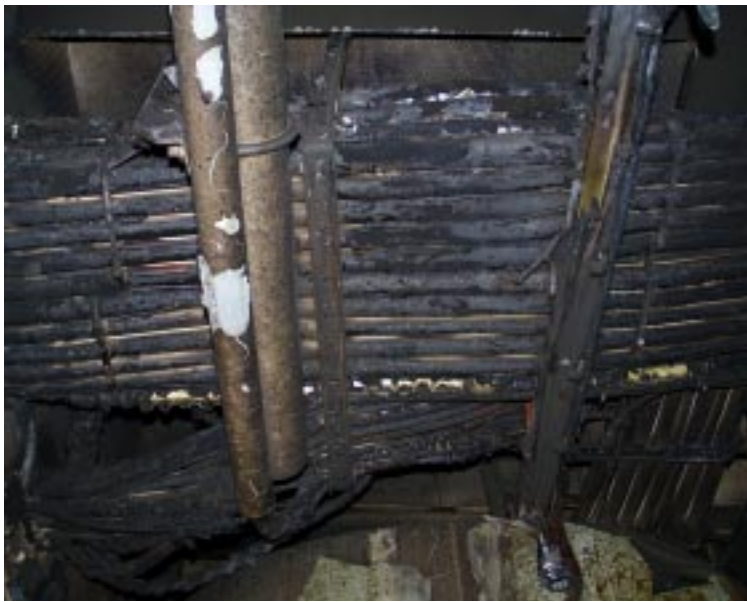
Following the extinction of the fire, an examination was made of the damage to no. 1/2 diesel generator room. It was evident that the most significant damage was to electrical cabling, as cable trays carrying the main power cables from the three generators to the main switchboard run along the deckhead above no. 1 generator. In addition to the power cables, a large number of control, monitoring, alarm and communications cables were also damaged by heat.

FIGURE 4
Fire damage to deckhead cables and fittings

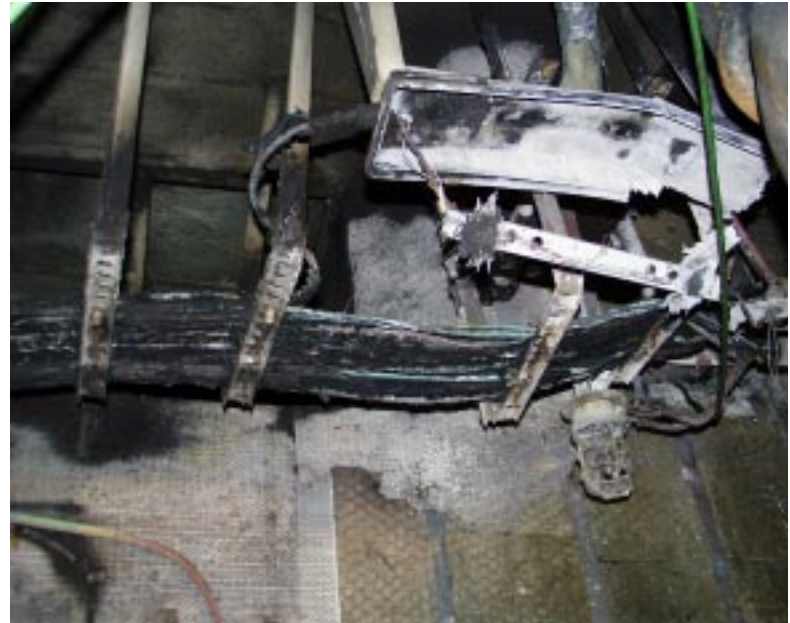
FIGURE 5
Fire damage to deckhead cables and fittings

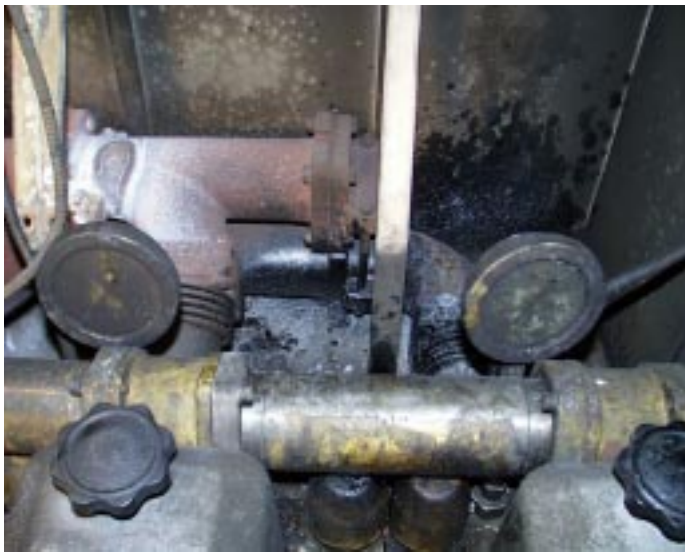
Considerable fresh residues of fuel oil were observed both on the inside of the exhaust casing at the forward outboard corner and also on the exhaust leading from no.1 unit. (fig. 6,7&8) Neither of these positions, however, are directly in line with the space between nos. 1 & 2 cylinder heads, but it appeared that the spray from the failed joint may have been deflected off the bottom of a bracket which supports the covers of the exhaust hot box. This bracket is in line with the space between the cylinder heads.

FIGURE 6
**Residue of fuel oil spray
within exhaust casing**

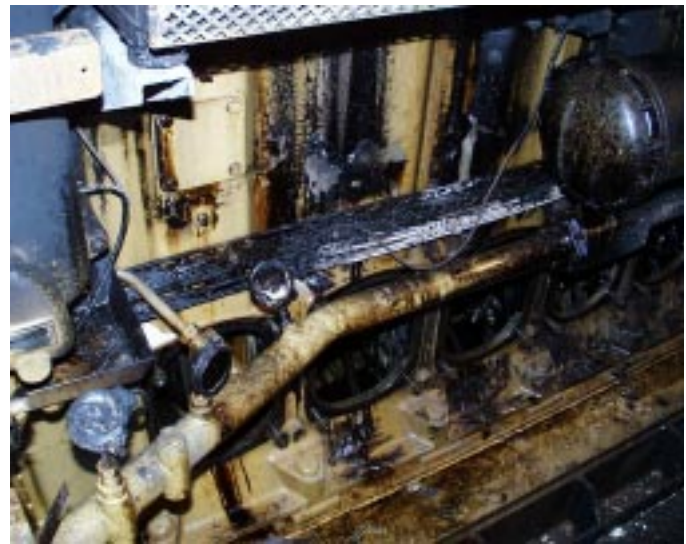
There remained, nevertheless, numerous stripes of scorched and burned paint down the side of the engine crankcase, extending from the top of the engine entablature down to the engine bedplate, along the full length of the engine. There are two possible causes for these burns. The first, and considered the most probable, is that these stripes were caused by burning fuel oil flowing down the side of the crankcase. The other possibility is that the burned paint was caused by radiant heat from the flames which were rising up the bulkhead at the outboard side of the walkway.(fig. 7)

The dark stripes of heavy oil flowing, or dribbling, down the side of the engine would absorb the radiant heat, while the relatively clean, light coloured cream paintwork would reflect much of the heat thus, when the oil had

been hosed off, leaving the burned and blistered paint in the form of stripes.

FIGURE 7
**Port side of engine showing
stripes of scorched paint**

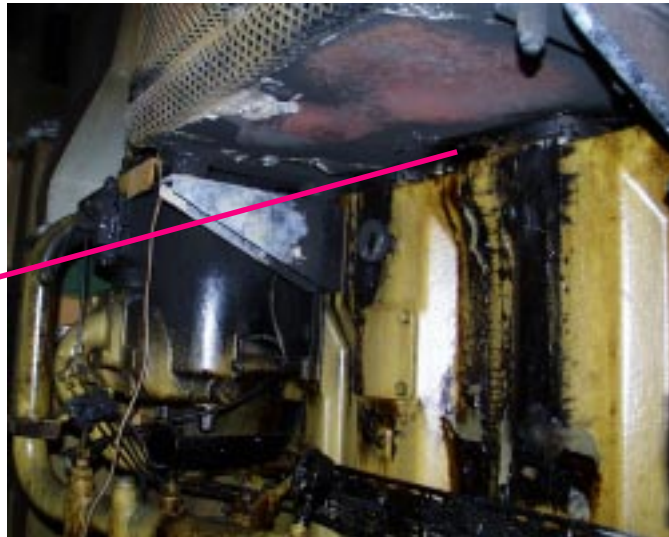
The flange which had parted was in line with the space between nos. 1 and 2 cylinder heads. This space connects directly to the port side of the engine, within the covers of which are contained the exhaust manifolds. The bottom of the exhaust box is raised above the level of the top of the engine entablature by approximately 40 mm and it is evident that it was through this gap, between the exhaust box and the top of the entablature, that the leaking fuel oil had escaped down the side of the engine. (fig. 6,7&8)

Oil flowed from gap here

FIGURE 8
**Underside of exhaust casing,
port side of no. 1 generator**

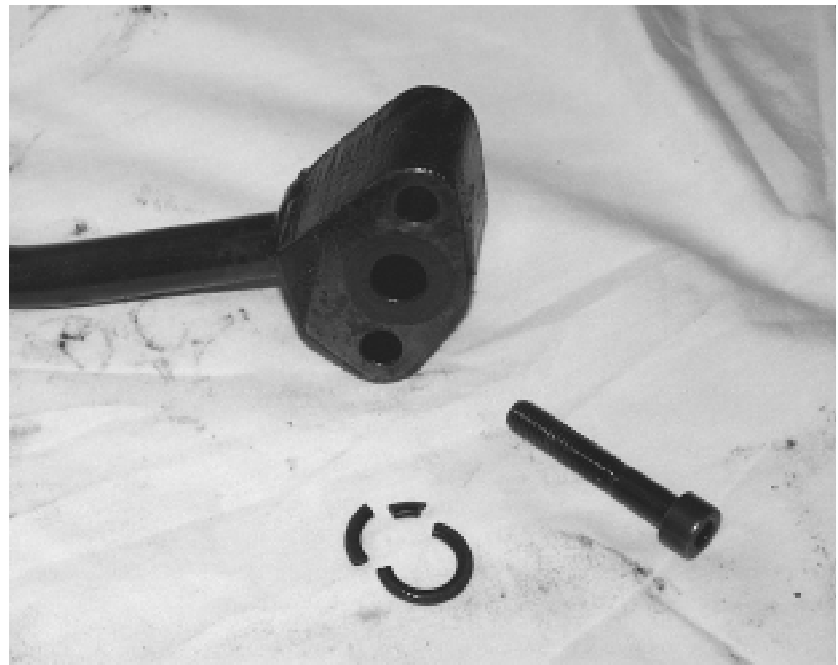
FIGURE 11

Shortly after the fire, ship's staff examined no. 1 diesel generator and removed the hot box covers from the fuel gallery. It was noticed that, on no. 2 unit, the upper of two Allen screws, was missing from the flange where the fuel suction pipe joins the fuel pump. The missing screw was reportedly found lying on the entablature. The other screw was found to have loosened, allowing the flange to part from the fuel pump body. The O-ring in the joint had broken into three pieces. (figs. 6, 7&8)

The two 8 mm × 45 mm allen screws which had secured the fuel suction pipe flange to the pump body were examined. The upper screw, which was reported to have fallen out and later found on the entablature, was stamped 'B109 18' on the side of the head, while the lower screw, which had remained in situ, although loose, was stamped M9 on its upper face. The two screws were subjected to non-destructive hardness tests and, although of different manufacture, returned similar results.

Pipe flange, 8 mm allen screw and pieces of O-Ring

The O-ring which had failed, at the joint of the suction pipe on no. 2 fuel pump, was found after the incident to be in 3 pieces. It was not clearly established, however, when the two breaks had occurred. ASP suggested in submission that these breaks had occurred after it had been removed from the joint. Compared to a new O-ring it had evidently hardened considerably, either during the 2,079 running hours since the fuel pump had been re-fitted, which the engine builder considered most unlikely in such a relatively short period, or it had been re-used at the time of the 20,000 hour overhaul. The latter possibility was adamantly refuted in a submission from ASP.

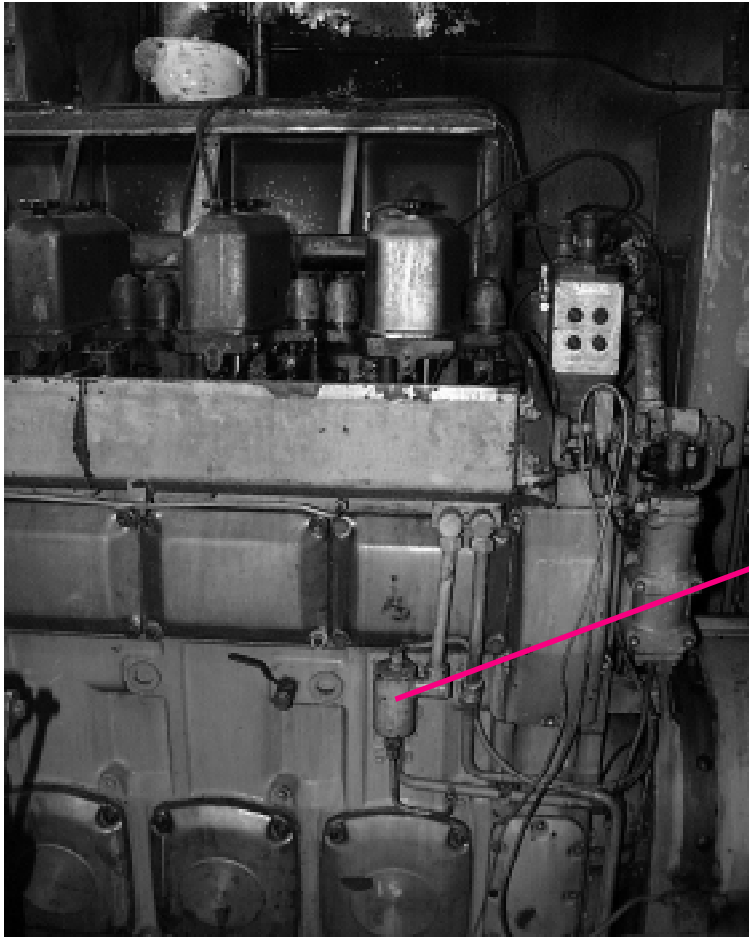
FIGURE 12

The hot box has, at each end, drains which lead down to the fuel oil drain tank. At the forward end, only, there is incorporated into the drain a fuel oil leakage alarm. (fig. 12). The leakage alarm is so designed that small amounts of fuel leakage, which may be considered normal, pass freely to the drain tank down a small pipe, connected to the main drain. However, a substantial quantity of fuel leakage will cause fuel oil to back up in the alarm chamber, thereby activating the leakage alarm.

aft end, the siting of the fuel leakage alarm at the forward end of the engine results in fuel being able to build up to a theoretical depth of approximately 40 mm at the aft end of the fuel gallery before it reaches the forward drain and the leakage alarm. It is probably for this reason that the alarm for channel 12106 'Fuel oil leakage A.E.1' (no. 1 generator) did not activate until after the fire had already started (16 seconds after the fire alarm).

It is clear that the siting of the fuel leakage alarm was overlooked when the generator sets were installed and were orientated with the drive end forward. If the leakage alarm had been correctly sited at the aft end of the engine, there is clearly a possibility that the fire may have been avoided.

Fuel oil leakage detector
