Team Helina

Summary

On 3 February 1995 the Norwegian flag tanker Team Heina was at anchor off Sydney Harbour, waiting to berth at Gore Bay, when, at about 0945, a compression fitting on a line to a fuel pressure gauge on No.3 diesel generator blew out. The resulting spray of hot heavy fuel oil at about 6 bar pressure, ignited on the engine's exhaust manifold and then spread burning oil over the deckhead above the engine. The fire intensified and expanded rapidly.

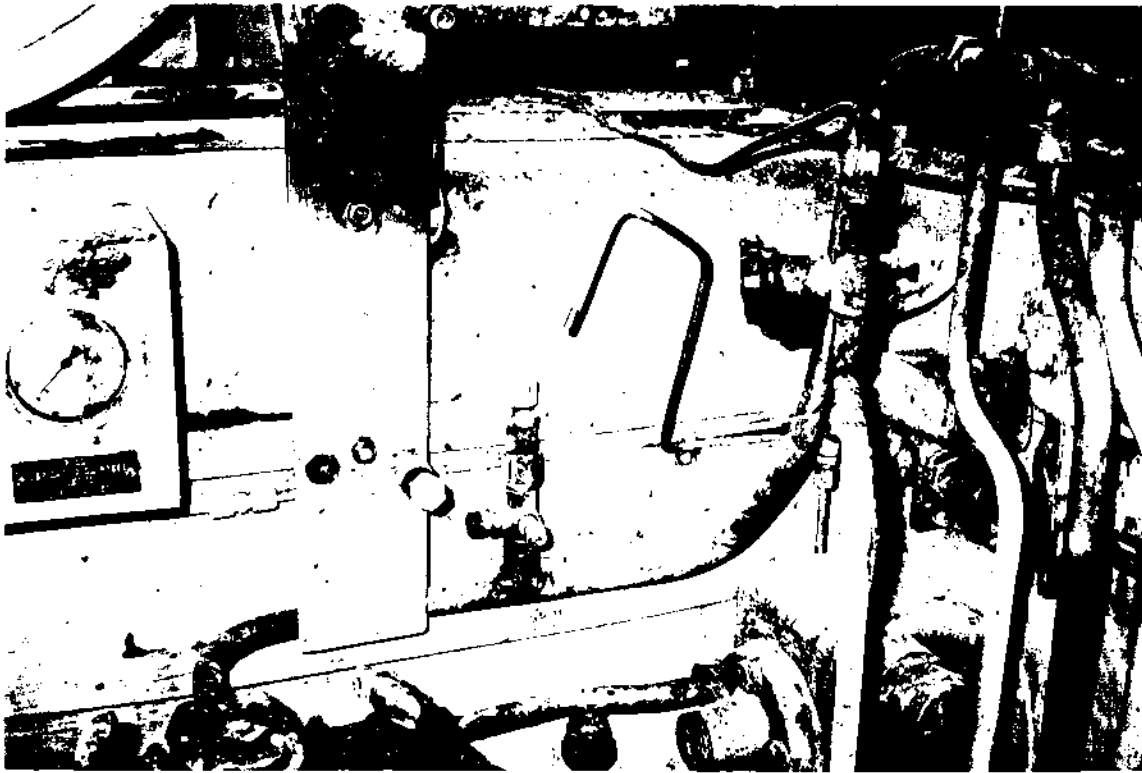
No.3 generator - fuel supply line showing steel gauge pipe disconnected from compression fitting

The cause of the fire was found to be at the forward end of No.3 generator, where a tapping for a 6 mm pressure gauge line comes off the main fuel pipe supplying the engine-mounted fuel injection pumps (the fuel rail). The end of the gauge pipe had blown out of its compression fitting, allowing hot heavy fuel oil, at a pressure of between 5 and 6 bar, to spray vertically upwards to the deckhead and ignite on the hot exhaust manifold and turbo-charger casing.

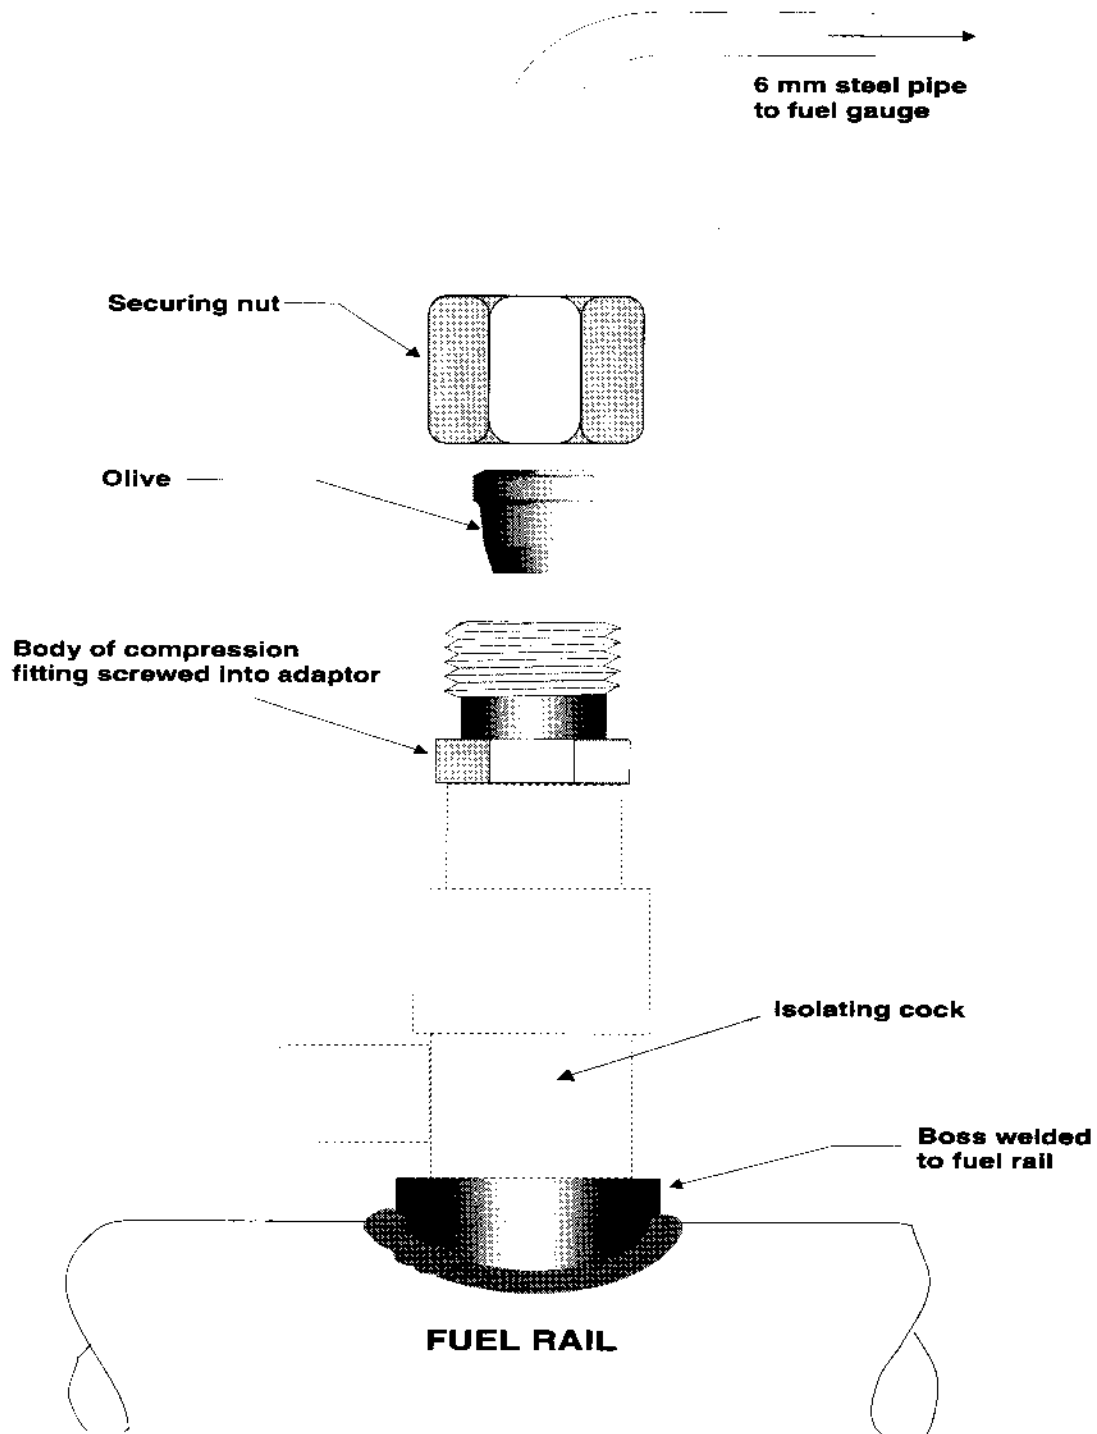
Assembly of compression fitting

Pressure of fuel in the fuel rail is measured by a gauge on the engine instrument panel mounted at the aft end of the engine. The tapping for the 6 mm steel pipe leading to this gauge is situated at the forward end in the fuel rail supplying the engine-mounted injection pumps. The pressure in the fuel rail is maintained at a steady pressure of 5 to 6 bar by the fuel booster pump. The end of the 6 mm steel pipe to the gauge is inserted into a compression fitting (see diagram page opposite page). A steel collar, known as an "olive", is fitted around the pipe below the securing nut. When the securing nut is tightened, the olive is compressed by the tapered surfaces in the main body of the fitting and in the underside of the nut. The olive distorts slightly, thus compressing and gripping the outside surface of the pipe and at the same time providing a pressure-tight seal, so long as the nut is tight.

Assembly is simple. The nut is slid over the end of the pipe, followed by the olive, and the end of the pipe and the olive are fully inserted in the body of the fitting before the securing nut is tightened onto the top of the body of the fitting. Disassembly is equally easy should it be necessary to remove

the gauge pipe for maintenance or any other reason. It is necessary to ensure, however, that the pipe is inserted sufficiently far into the assembly (i.e. protruding below the bottom of the olive) to enable the correct compression to take place.

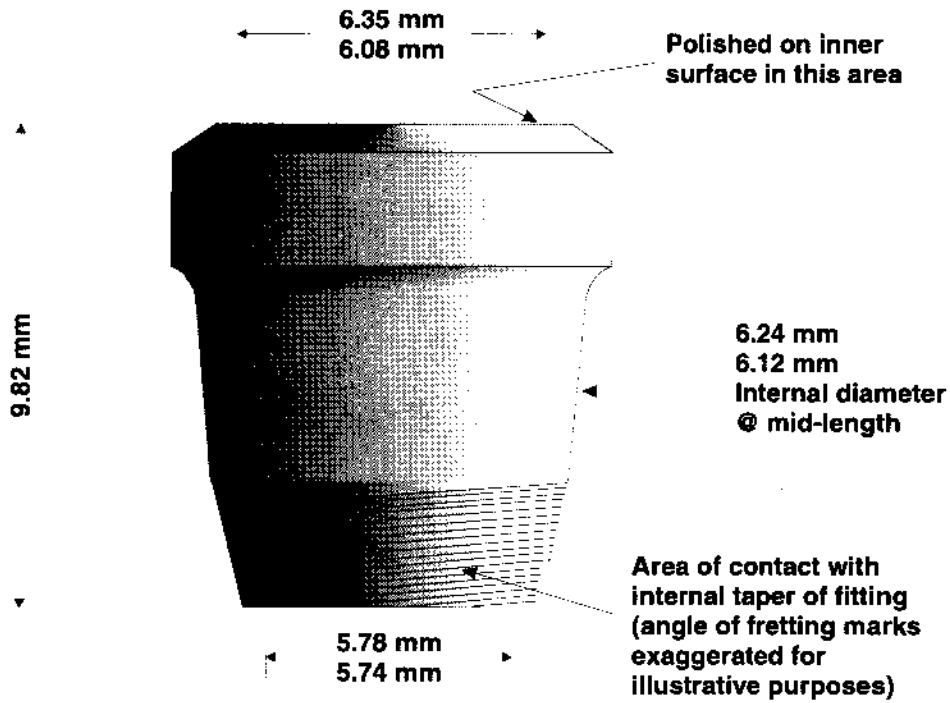
As part of the investigation, the olive from the compression fitting and the end of the steel gauge pipe were carefully measured to ascertain whether or not the pipe had been properly inserted into the fitting before the securing nut had been tightened. The resulting measurements are shown in the following diagrams. In addition, the olive was cleaned and examined under a microscope at the Materials Evaluation Facility of the Civil Aviation Authority in Canberra.

The measurements taken indicate that the olive and the pipe had been compressed, and the pipe had been gripped by the fitting. However, as there was no short uncompressed length at the very end of the pipe, where it should have protruded through the olive, it appears that the pipe may not have been fully inserted into the fitting before the nut was tightened upon initial assembly. In addition to this, fretting marks on the tapered surface of the olive, where it mates with the inside of the fitting, indicated that the pipe and olive had not been sitting squarely in the fitting.

Max. and min. internal diameters shown

**"Team Heina" - No.3 generator
Olive from gauge connection**

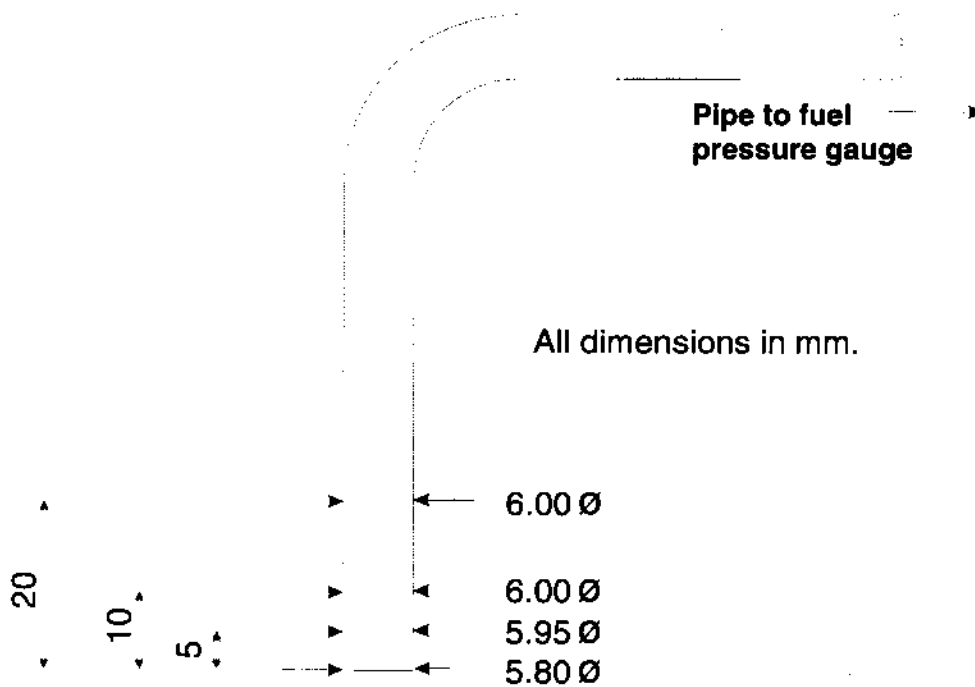
**"Team Heina" - No.3 generator
End of steel pressure-gauge pipe**

This can be seen in the photograph above and is illustrated in the top diagram on the opposite page (the angle being exaggerated for illustrative purposes) On the top inside surface of the olive, on one side only, at the position shown in the diagram, could be seen a polished area where the surface of the pipe had been rubbing on the olive at the one spot. This would further indicate that the gauge pipe did not enter the fitting squarely and the spring of the steel pipe was exerting a sideways pull on the compression fitting. Microscopic examination of the olive also revealed a crack down one side extending the full length of, and right through, the wall.

As most diesel generators suffer from some considerable degree of vibration, it is probable that the vibration, combined with the sideways pull exerted by the steel pipe in the fitting, caused fretting, with the result that, over what may have been a considerable period of time, the securing nut slackened back slightly and eventually allowed the pipe to be

pushed out of the olive by the pressure of the fuel oil. Had the pipe been fully inserted into the olive upon initial assembly, the short length of uncompressed pipe protruding below the olive should have prevented the pipe from being pushed out of the olive and an observable leak from the fitting would have developed instead.

2. The pipe to the fuel pressure gauge had blown out of the compression fitting following prolonged fretting of the pipe within the olive and of the olive within the compression fitting. The fretting was caused by misalignment of the pipe with the fitting and the added fact that the pipe had probably not been inserted sufficiently far into the olive on initial assembly. The combined effect would have been exacerbated by engine vibration.

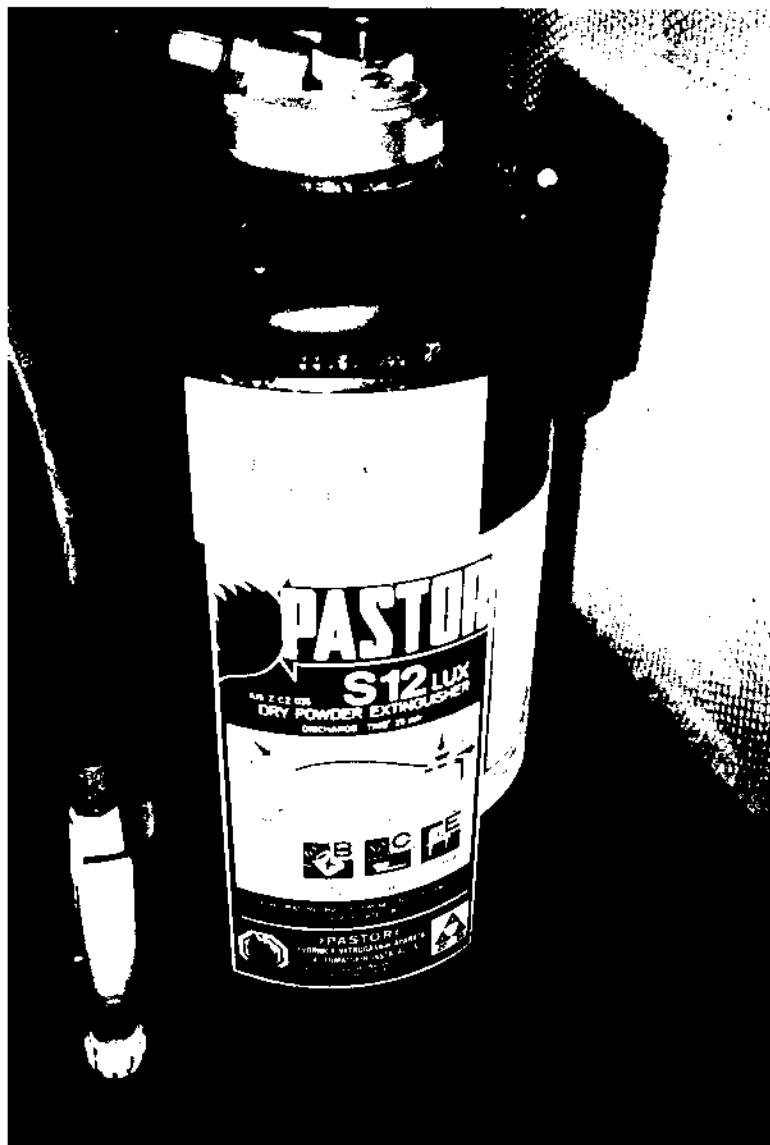
The fire was initially tackled by the First Engineer and the Motorman with two "Pastor" 12 kg dry powder extinguishers. Both of these extinguishers failed to discharge when actuated. Five or six more extinguishers were brought by the crew from other areas of the engine room and these operated successfully. The fire, however, had grown significantly in the intervening period. Given the nature of the fire, it is possible the situation would not have been under control even if the flames had been extinguished by the dry powder in the early stages of the incident. Hot fuel oil was still issuing from the compression fitting on the fuel rail and spraying onto the exhaust manifold and the turbo-charger of No.3 generator, where it might well have been re-ignited. The outcome of such a scenario, however, is a matter for conjecture and depends in part on how rapidly the exhaust manifold and turbo-charger would have cooled after the engine was shut down.

The Inspector considers that, in view of the work load that this schedule imposed on one man, the service of each item of equipment could not possibly have been carried out thoroughly. This view is supported by the fact that when the investigators inverted one of the fire extinguishers in the engine room which had failed to discharge, the dry powder in the

extinguisher could be felt falling as a lump to the opposite end. Item 8 of the company's relevant service work sheet for these extinguishers indicates that, as part of the service schedule, the cylinder should be inverted and the powder loosened.

12 kg dry powder extinguisher of the type which failed to discharge

4. It is speculative as to whether the failure of the first two dry powder fire extinguishers to discharge had any effect on the overall fire-fighting operations. However, it is not expected that two extinguishers serviced only six days previously, should fail in such a manner. The Inspector considers that the work load and schedule for servicing the ship's fire-fighting equipment by one man was such that the service could not have been sufficiently thorough.
