Summary

On 22 July 1991, the Netherlands flag livestock vessel Zebu Express was lying at anchor in Darwin Harbour. The Master and Second Mate had left the ship, the Chief Officer being the Officer in Charge.

A surveyor of the Australian Maritime Safety Authority conducted an investigation into the incident under the provisions of the Navigation Act.

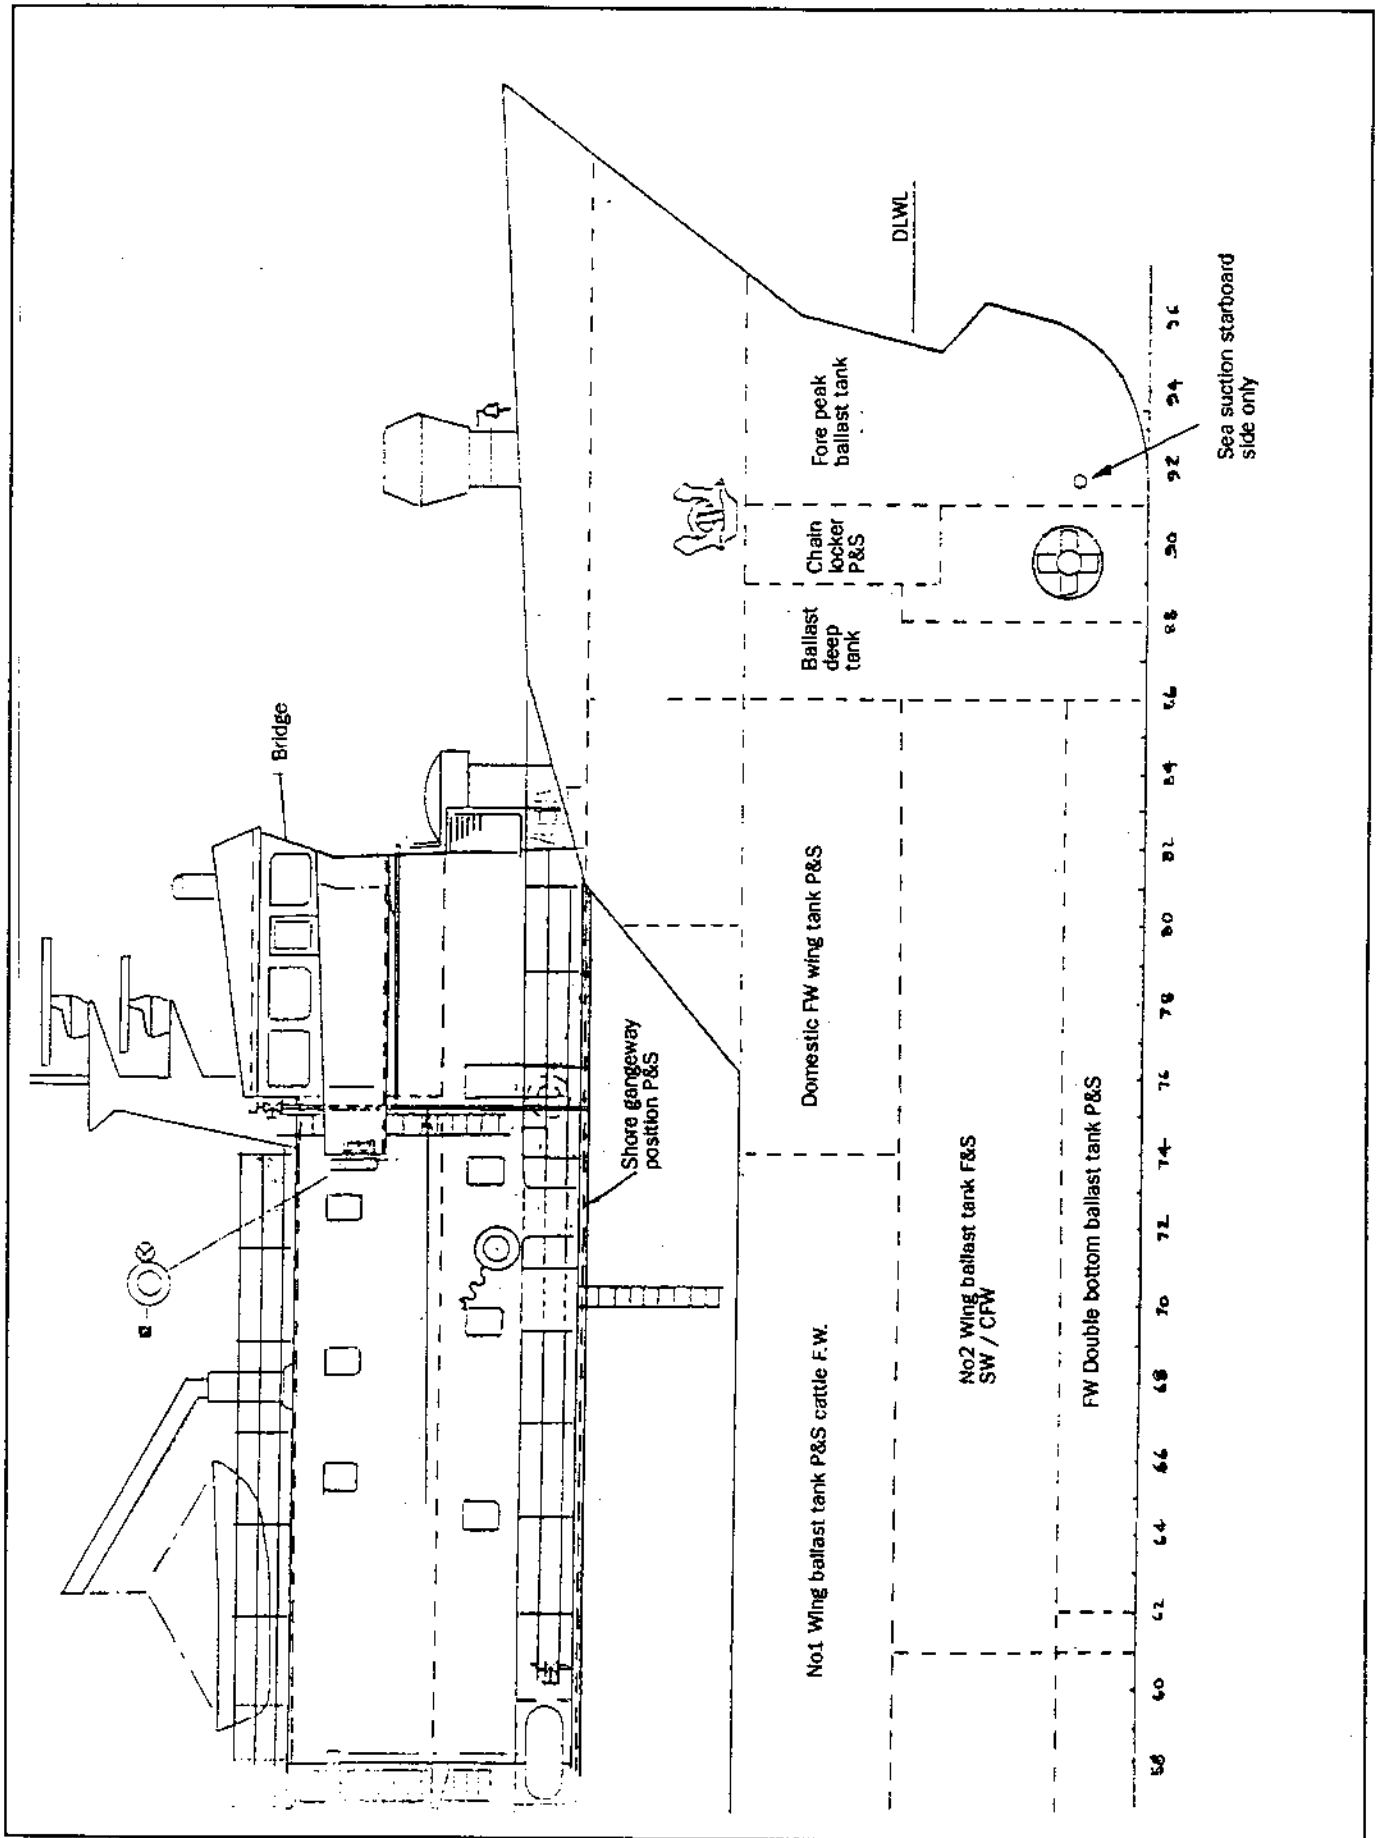
General Arrangement - Forward Section

The forward bow thruster compartment is an enclosed space located between the fore peak tank and deep tank, beneath the chain lockers and accessed by a trunking located between the two chain lockers. Access to the trunking is through a hatch located within the forecastle space, itself an enclosed space accessed through a hatchway on the main deck.

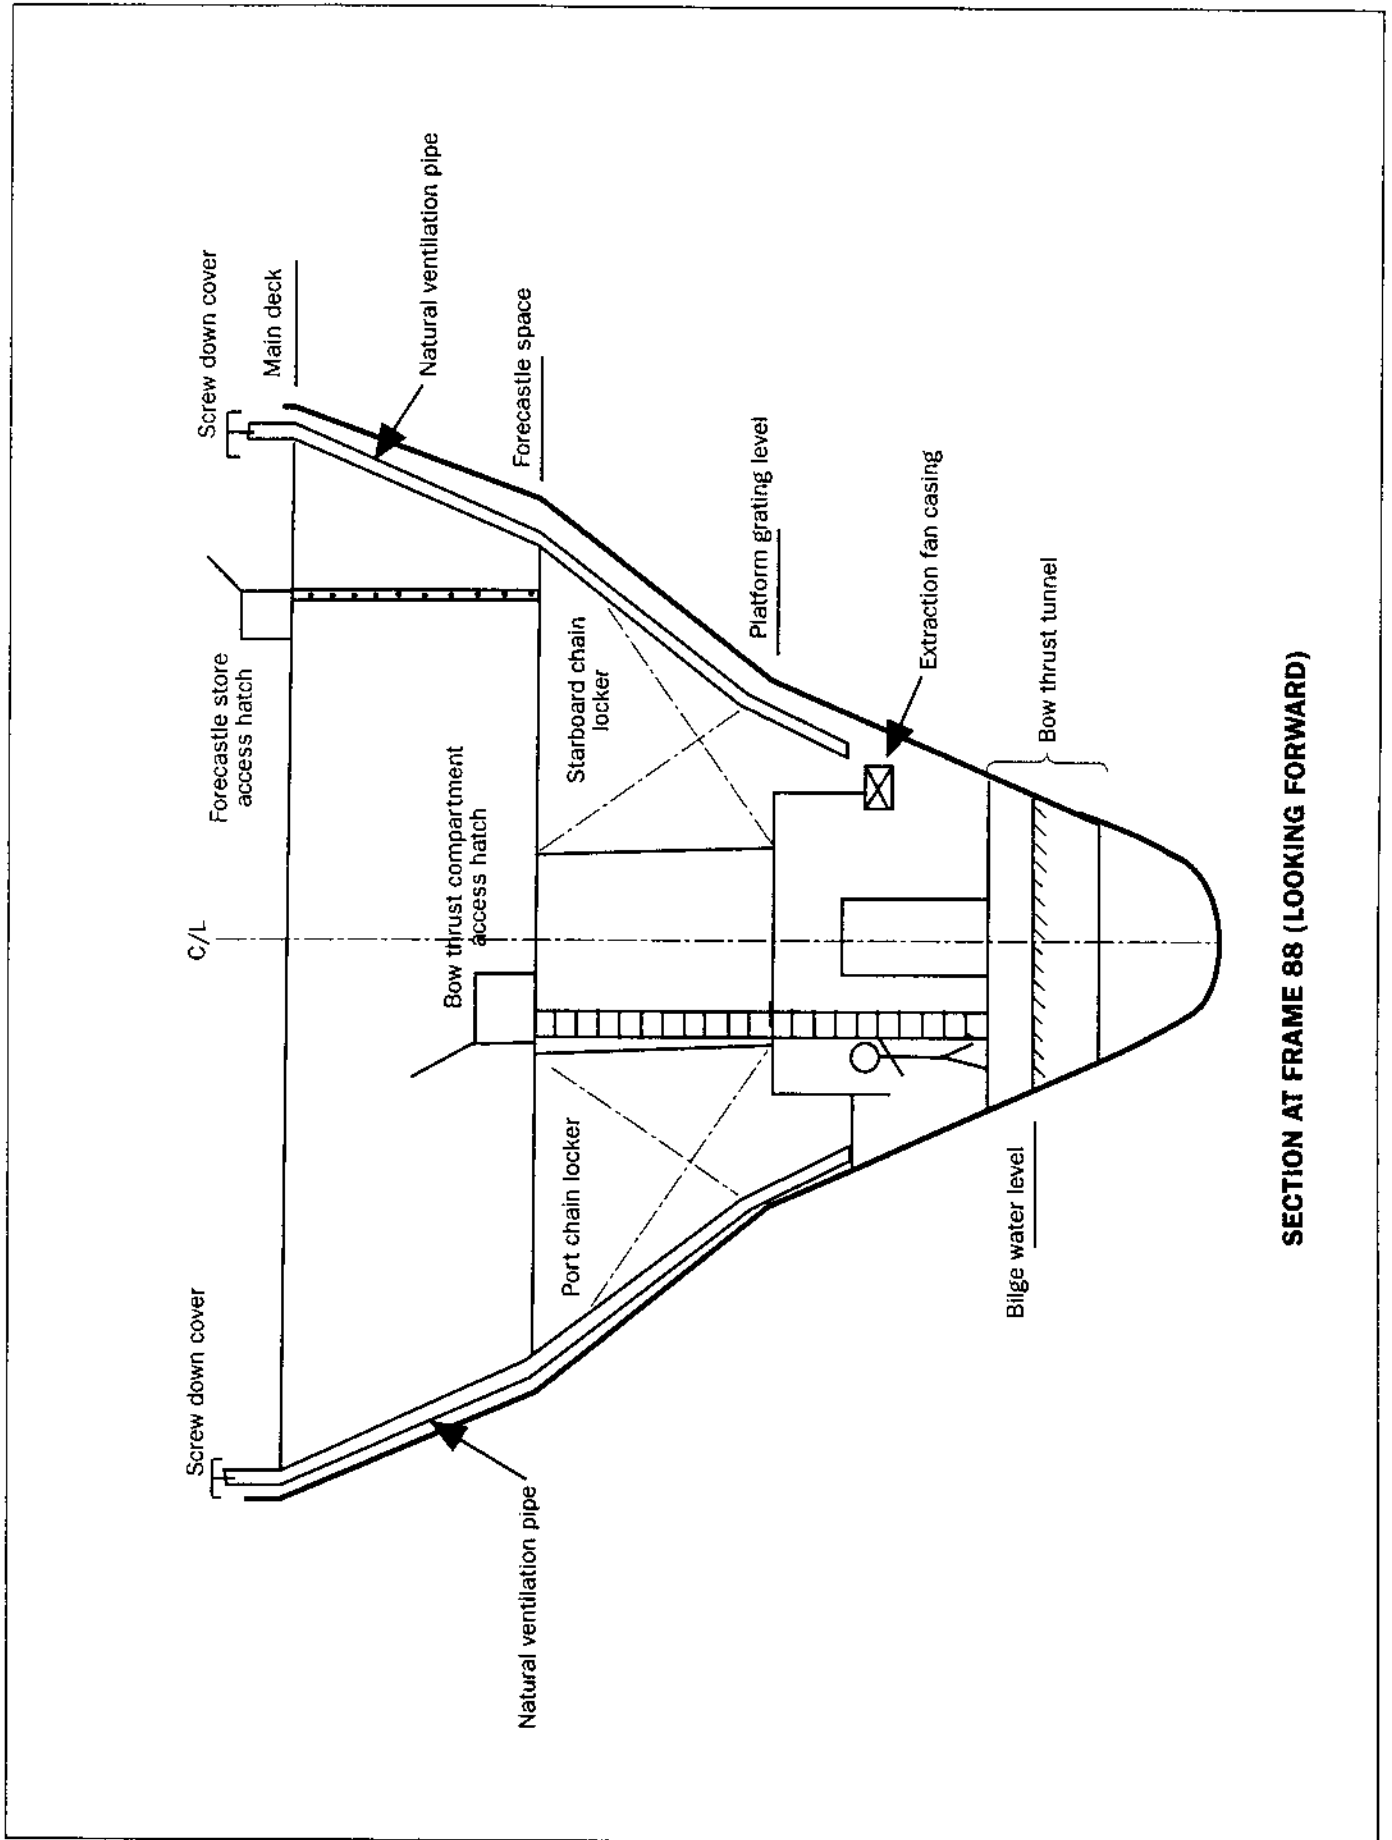
Diagrammatic Arrangement of Bow Thruster Compartment

Two air ventilation pipes, fitted with screw-down mushroom covers and located one on either side of the ship, lead down from the main-deck into the compartment. An electrical fan is located within the compartment itself, fixed to the framing beneath the starboard chain locker. The fan is not provided with any trunking, but is fixed so as to direct the airflow towards the after starboard corner, to the bottom of the starboard air pipe leading to the main-deck. When operating, the fan generates a cooling air flow, down the port air ventilation pipe, across the bow thruster motor and up the starboard air ventilation pipe.

The electrical supply cables for the fan are directly coupled to the main contactor starting circuits of the main bow thruster motor, located in the forecastle space. The fan does not have a separate start/stop arrangement. Under normal operating conditions, the fan automatically starts or stops with the supply of power to the bow thruster motor.

The bow thruster motor is fed from a selector switch on the main switchboard and the only electrical supply to that selector switch is from the main engine driven shaft alternator. With the main engine and, therefore, the main shaft alternator stopped, there is no power supply to the bow thruster motor contactor box and, therefore, the fan is inoperative.

The ventilation system of the bow thruster compartment was designed to comply with Classification Society requirements and was adequate for the purpose of cooling the bow thruster unit. However, it was not available at times when maintenance work was being carried out on the unit, when chemical solvents and cleaners might normally be expected to be used.

Whether the Drew Electric was used during the morning is not known, but it was evident that the spray gun was used at some time to spray the cleaner on to the electric motor. Use of the spray gun would have caused the cleaner to evaporate much more rapidly than if applied by brush and with no, or inadequate, ventilation, a toxic atmosphere would have been generated quite rapidly.

It is considered that the Second Engineer died as a result of becoming asphyxiated by accumulated vapour produced by the Drew Electric being used in a confined, enclosed space without adequate ventilation.

It is considered that some form of mechanical, fresh-air ventilation should be available for use during maintenance work in such spaces.

- 5 Some form of mechanical, fresh-air ventilation should be available for use in bow thruster compartments, to provide for periods of maintenance work involving chemical solvents and cleaners.
