U.S. CHEMICAL SAFETY AND HAZARD INVESTIGATION BOARD

# INVESTIGATION REPORT

## HYDROGEN SULFIDE POISONING

**GEORGIA-PACIFIC  
Naheola Mill**

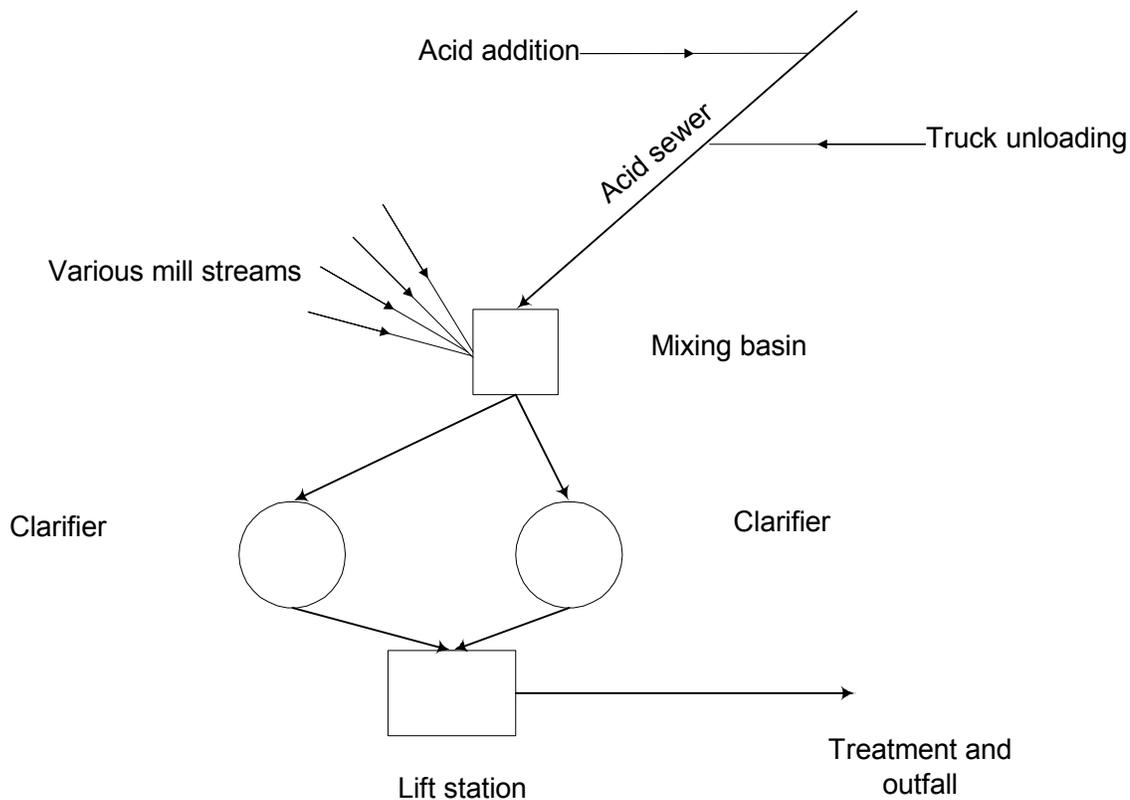
Figure 1. Naheola mill waste treatment process.

*Drainage from the truck unloading station flows to the acid sewer and mixes with other mill waste streams in the mixing basin.*

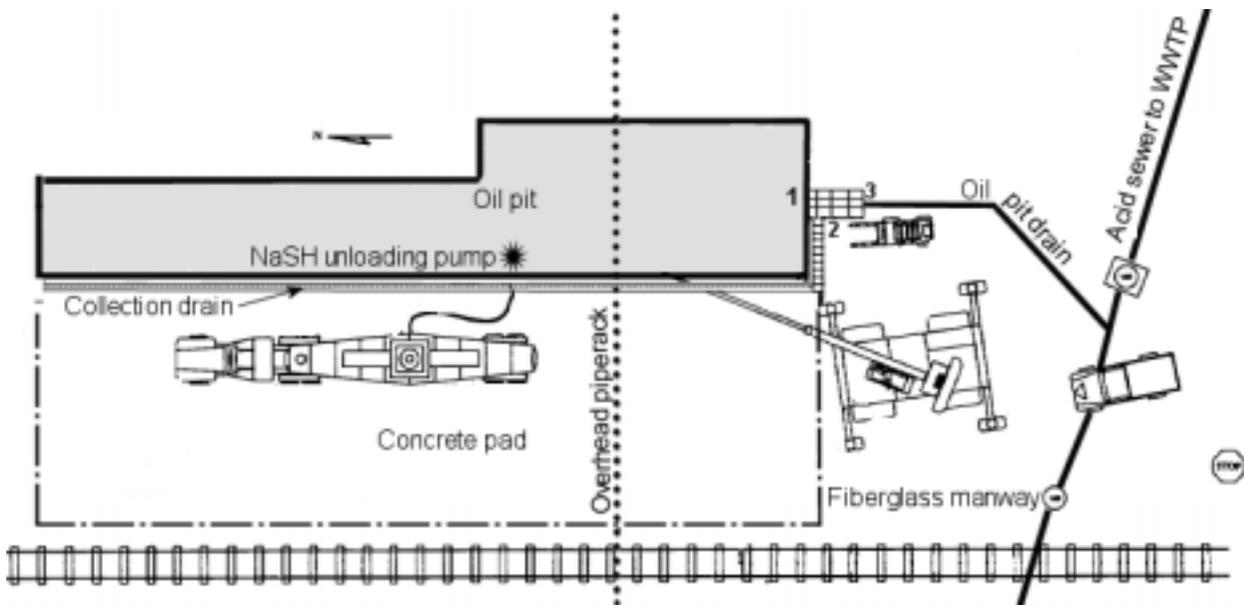
Figure 2. Tank truck unloading station.

Burkes Construction was contracted to replace supports on an overhead piperack located near the fiberglass manway; the piperack crossed over the tank truck unloading station and the oil pit, as shown in Figure 2. As the supports were removed, they were placed on the side of the road, directly in front of the manway.<sup>4</sup> On the day of the incident, the contractors were working in the area of the tank truck unloading station.

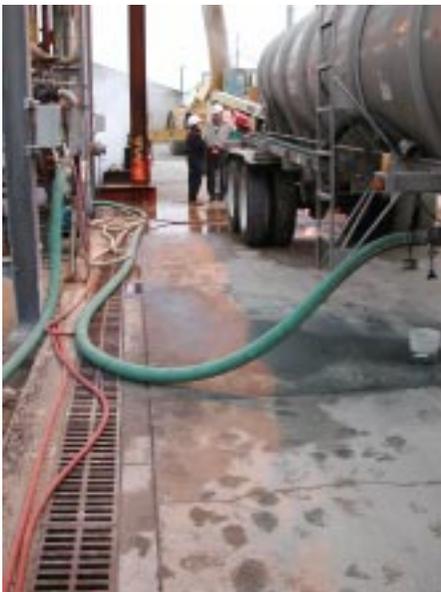
Figure 3. Collection drain next to tank truck unloading station.

5. During the truck unloading process, several potential sources of NaSH could leak and drain through the oil pit or collection drain to the acid sewer—such as material released from connecting and disconnecting the trucks, from flushing the loading line, or from a leaking pump seal or packing. In the 24 hours prior to the incident, 15 tank trucks of NaSH were unloaded, and one was connected to begin unloading. This activity resulted in NaSH collecting in the oil pit and draining to the sewer.

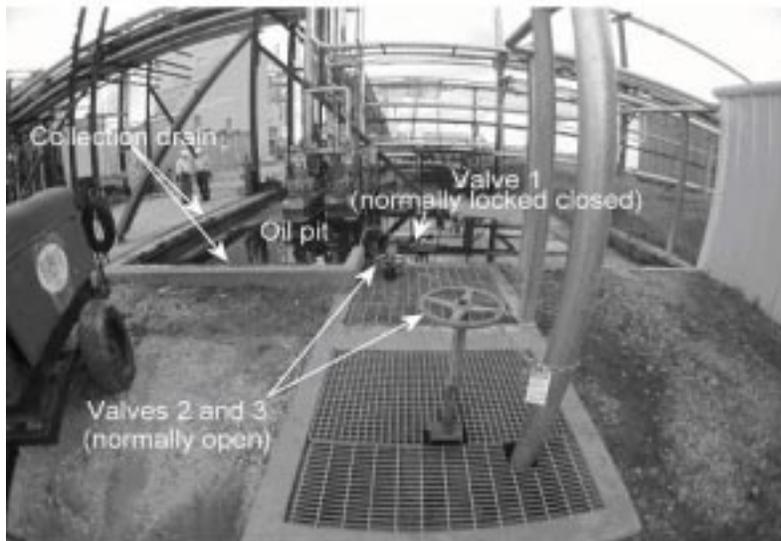
Figure 4. Oil pit and adjacent tank truck unloading station.

The oil pit (with a maximum depth of 20 inches) collects rainwater, condensate, and incidentally spilled chemicals from the tank truck unloading station. It is emptied through two valves (see also Figure 5). The drain valve (valve 1) on the pit is kept closed and locked due to environmental concerns about oil getting into the mill effluent; valve 3 is kept open. Per procedure, operators periodically inspect the oil pit; if no oil is present, they unlock valve 1 and drain the pit to the acid sewer.

Personnel interviewed estimate that it is typical for approximately 5 gallons of NaSH to collect in the oil pit from various sources (pump leaking, flushing unloading lines, etc.) during each offloading of a tank truck. NaSH spilled during hose connections to the truck flows through the collection drain to the acid sewer. Material lost from the pump or piping during the unloading process accumulates in the oil pit until drained.

After the identification of a reactive hazard, precautions should be taken to mitigate the hazard. If such precautions were in place at the Naheola mill, the oil pit containing NaSH would likely not have been tied into the acid sewer.

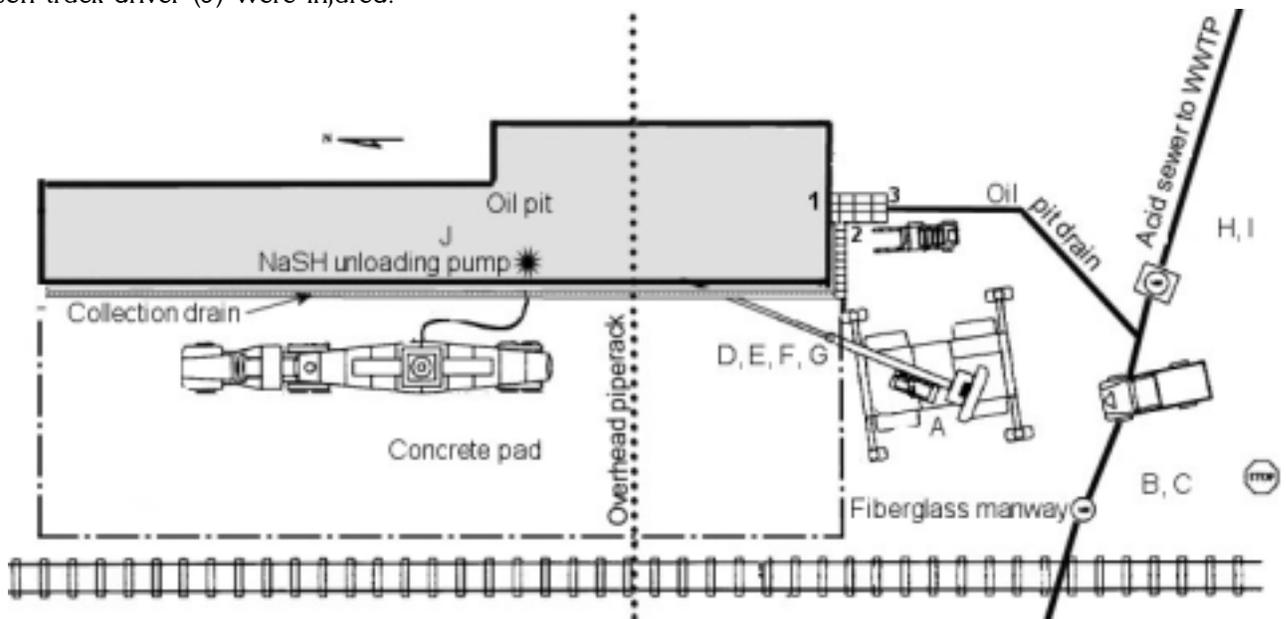
Figure 6. Approximate locations of the 10 victims ("A" through "J").

Within 5 minutes of the material draining from the oil pit and collection drain to the acid sewer, an invisible cloud of highly toxic H<sub>2</sub>S gas leaked through a gap in the seal of the manway near the Burkes Construction workers. Three contractors (A, B, and C in Figure 6) were immediately overcome by H<sub>2</sub>S and fell down. Another contractor (D) passed out as he rushed to aid a coworker (A). Simultaneously, one contractor (I) left the area, and four others (E, F, G, and H) walked to fresh air. One of these men (F) passed out momentarily before he and another contractor (E) realized that their coworkers had fallen; the two returned to the area to assist in removing the others to fresh air. Contractor (F) passed out a second time while attempting to assist his coworkers. Georgia-Pacific operators working in the vicinity of the NaSH tank truck saw the Burkes employees falling and went to the control room to report the incident.

*Two Burkes employees in the immediate area of the manway were killed.*
