Worker Dies from Burn Injuries

Date of Incident: 99 04 01

Type of Incident: Fatal

1.1 F-141816

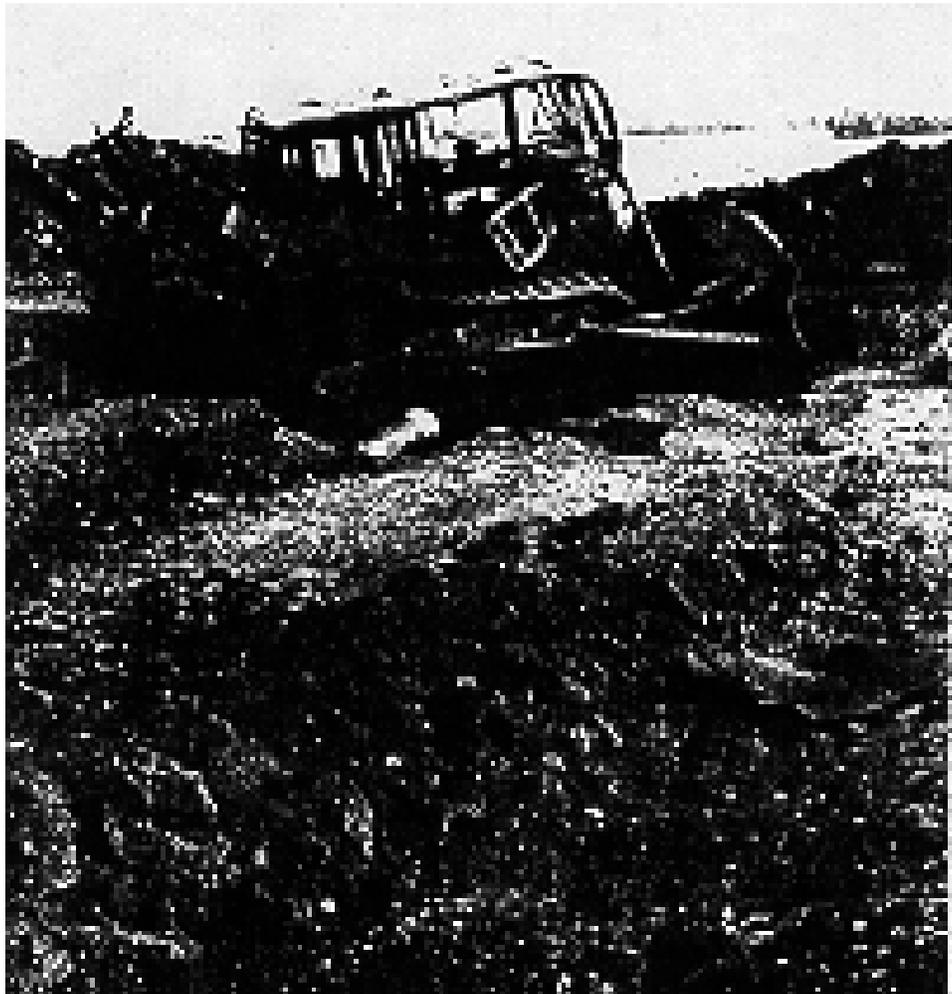
Photograph #2

- 10.4 The cat involved was a 1987 model D8N, S/N 9TC01715. It was equipped with a dozer blade and a single hydraulically controlled ripper tooth (see photograph #2).
- 10.5 The NW of 5-82-9-W6M was being used as pasture land for livestock. The quarter was snow covered at the time. Under the snow, ground cover consisted of grasses, sedges and scattered brush/willows.

Taken looking southeast (see diagram #2), this picture shows the D8N cat complete with dozer and ripper. The red arrow indicates the exposed end of the southern end of the pipeline under the cat's track. Debris in the foreground is part of the pipeline that was blown away.

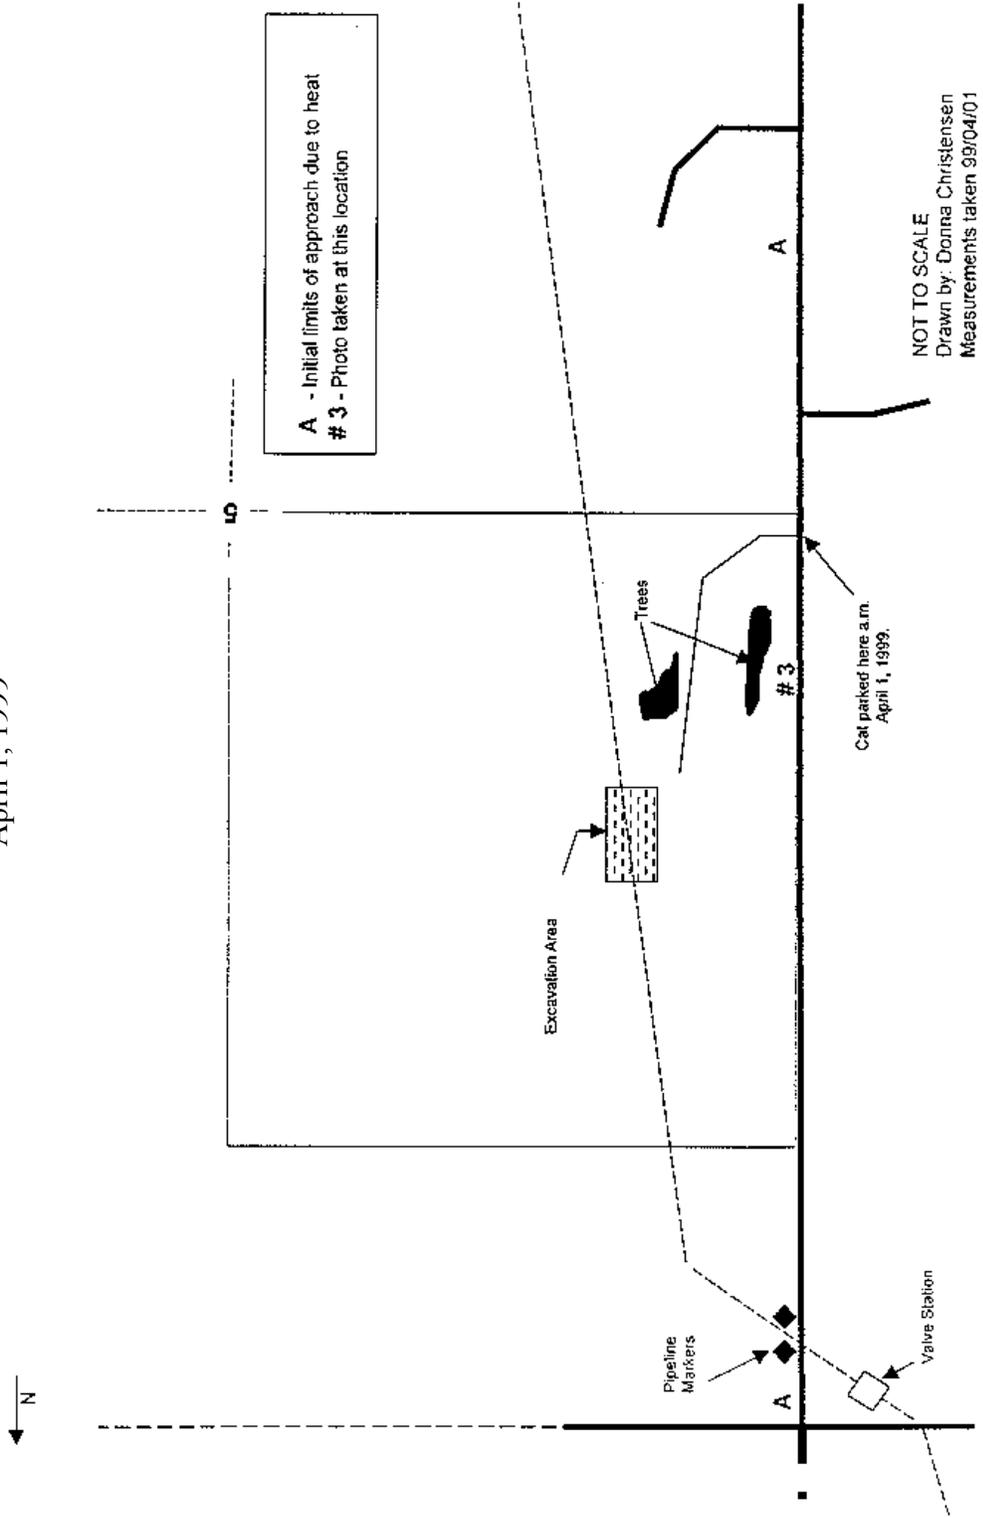
Diagram 1
Fatality Investigation
NW5-82-9-W6
April 1, 1999

- 12.2 On March 31, the D8N cat was walked across country and left at the approach to NW5 by another operator (see diagram #1).
- 12.3 On April 1 at 0800 hours, the landowner, the operator, and a Taves Contractors Ltd. employee met at the cat. The landowner selected a low/wet area in the field as a suitable location for the dugout. The Taves Contractors Ltd. employee explained the most efficient way to construct the dugout.

- 12.7 The landowner heard an explosion, saw the fireball and drove from his home to the site, approximately 4.8 km away. Several community residents were already on site. The intense heat prevented approaching the fire (see diagram #1). The landowner phoned Taves Contractors Ltd. to notify them.

- 12.11 At 13:43 hours the R.C.M.P., the Savannah Fire Department, ambulance, and Trans Canada operators arrived on site. The fire was diminishing; however, intense heat still prevented approach to the site. Trees south of the incident blocked the site lines to parts of the dugout area (see diagram#1).

- 13.1.3 The cat was driven to the site the night before by another Taves Contractors Ltd. employee. The three people on the site that morning had not driven by pipeline signs/markers just a few hundred metres north of the site when accessing the cat (diagram # 1).
