**Investigation of Blowout and Fire
Grand Isle Block 93, Well C-4ST
OCS-G 2628
August 8, 2002**

Gulf of Mexico
Off the Louisiana Coast

U.S. Department of the Interior
Minerals Management Service
Gulf of Mexico OCS Regional Office

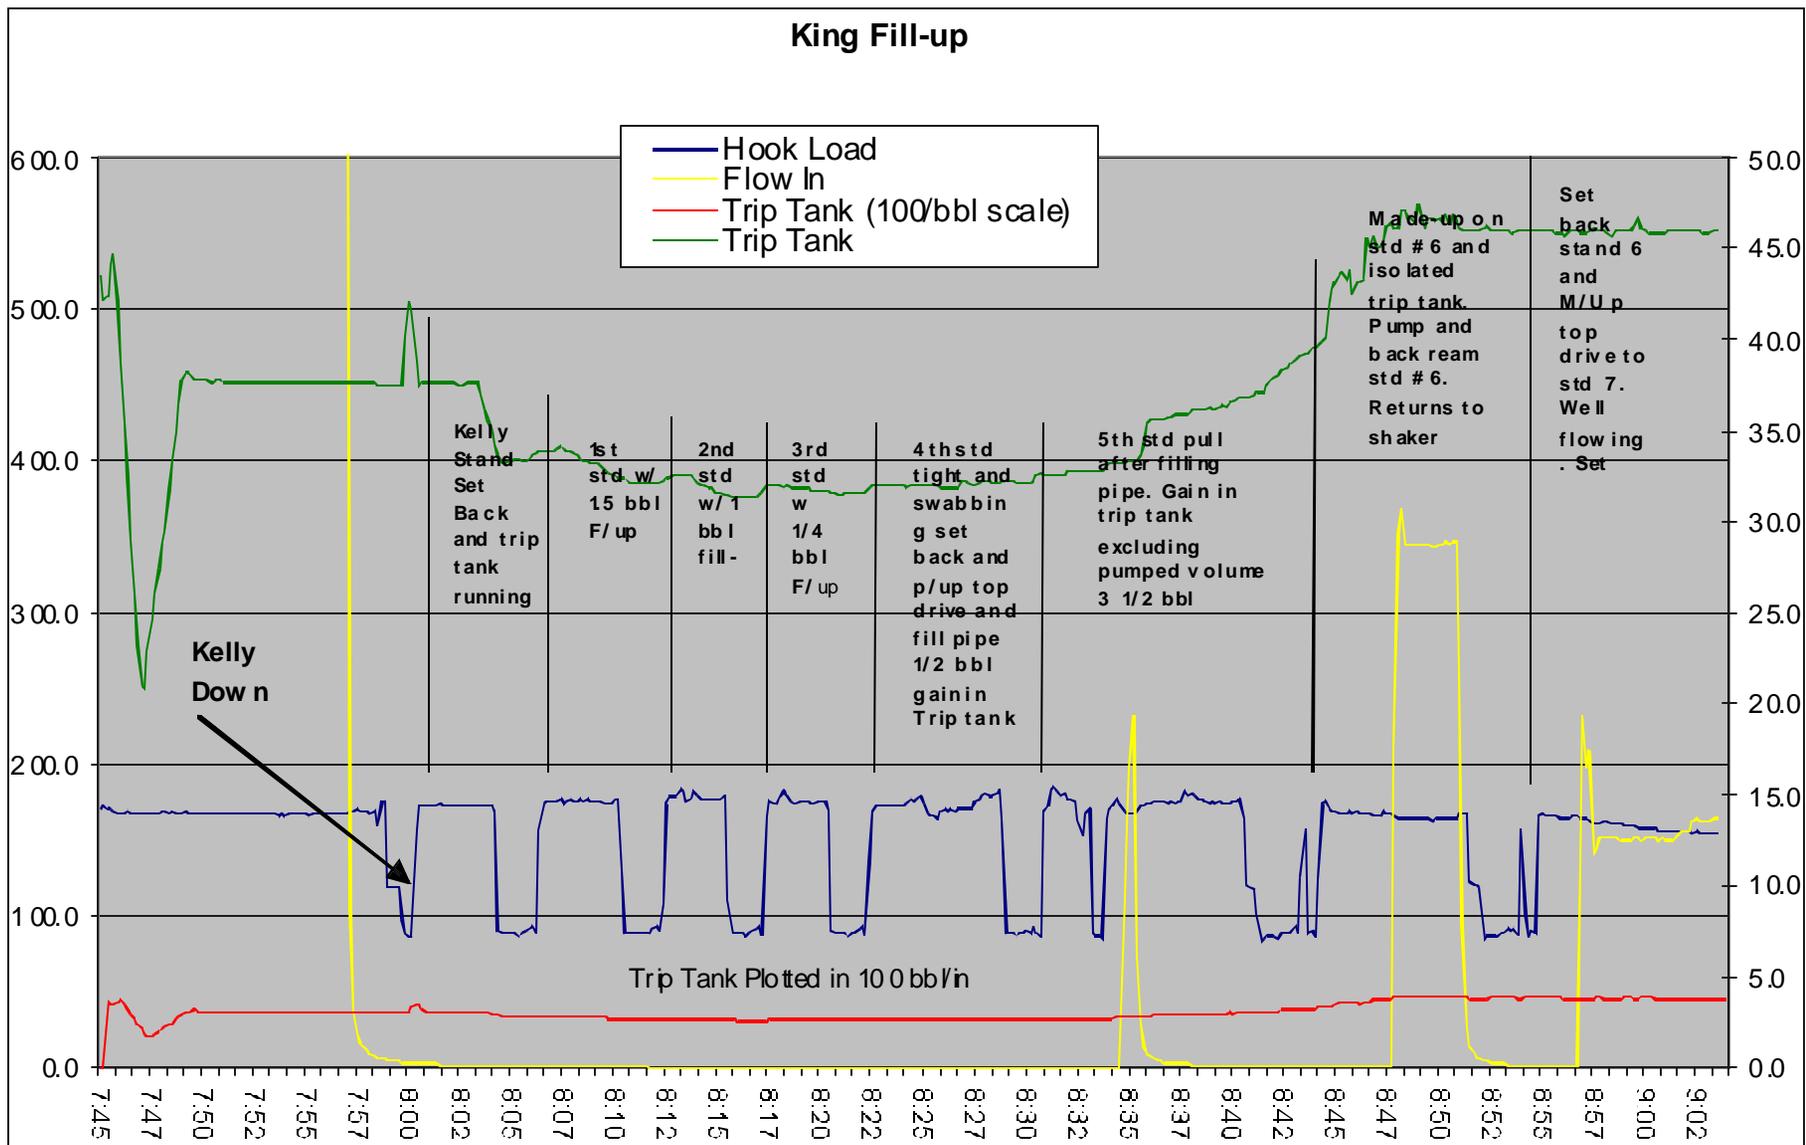
Rig, Trip Tank Fill-Up, 8 August 2002

8 August, 0800 hrs. – Begin pulling pipe, pulled stand #1, filled the hole with 2 bbls (*for fill record and time during trip, see Attachment 3*). Pulled stand #2, filled hole, took 1 bbl. Pulled stand #3, the driller observed a slight weight bobble, worked pipe some, filled with about 1 bbl. The string was pulling wet. When the driller pulled stand #4, he observed a 20,000-lb over-pull. He worked the string up and down for gumbo. Working the pipe decreased the overpull; hole fill for stand #4 was 0.25 bbls.

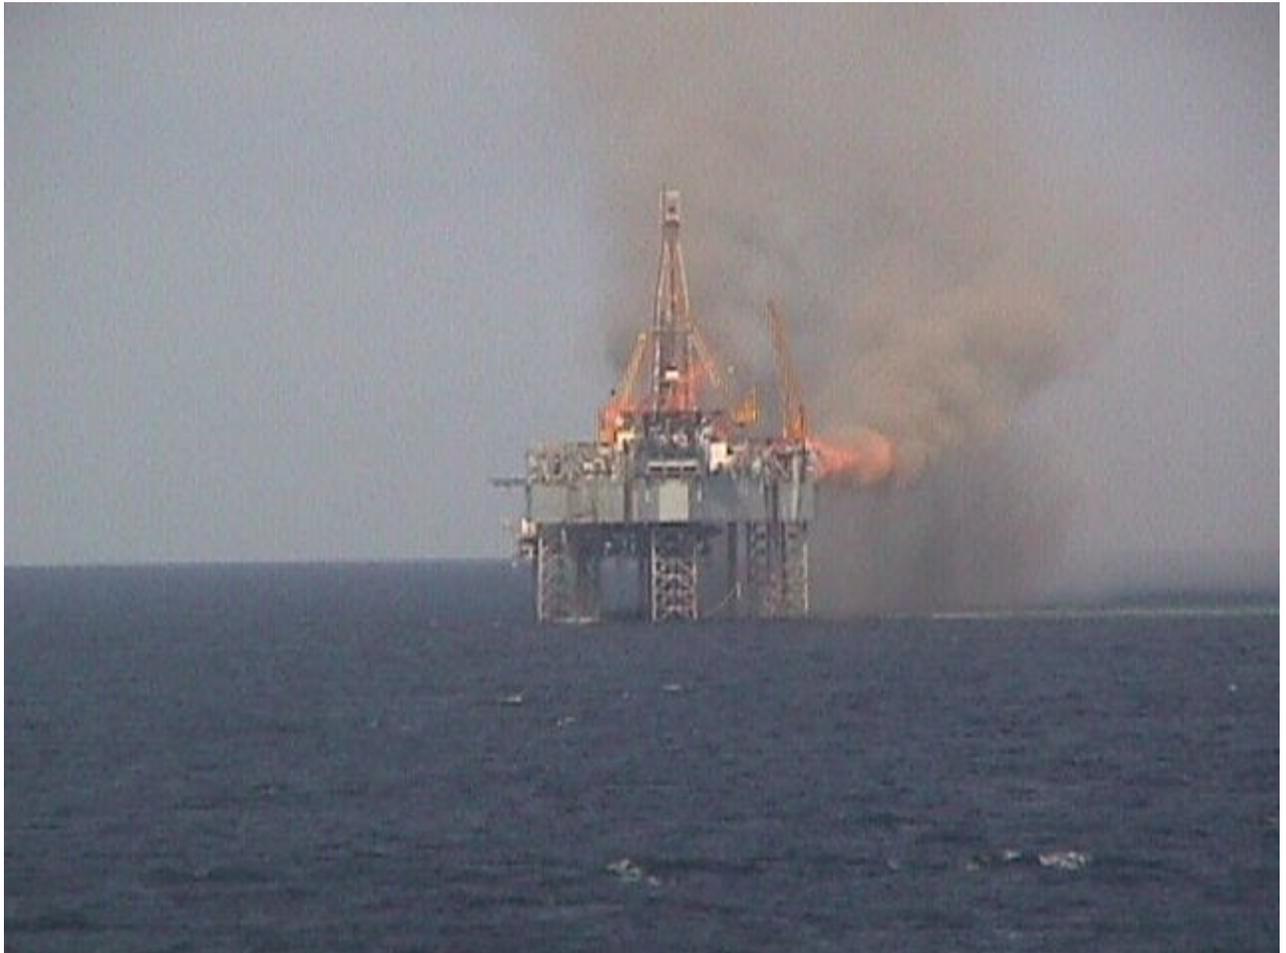
crew decided to ESD the Platform and abandon from the Platform's plus-ten deck onto the field boat. The OIM asked the driller to switch pumps to seawater. The driller, derrickman and motorman went back below deck and swapped the pumps over to pumping seawater, an operation that took about 40 seconds. The driller then checked through the living quarters to confirm complete evacuation. The Company-man tried to phone several superintendent and supervisory personnel without success. The diverted flow from the well was now rocking the rig as the company-man gave up the effort to establish phone contact with supervisory personnel. The OIM contacted and briefed the Rig area manager on the situation until the company-man re-entered the office and suggested they quit trying to contact supervisors, at which time all went to abandon stations. At the abandon stations, the roster was checked but there was some uncertainty because of the confusion generated by crew change earlier in the morning and a discrepancy in the onboard roster, which was being updated to reflect the crew change. Consensus review and radio contact with the two capsules already launched indicated that everyone was believed accounted for (*for photographic review of the blowout progress, see Attachments 4-6*).

Rig on fire 8 August 2002.

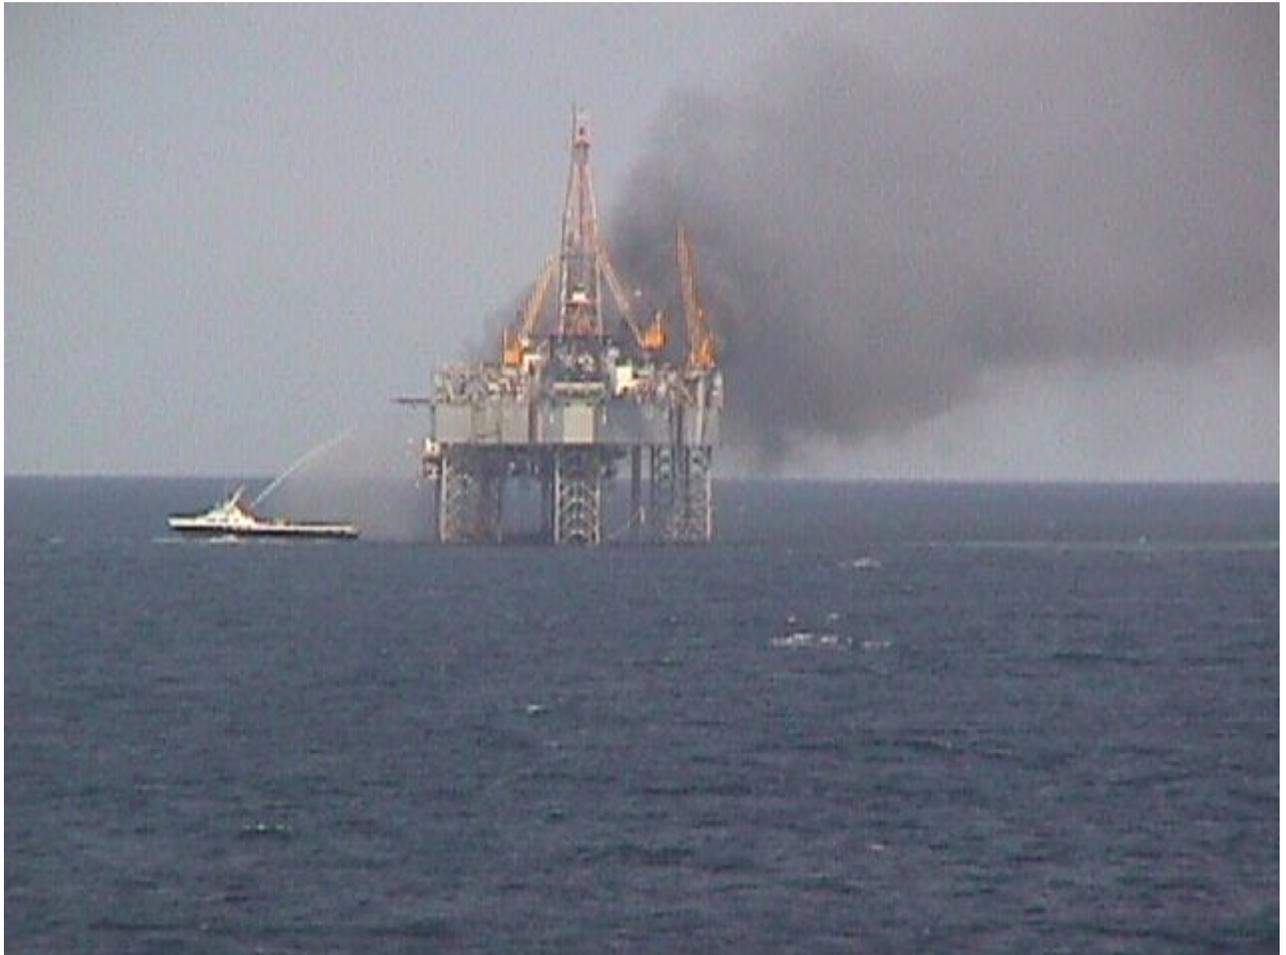
Rig fire after wildwell C-4 ST bridged.

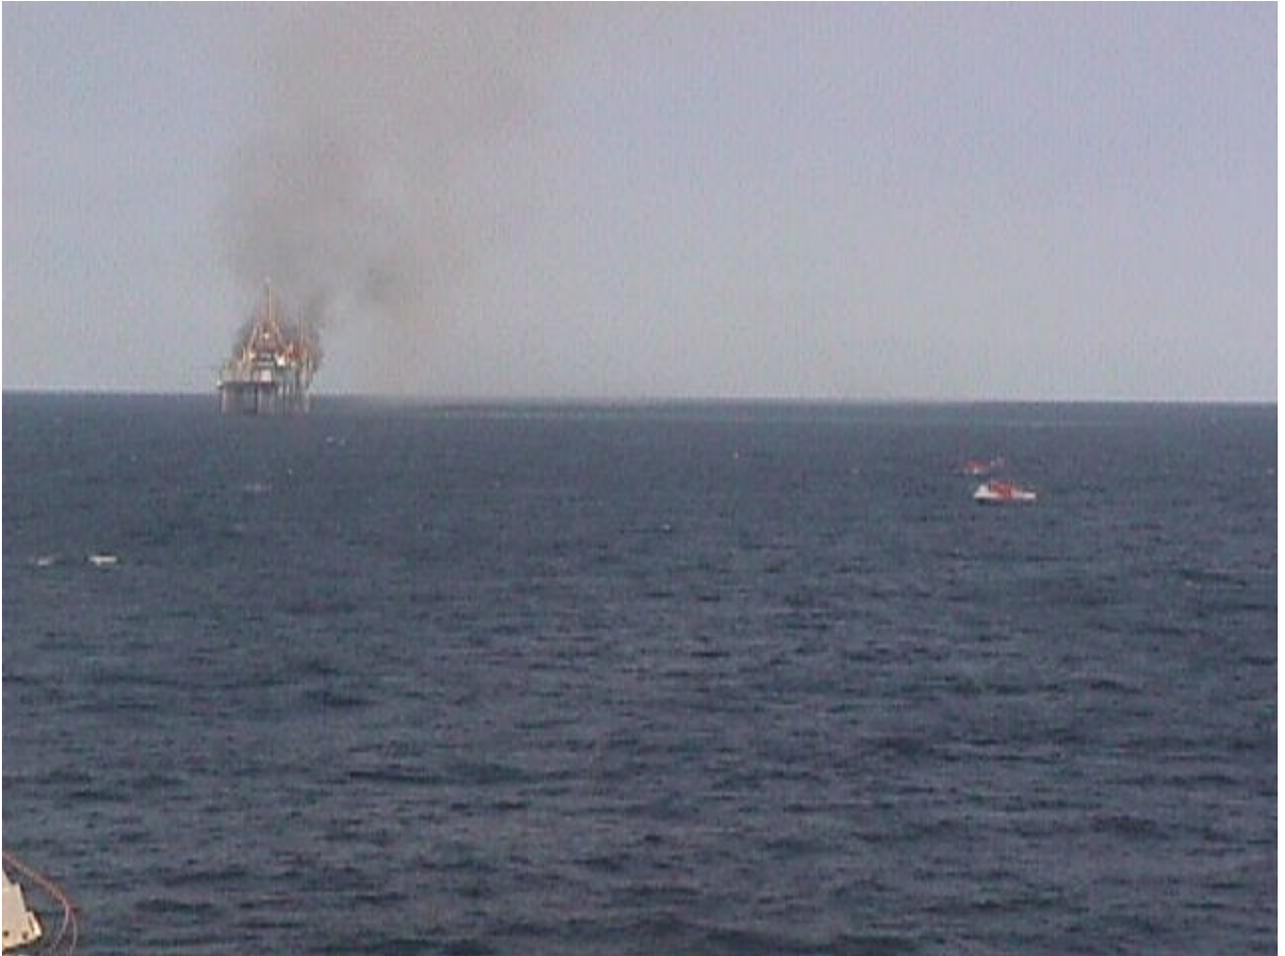
Rig fire and escape capsules navigating to rescue point.

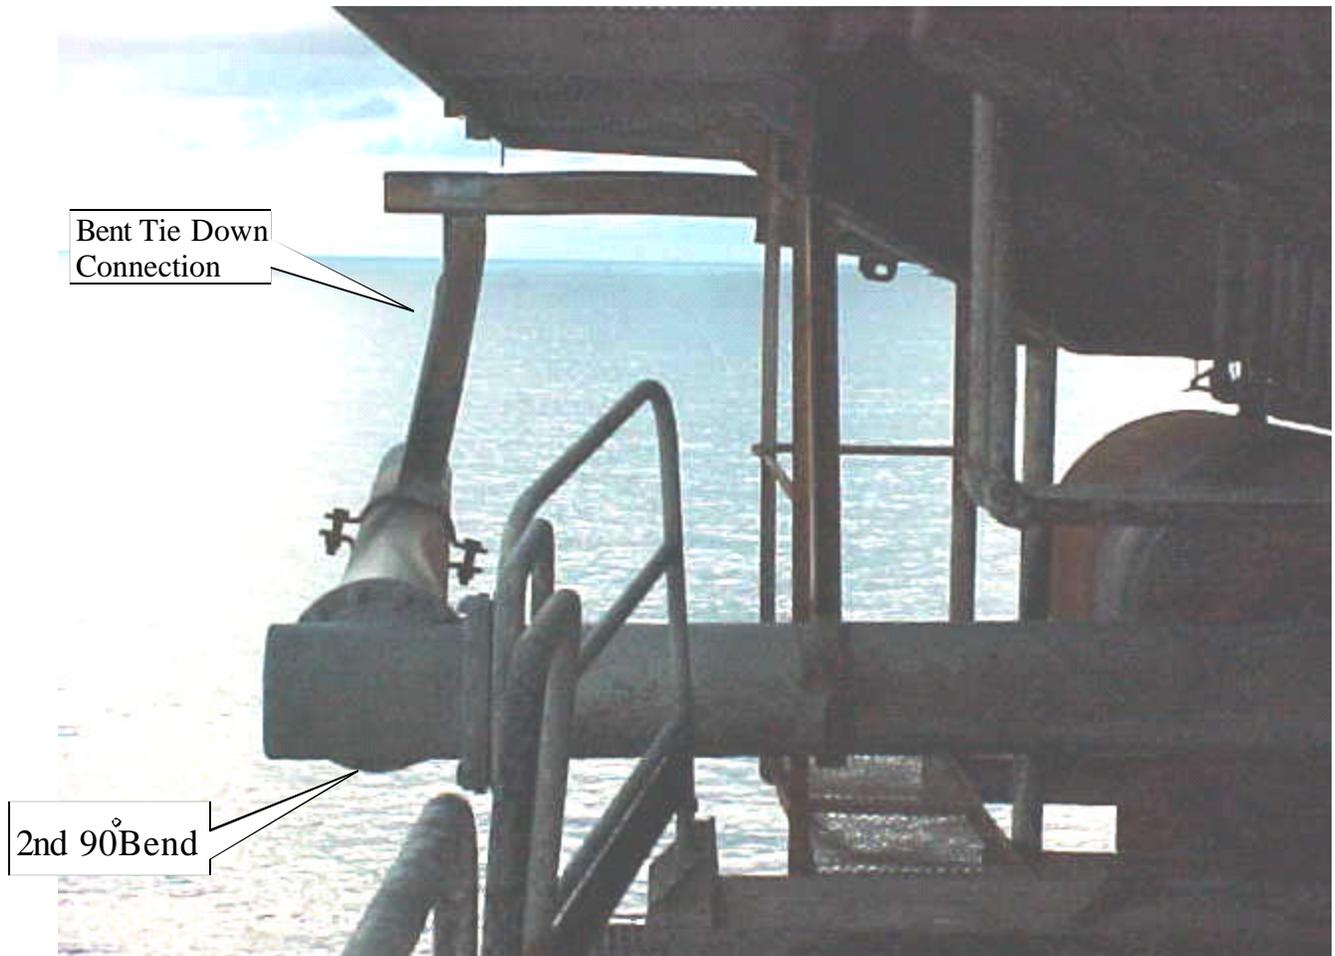
On 26 August 2002, three members of the MMS panel inspected the Rig and the significant damage. While the structural damage to the Rig itself was not major, significant repairs were required to the wiring, paint, lighting fixtures, beneath the floor, and on the superstructure. The diverter was heavily damaged, with end of the portside diverter pipe being blown off in the course of the uncontrolled flow. Additionally, the main diverter line teeing into the port and starboard diversion lines was heavily sand cut. Both the starboard and port diverter lines themselves exhibited some sand erosion and damage, and most of the bracing was bent and degraded by flexing (*see Attachments 7 – 9*).

Starboard diverter piping discharge after blowout.

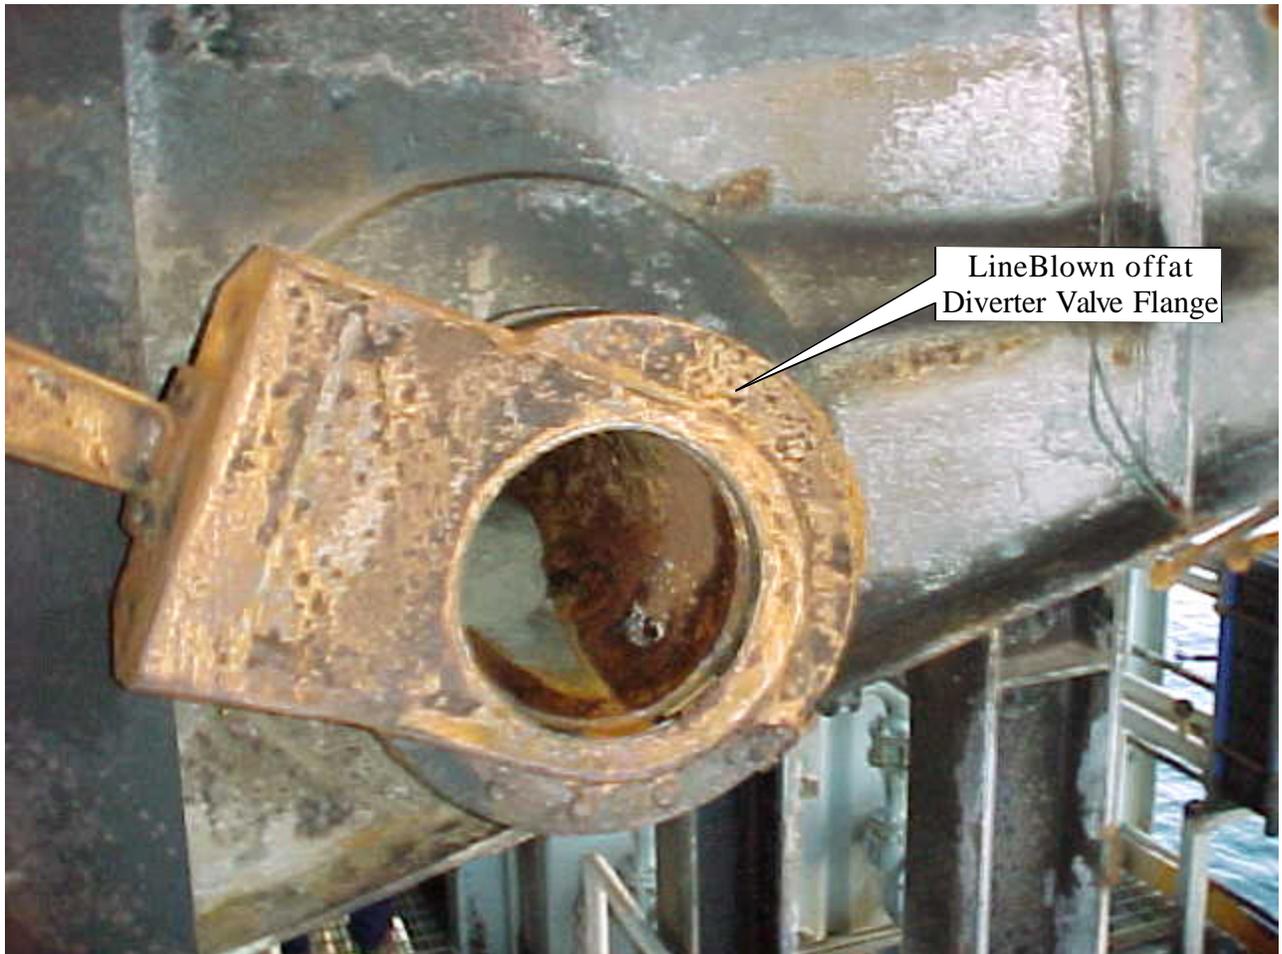
During the course of the events of the blowout, after the initial loss of control, the flow was reportedly directed into the portside, or (presumably) downwind, line. However, the entire system began to flex and bend because of the power of the flow. This flexing of the pipe apparently placed significant stress on the 2-inch braces and on the end of the portside line. The force transmitted to the portside line was increased because of back pressure generated by the aforementioned 90-degree bend at the end of the line. This back pressure, and the flexing of the inadequate 2-inch bracing, eventually resulted in the end of the portside line being blown off upstream of the 90-degree bend.

Portside diverter piping exit after loss of pipe end.

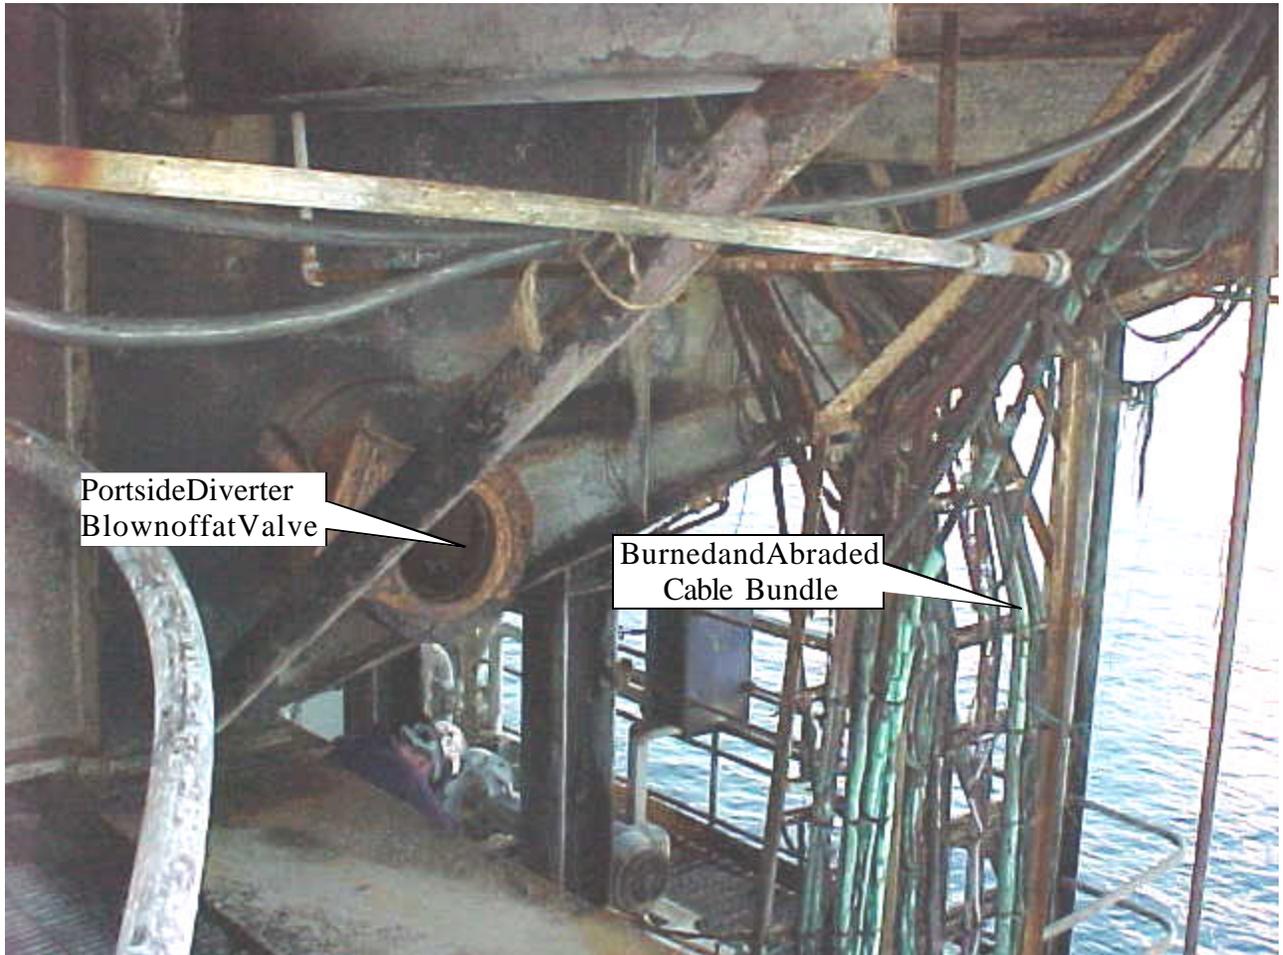
1. The failure of the diverter, specifically the end of the portside line, possibly led to fire on the Rig floor by allowing uncontrolled hydrocarbons to exit the diverter beneath the Rig floor rather than outboard.
2. The diverter failed in two locations, possibly because of insufficient tiedown supports, an unapproved routing plan, and a marginal design that allowed the flow to impact an inclined pipe wall immediately upon exiting the diverter housing.
3. Ignition of the uncontrolled hydrocarbon flow was possibly caused by electrical arcing in the electrical cable bundles that were subjected to the diverter flow stream. These bundles were routed in close proximity to the diverter and were subjected to direct

impact of an abrasive mixture after the failure of the portside diverter. Once the insulation of the cables was abraded, arcing may have been allowed.

Portside diverter after blowout: and abraded burned cable bundles.

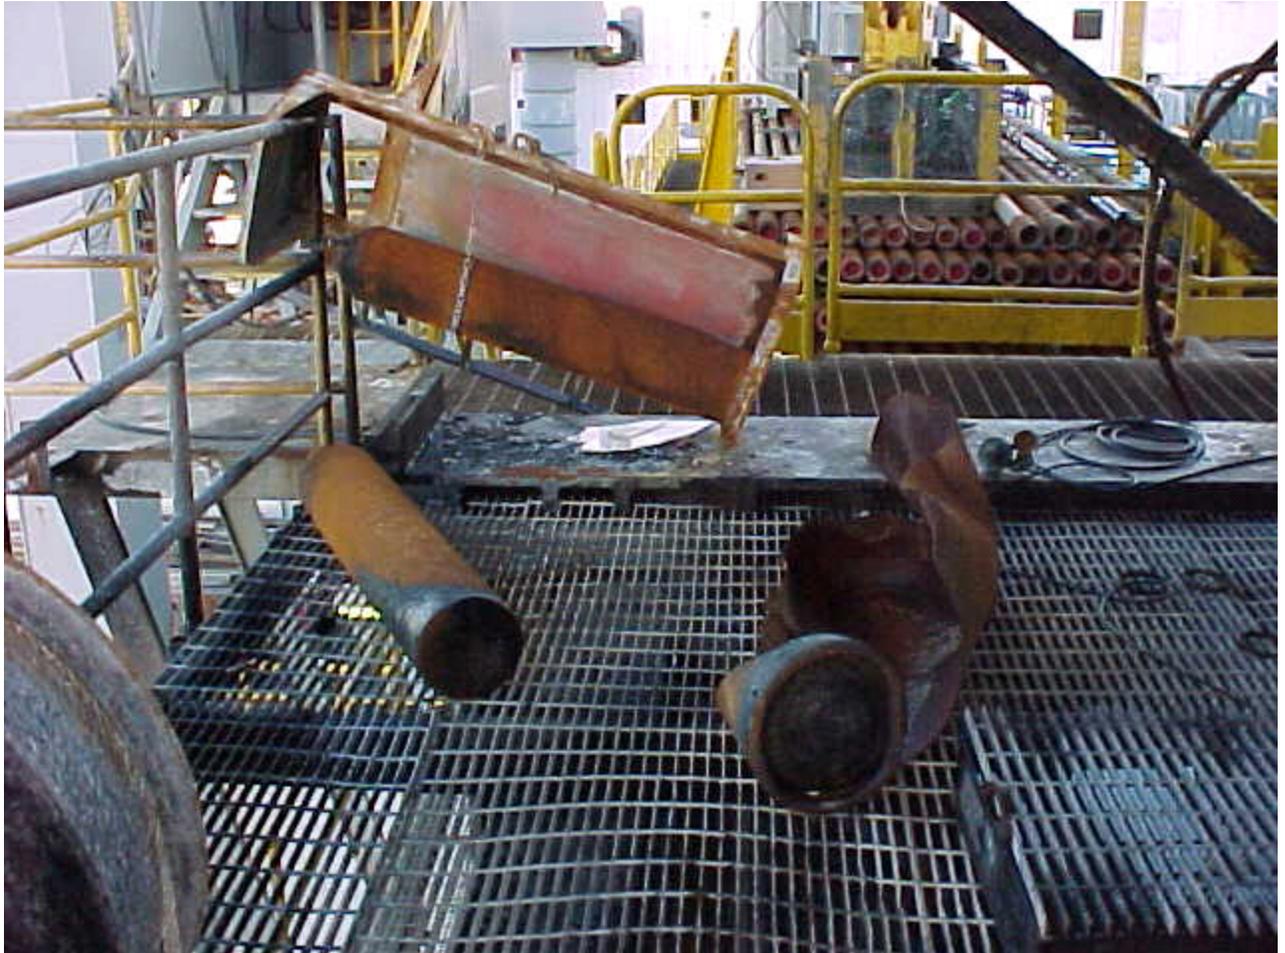
It was apparent from the inspection that after the end of the portside diverter line blew off; the uncontrolled flow was directed overboard from a point directly beneath the rig floor rather than from a point outside of the vessel's structure. As a result, the uncontrolled flow apparently impacted against equipment stored on the catwalk and other infrastructure utilizing the area. This included welding equipment and electric cable bundles that were routed in close proximity to the diverter. A number of acetylene tanks were among the stored equipment that received the force of the discharge after the end of the portside diverter blew off. When the flow ignited, several of these tanks exploded and apparently added to the intensity of the fire (*see Attachment 10*).

4. After the end of the portside diverter was blown off, the uncontrolled flow directly impacted acetylene bottles stored on the catwalk next to the diverter system. The ignition of the flow led to the explosion of some of these bottles, possibly contributing to the intensity of the fire and damages.

Portside floor adjacent to diverter, exploded acetylene bottles.

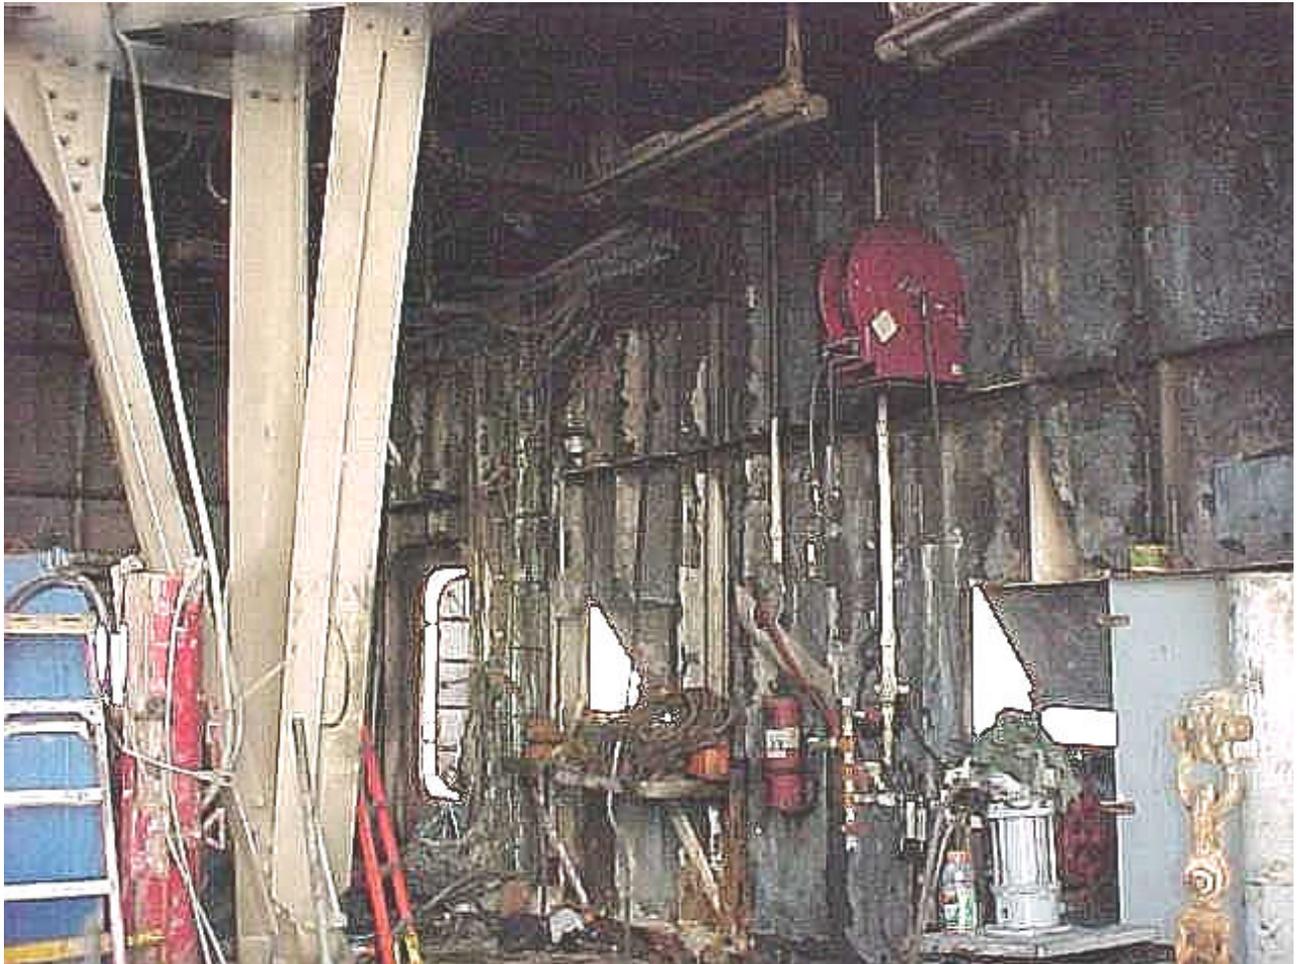
When the uncontrolled flow ignited, the flames also apparently immediately ignited the combustibles on the portside of the Rig floor above (*see Attachments 11, 12, 13*). The paint, some stored lubrication products, electrical wiring, etc., continued to burn for some time after the blowout had bridged and the uncontrolled flow ceased.

Portside drill floor motor shed, above diverter, after fire.

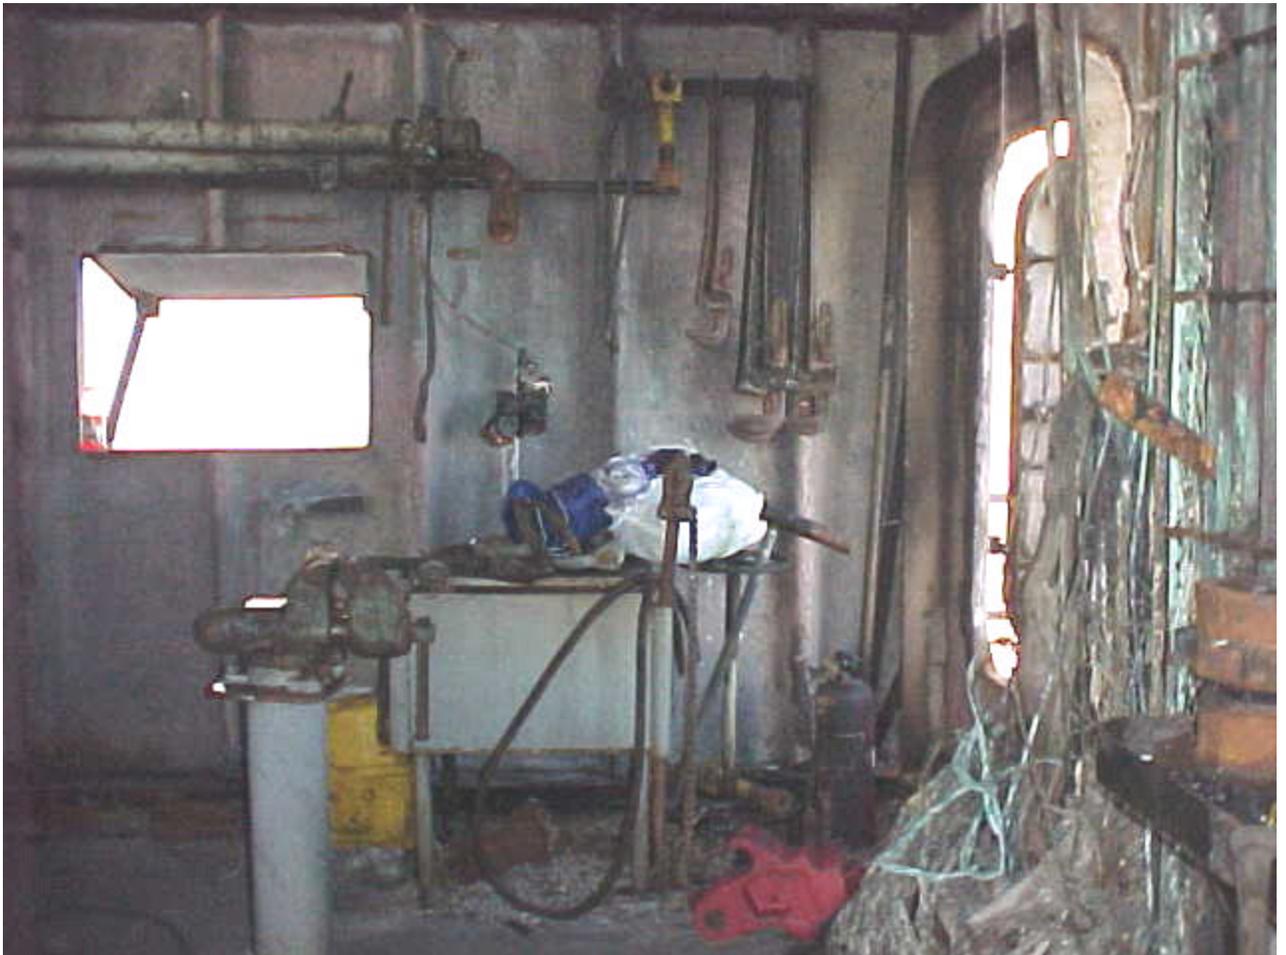
Portside drill floor motor shed aft above diverter. Destroyed cables and damage.

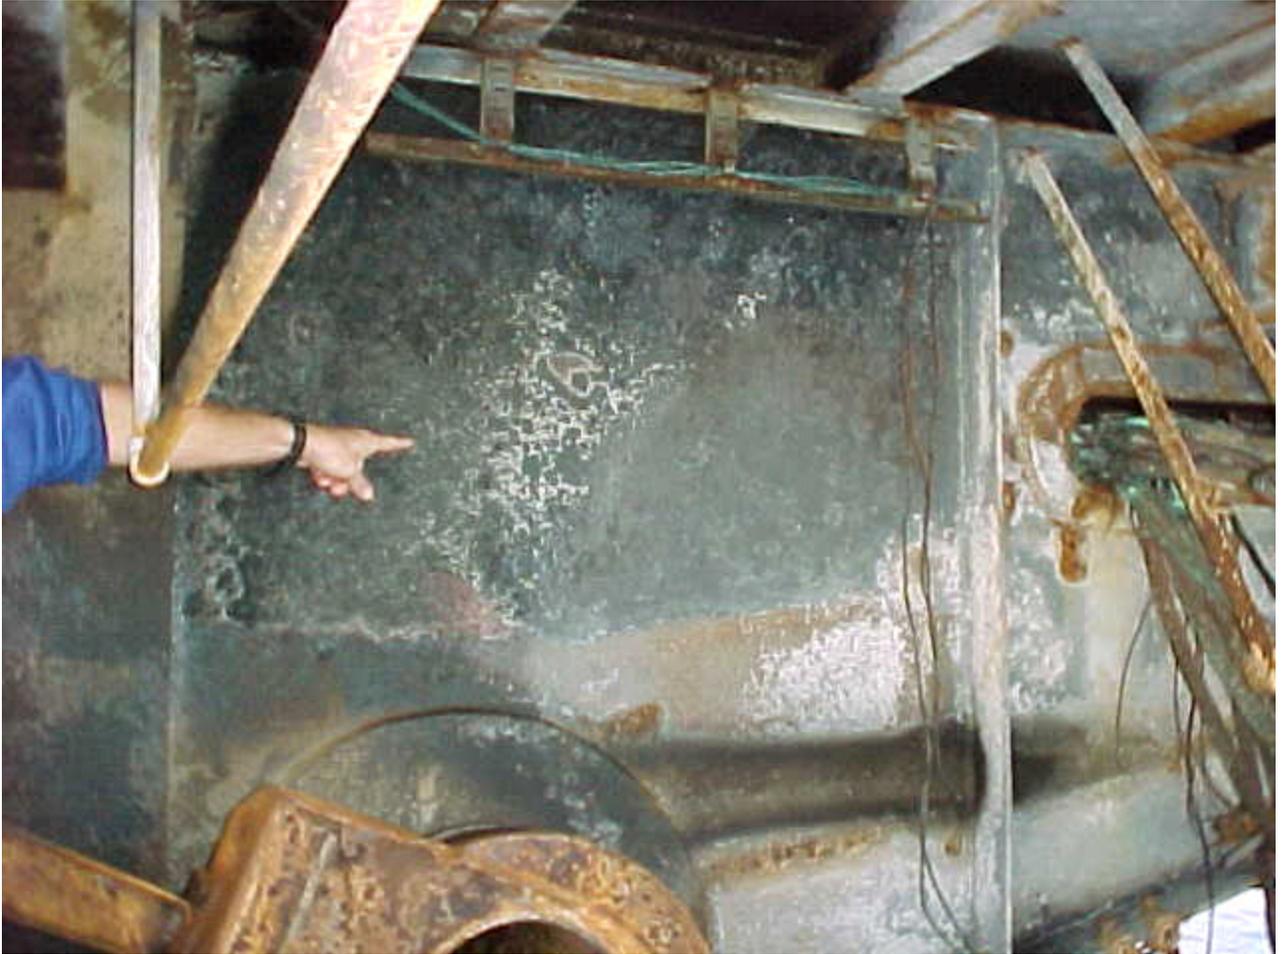
Fire damage to beam above port diverter, beneath drilling floor.

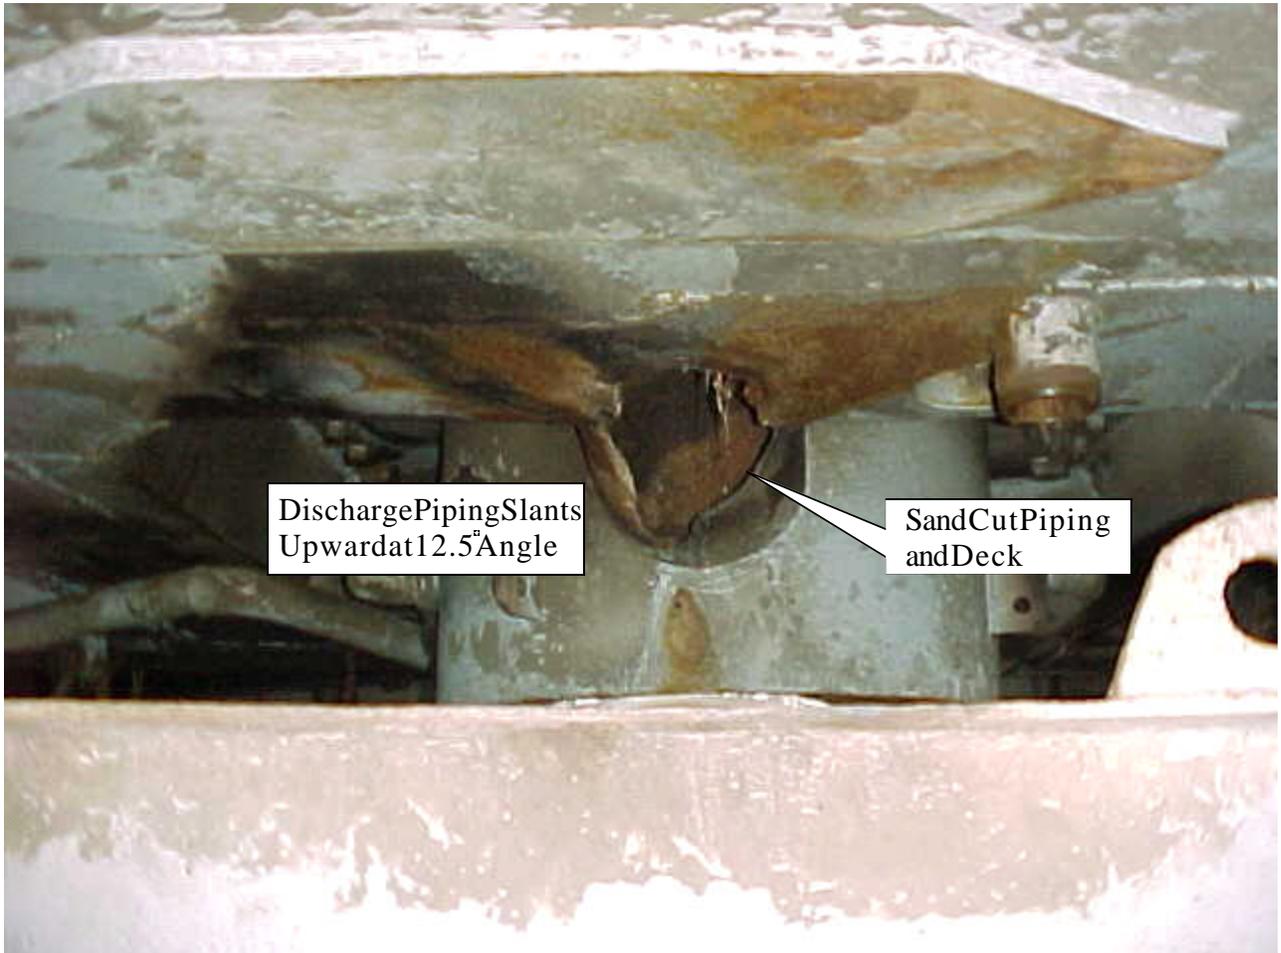
Separate from the loss of the end of the portside diverter line, sand in the blowout stream cut out portions of the main, 16-inch diverter piping at the exit of the diverter housing next to the wellhead (*see Attachment 14*). This pipe was routed for about ten feet at an incline of about 12.5 degrees from horizontal from the housing to the tee into the port and starboard lines. The pipe was sand cut on the lower wall, where the pipe took the initial impact from the flow because of the inclination. This cut allowed the gas to migrate directly upward from this point. This gas apparently ignited on the rig floor above the rotary table almost simultaneously with the ignition of the stream exiting the portside diverter line. This fire, in turn, apparently ignited the combustibles in that portion of the Rig separately from the portside ignition. Significant damage was sustained in this area, especially to the “hawkjaw” of the iron roughneck, though the machinery was ultimately salvaged and repaired. Additionally, burn damage to components in the drill floor electrical room and various hoses and other connections was significant. Some additional damage was suffered as a result of saltwater from the fire boats.

Diverter discharge piping, sand cut at exit from diverter housing.

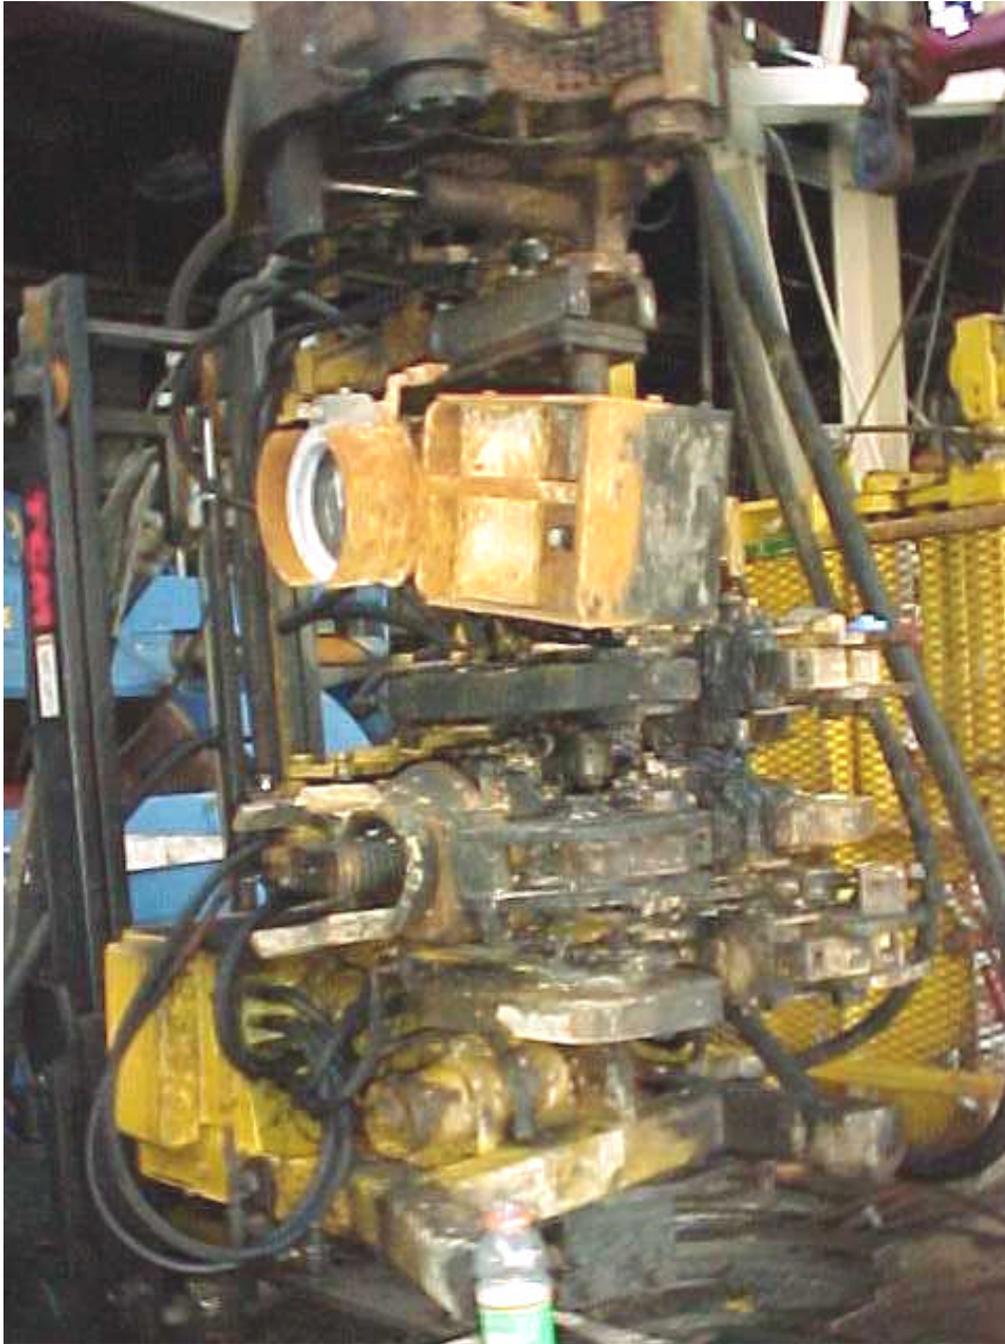
Fire damaged "Hawkjaw" above rotary table.

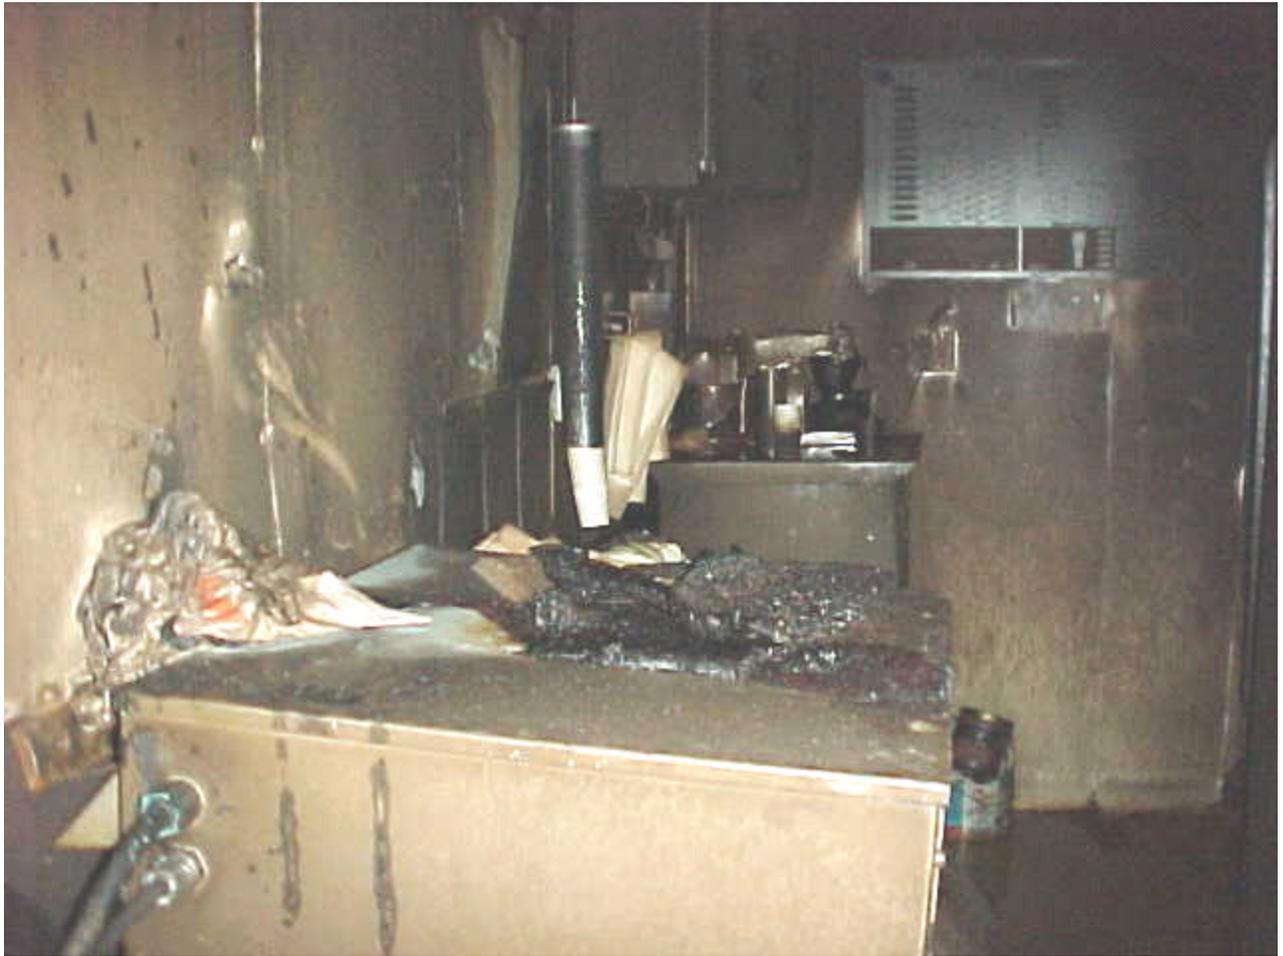
Fire damaged drill floor MCC Room.

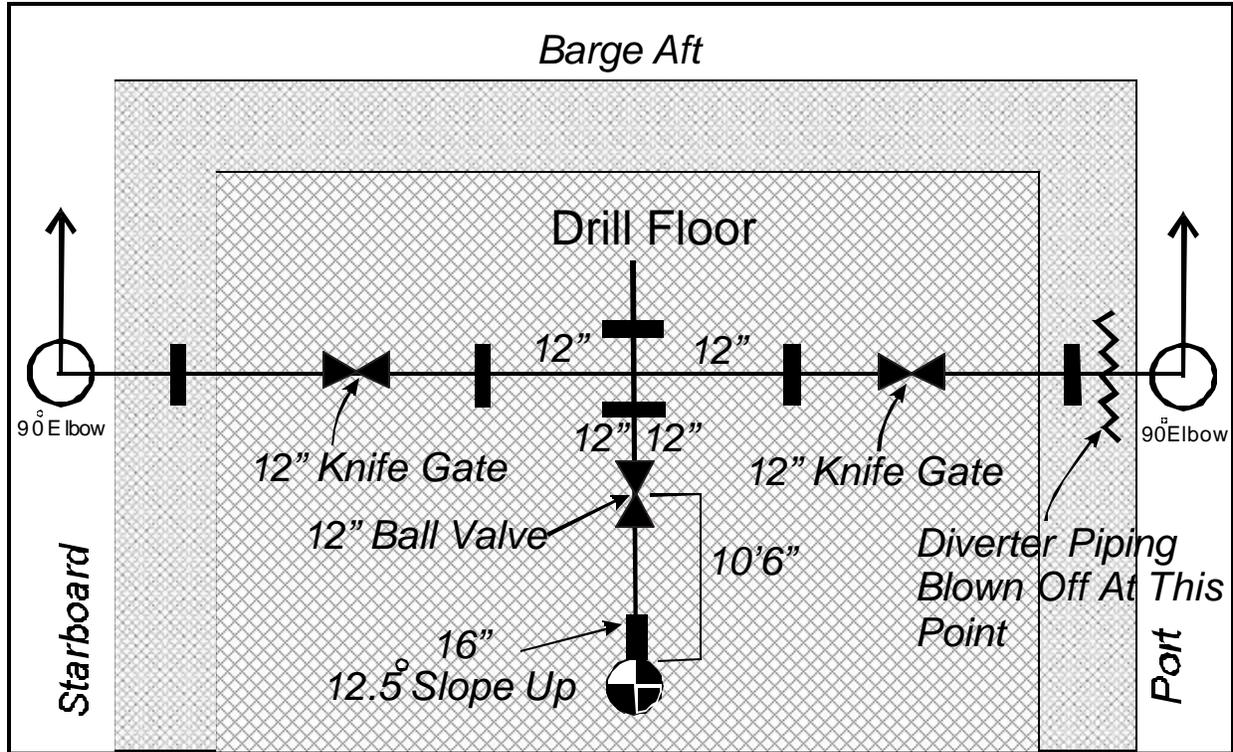
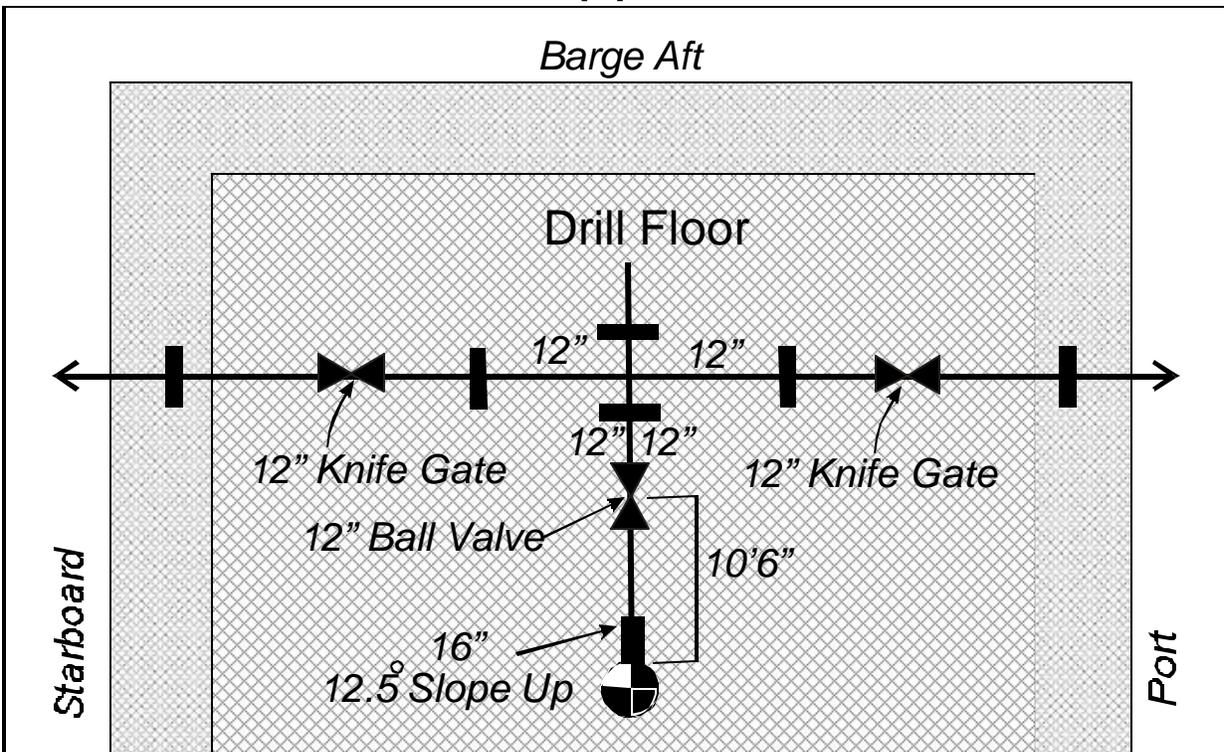
Diverter Piping System as approved, as built

During the preliminary investigation of the blowout, MMS discovered that possibly the diverter system was not installed per the approved drawing. Therefore, MMS requested the Operator to supply an as-built drawing of the diverter system. The as-built drawing showed the diverter installed was different from the approved diverter system, and this installation failed to meet MMS regulations and policies (*see Attachment 17*).

The diverter system installed had one 16-inch outlet from the diverter housing, departing the housing at a 12.5-degree angle. This outlet, which ran approximately 10-15 feet, teed (a 90-degree connection) into two 12-inch lines, these lines being routed to the starboard and portside of the Rig. However, each line subsequently made a second right-angle turn just beyond the sides of the Rig, directing the ends of both lines toward the rig's stern. Therefore, both lines terminated with the ends facing in the same direction, which would not facilitate downwind diversion, if the wind were to have come directly from the stern or westerly direction. All right-angle turns were targeted. However, the piping was apparently inadequately braced, using 2-inch angle iron welded to the rig substructure.

Subsequently, an Incident of Non-compliance (INC) dated 17 September 2002 was issued to the Operator on or about 4 November 2002. The INC was issued for failure "to obtain approval before making changes in major drilling equipment" and "to install diverter branch lines to provide downwind diversion capability," and was issued in accordance with Authority 30 CFR 250.415(a), and 250.409 (d) (1) and 409 (e)(1), respectively.

1. Shallow-gas hazard studies prepared for new wells from previously drilled surface locations should include a study of the old logs as well as seismic data. Drilling operations should be explicitly warned of shallow-gas deposits identified in previously drilled wells.
2. Care should be taken in the design, installation, and bracing of diverter systems to allow enough rigidity to resist flexing failure and to allow uncontrolled flows

to exit the system downwind and outboard of the rig. Proper design, construction, and targeting to limit the direct impact of flow upon pipe walls should be observed.
