MARINE CASUALTY REPORT

SS AMERICAN EAGLE, O.N. 278327

EXPLOSION IN THE GULF OF MEXICO

**Marine Board of Investigation Report
and
Commandant's Action**

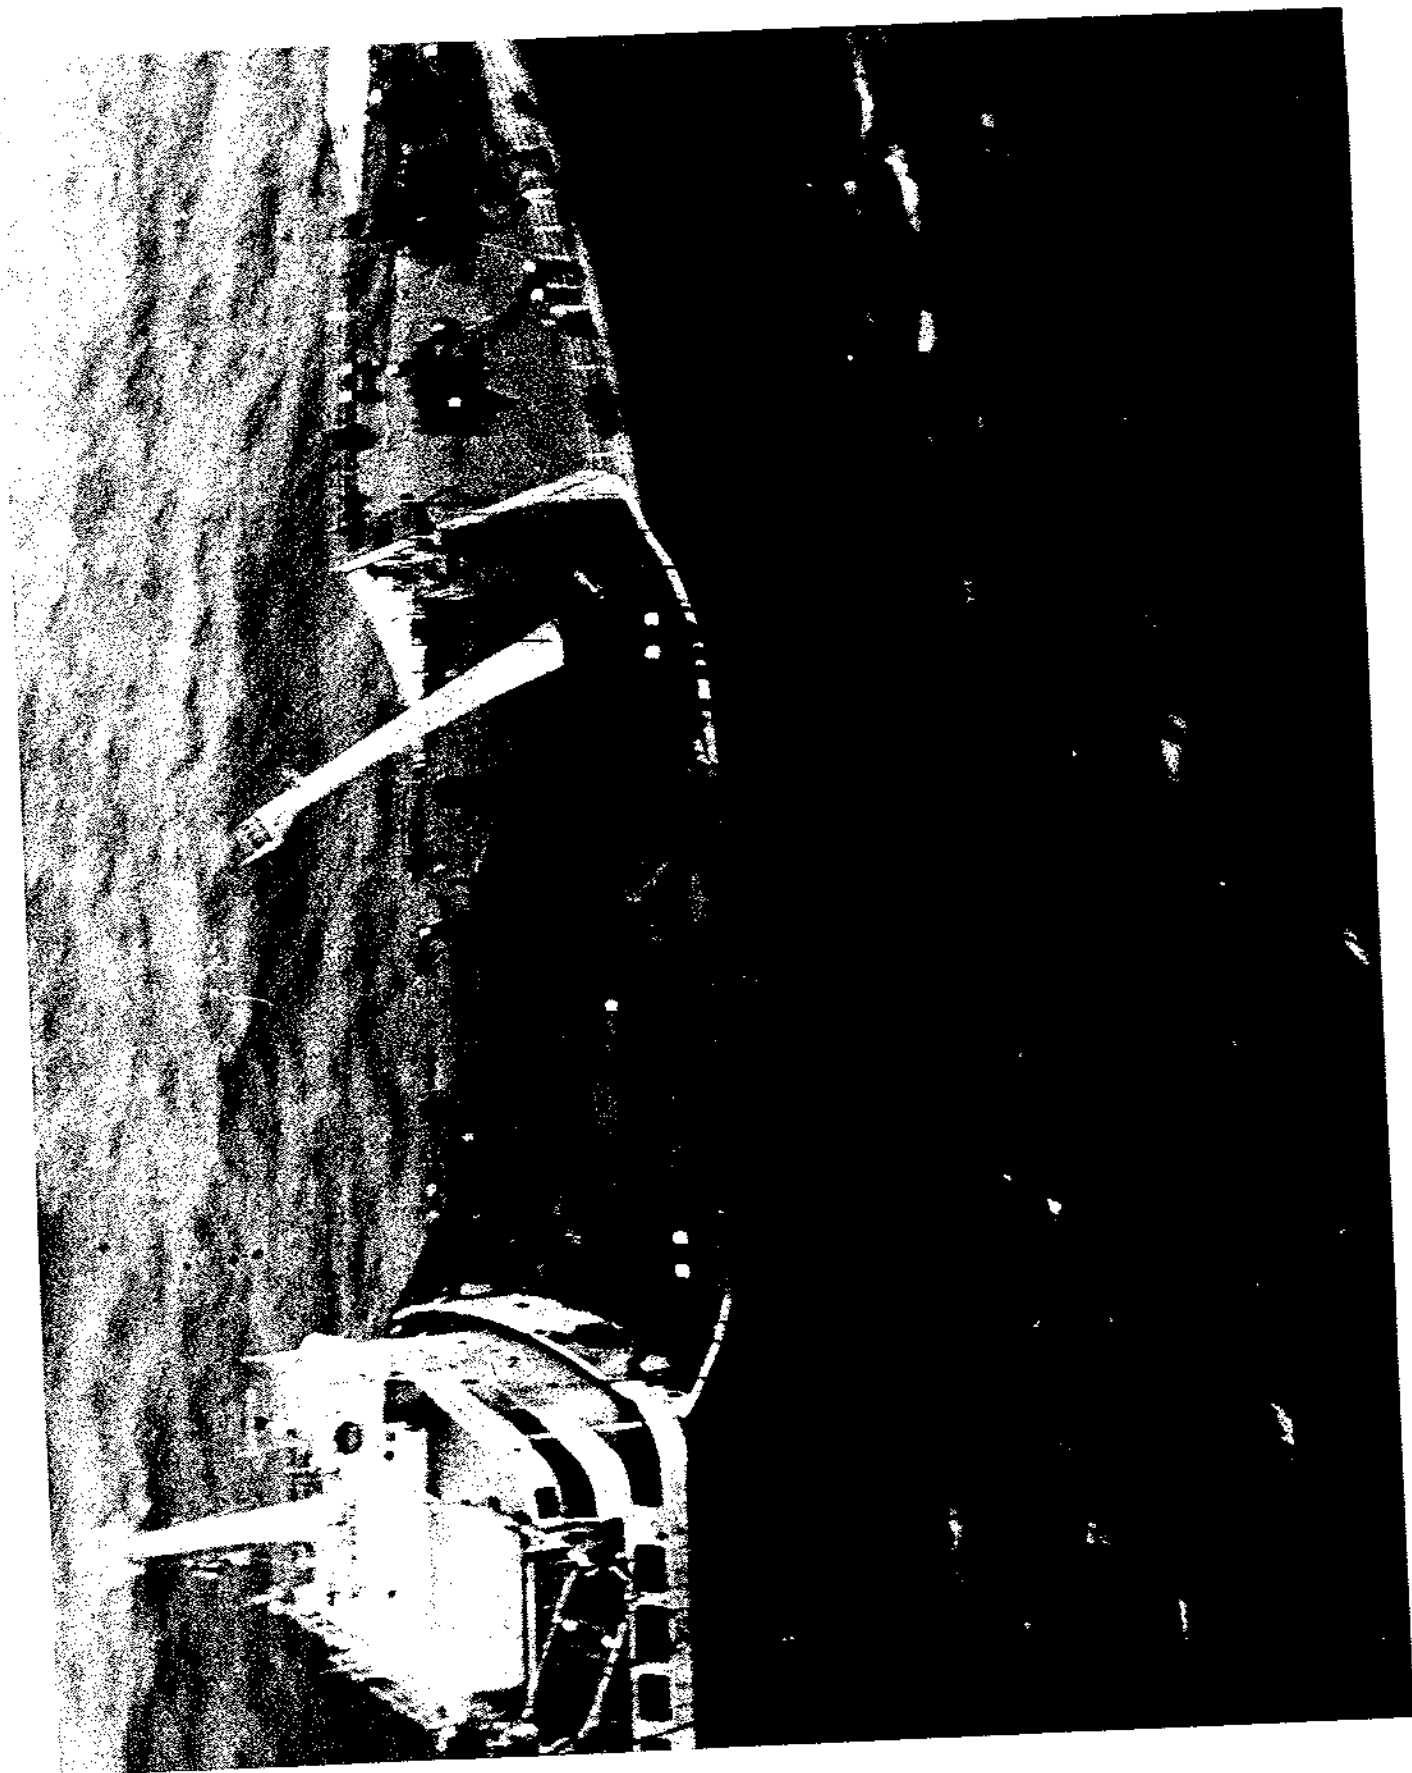
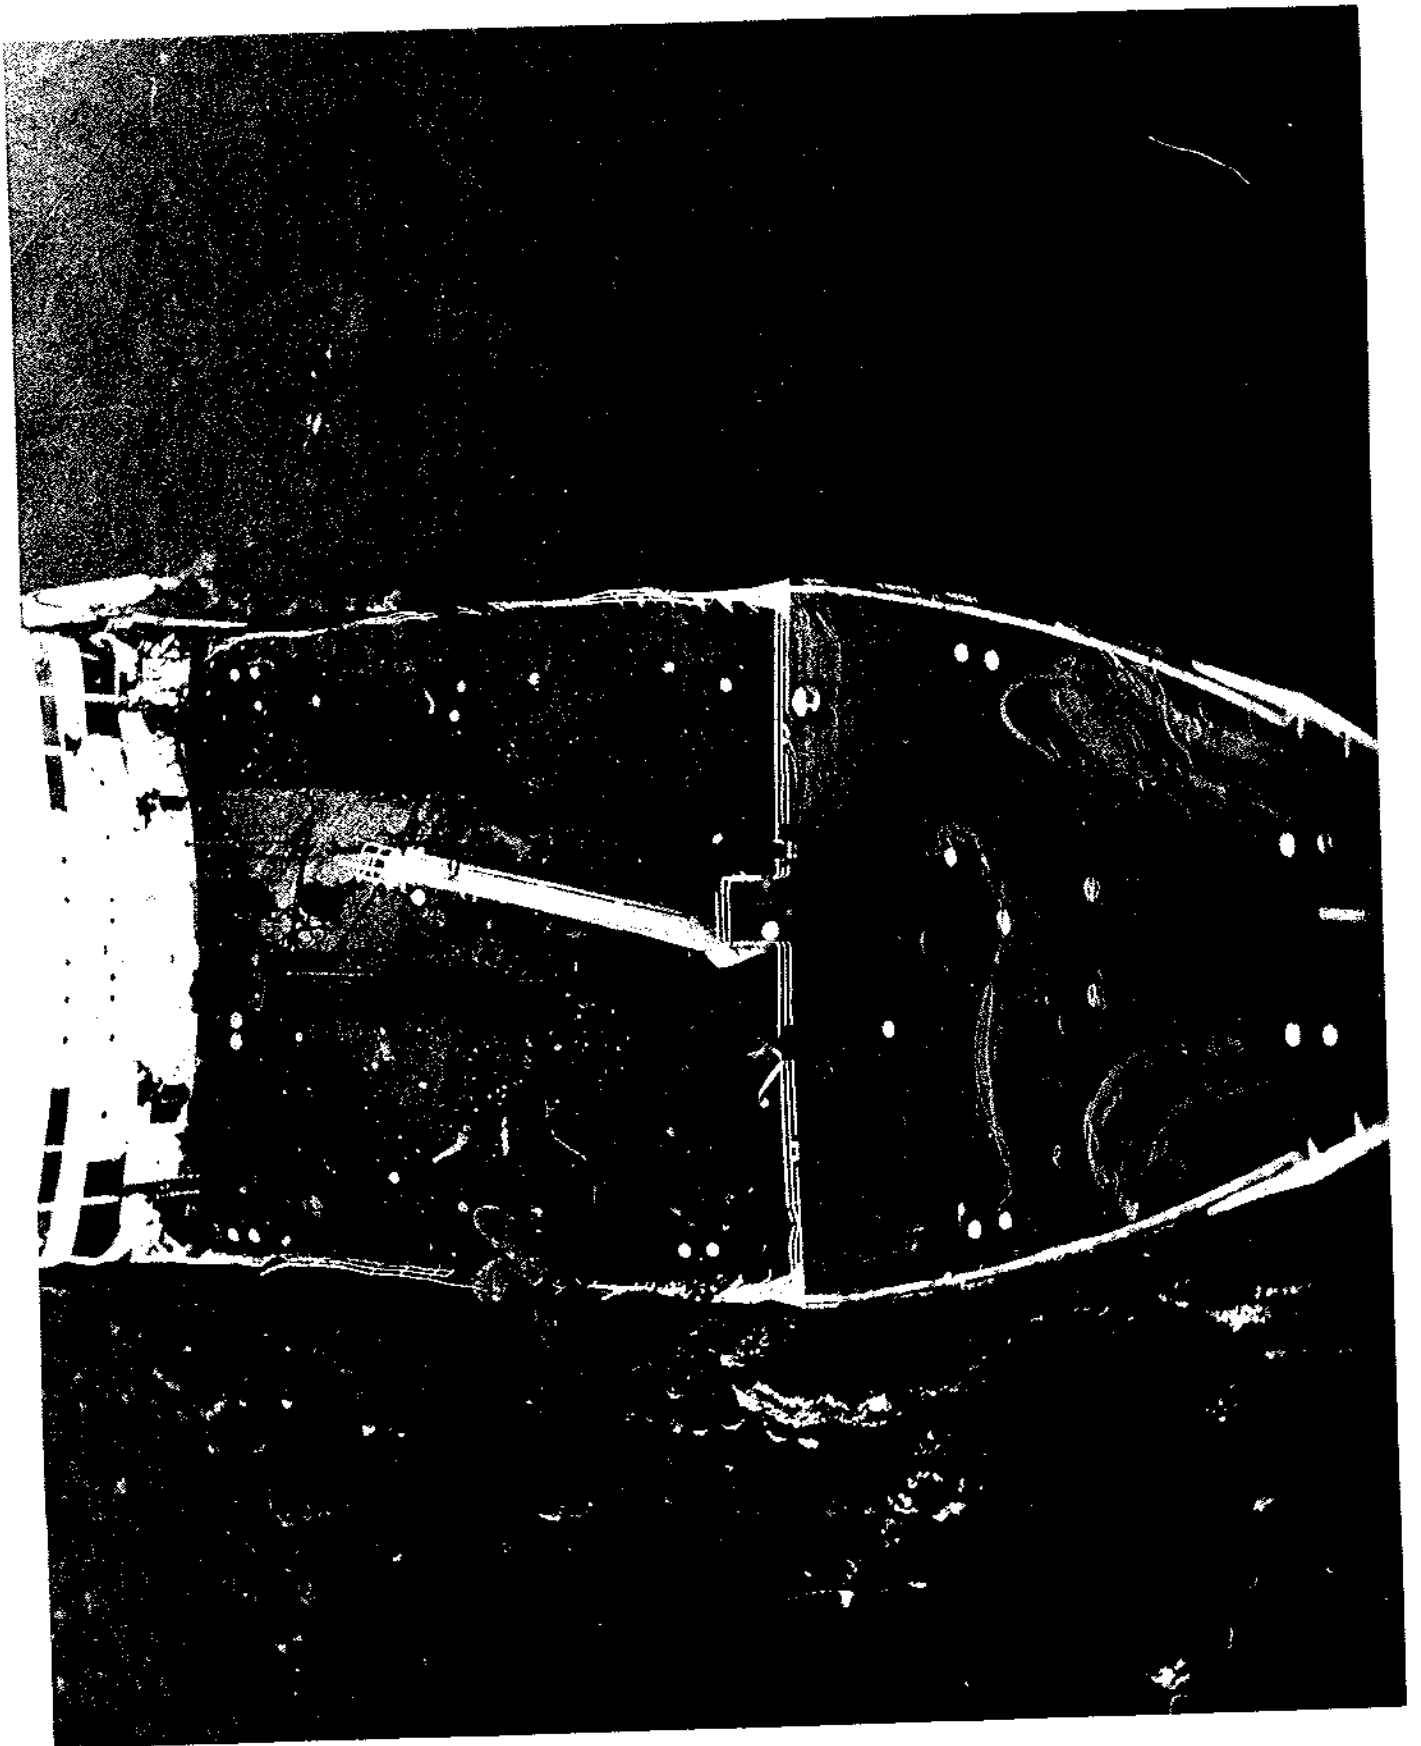
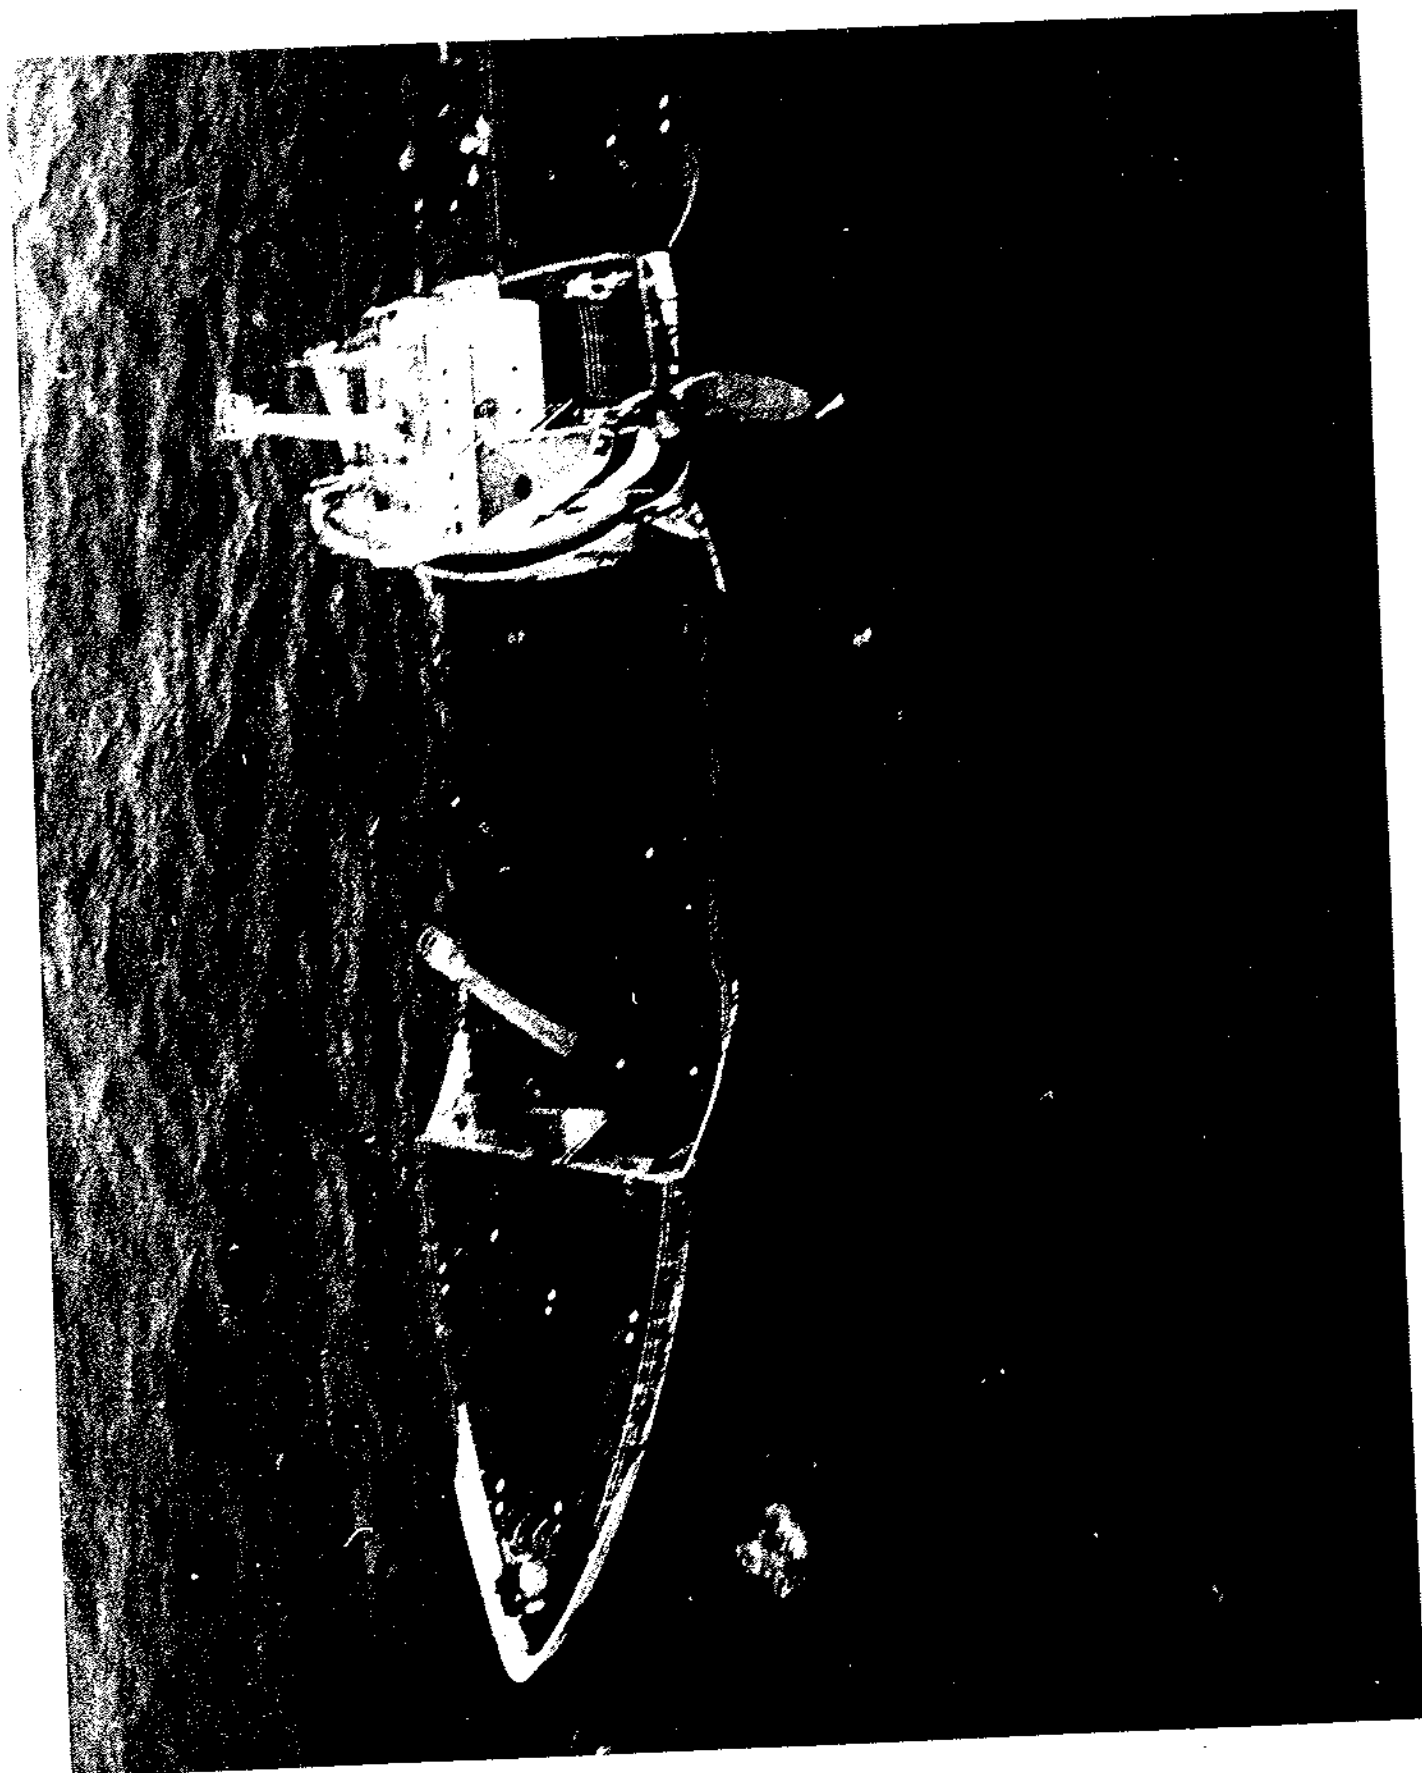
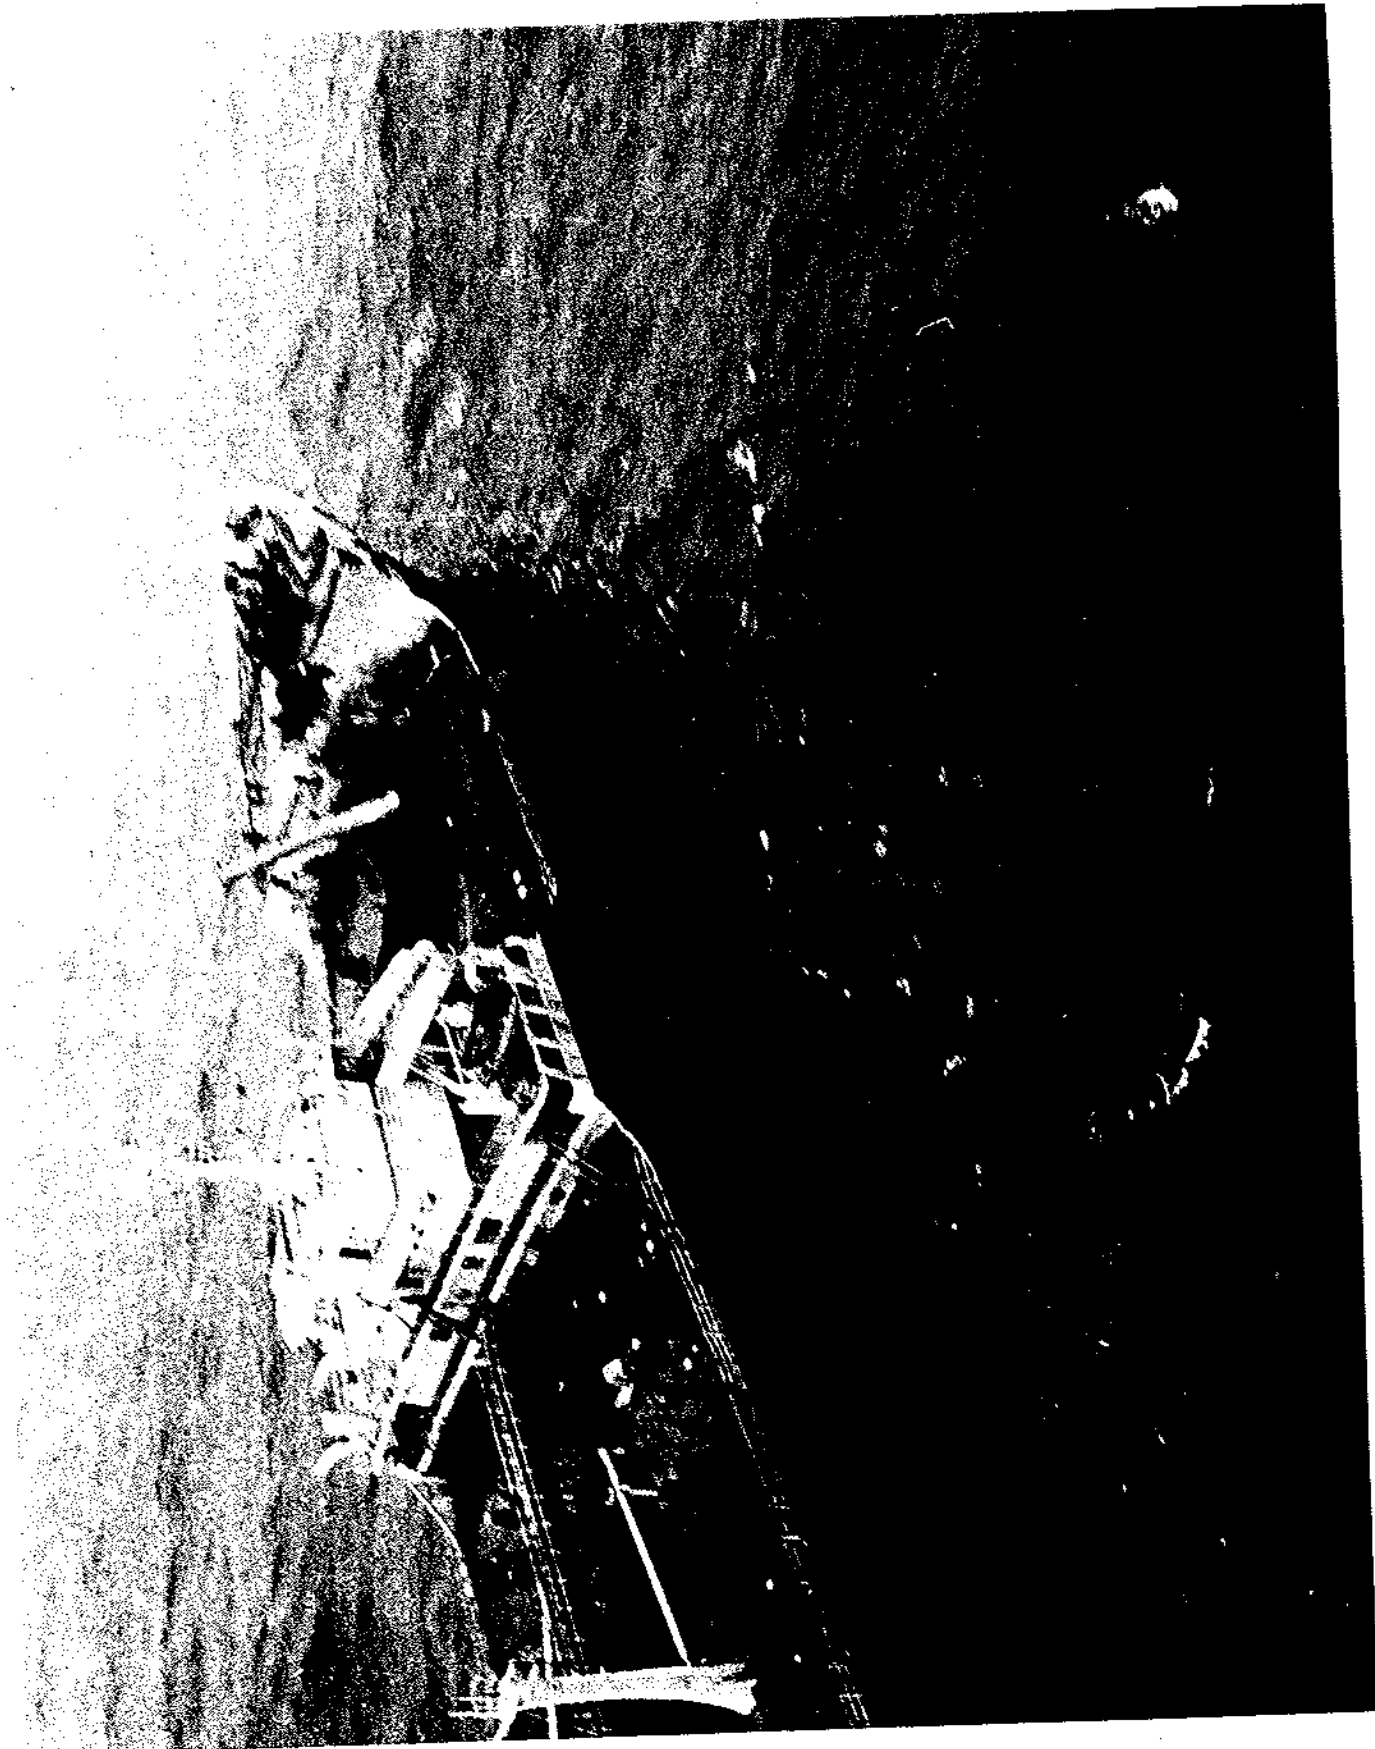
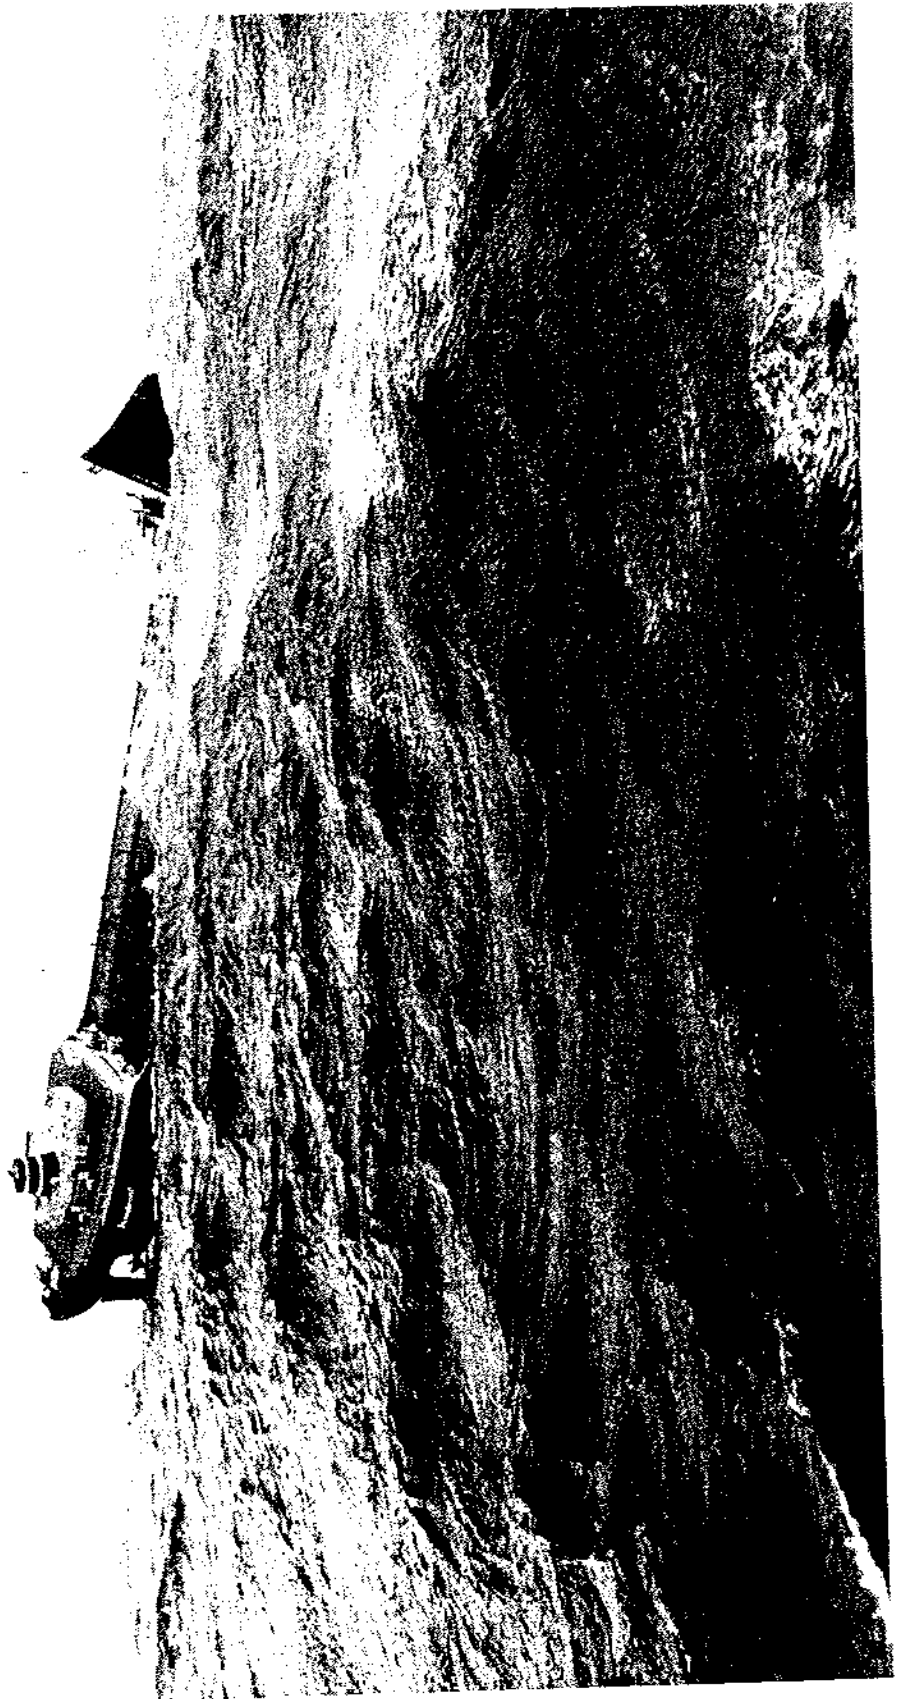
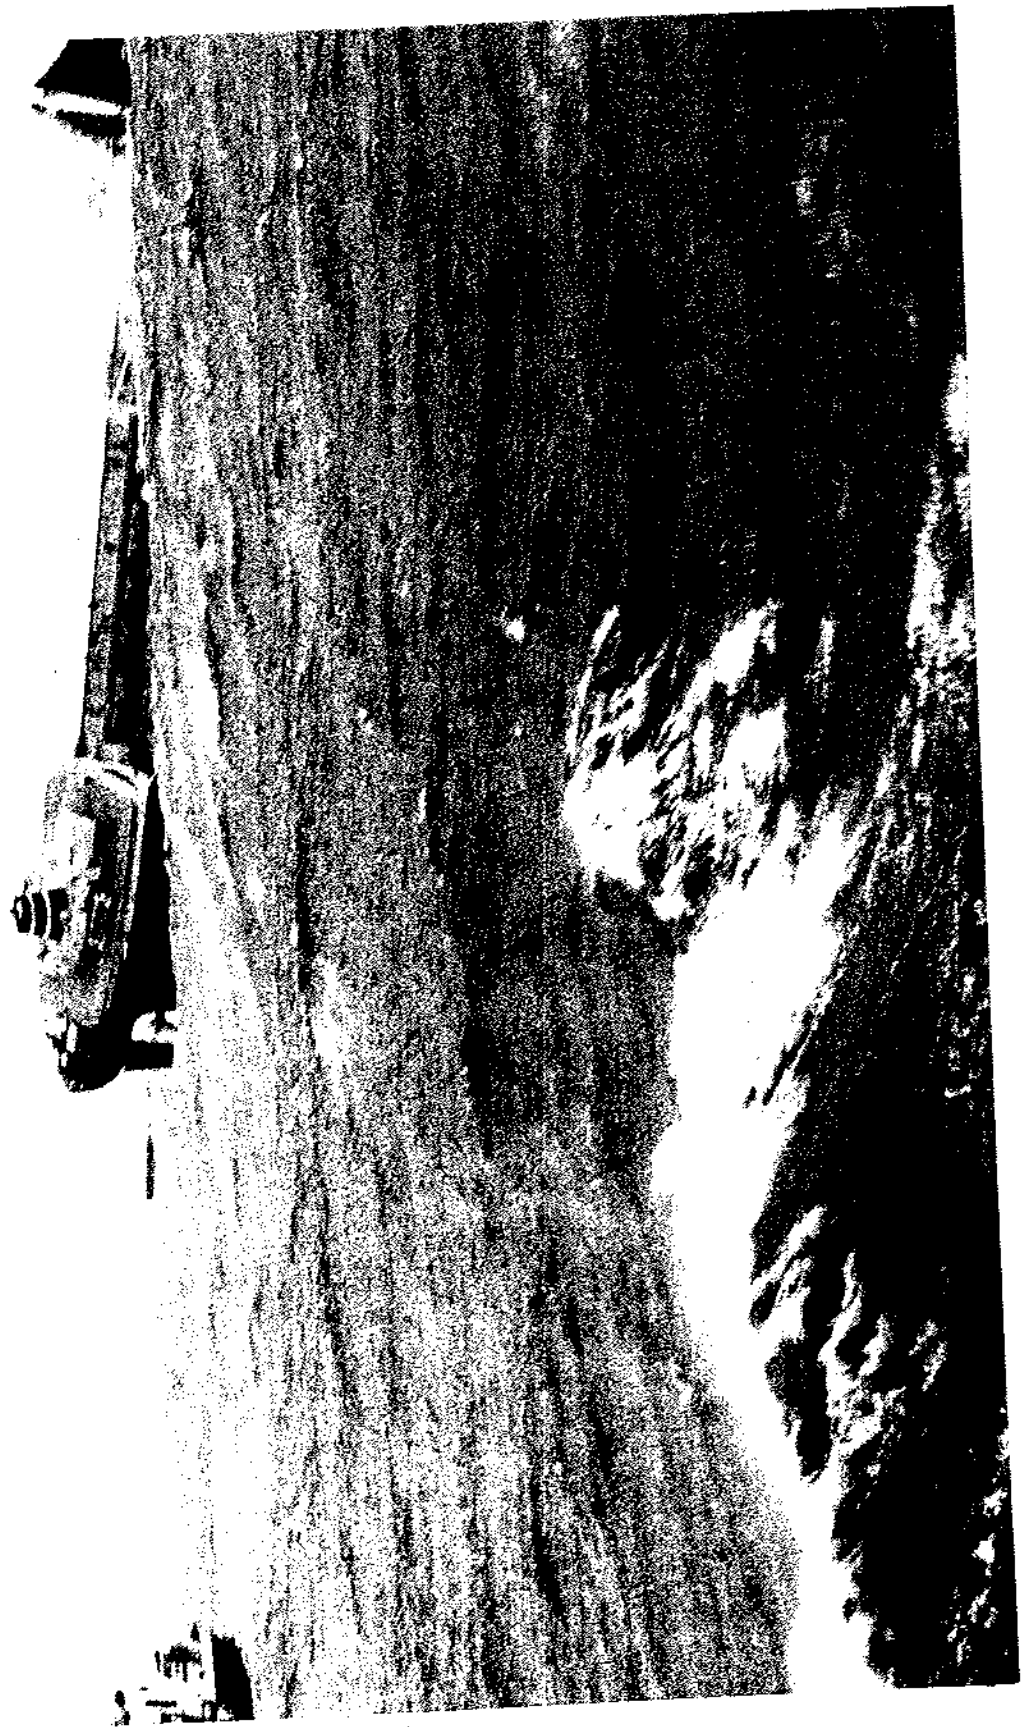
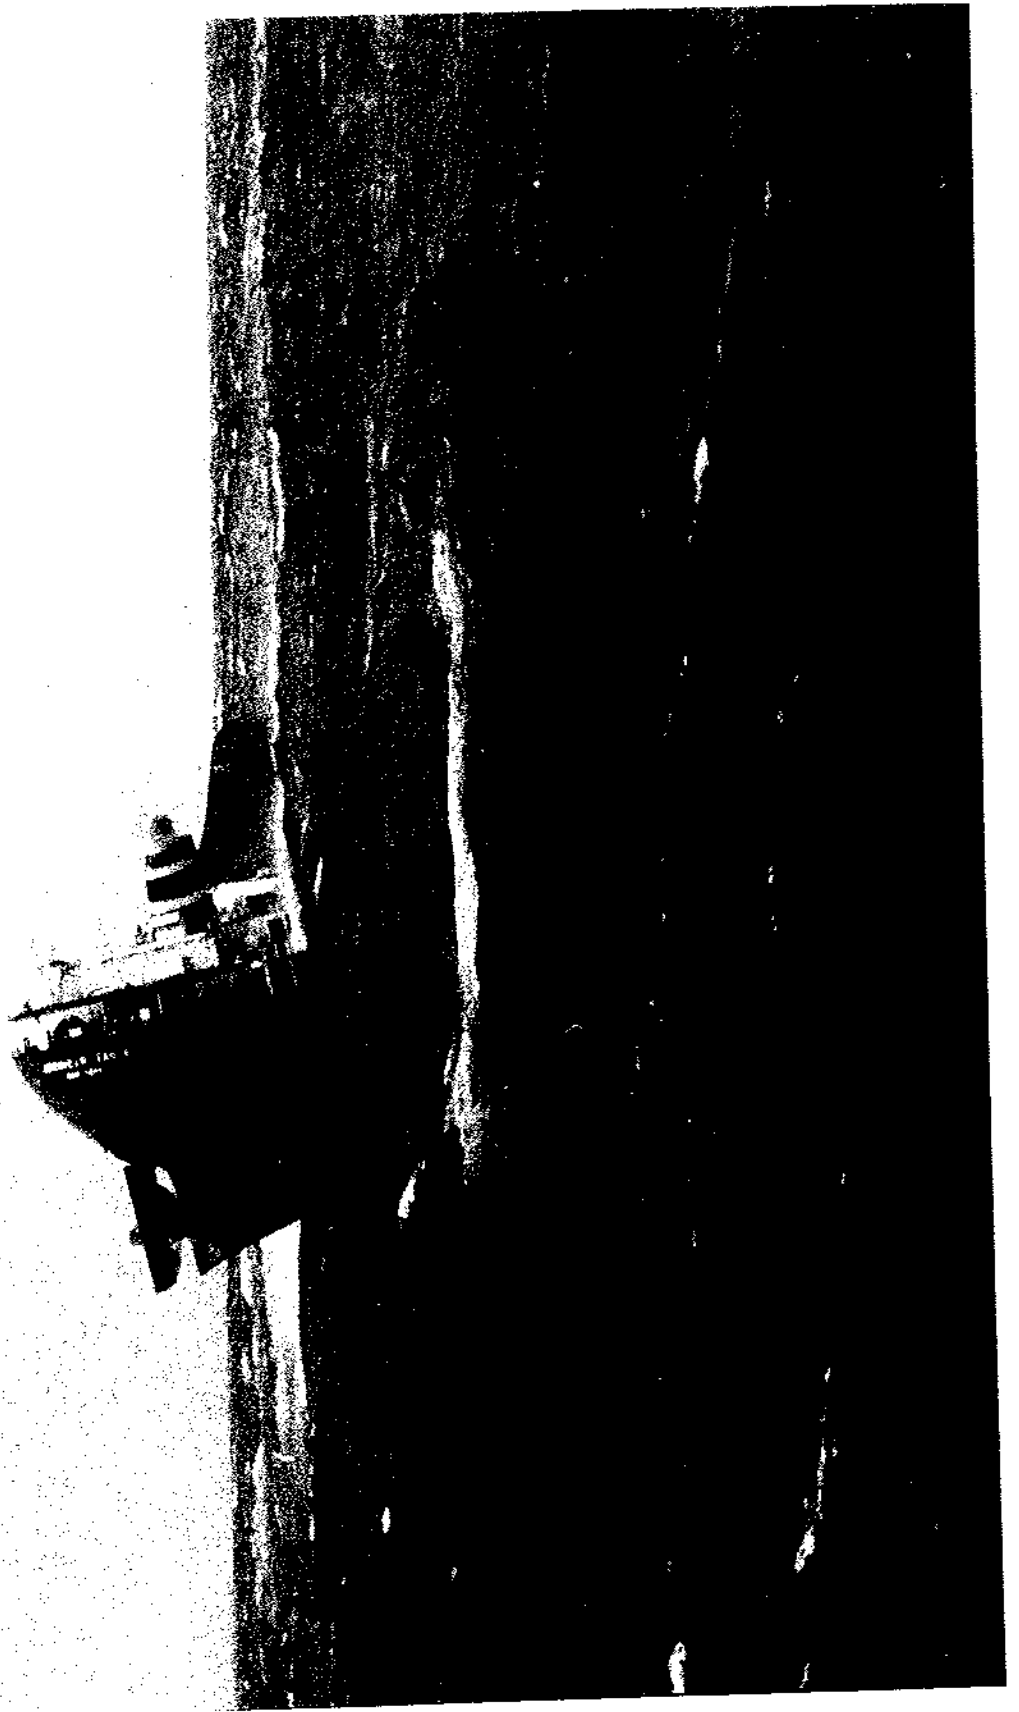
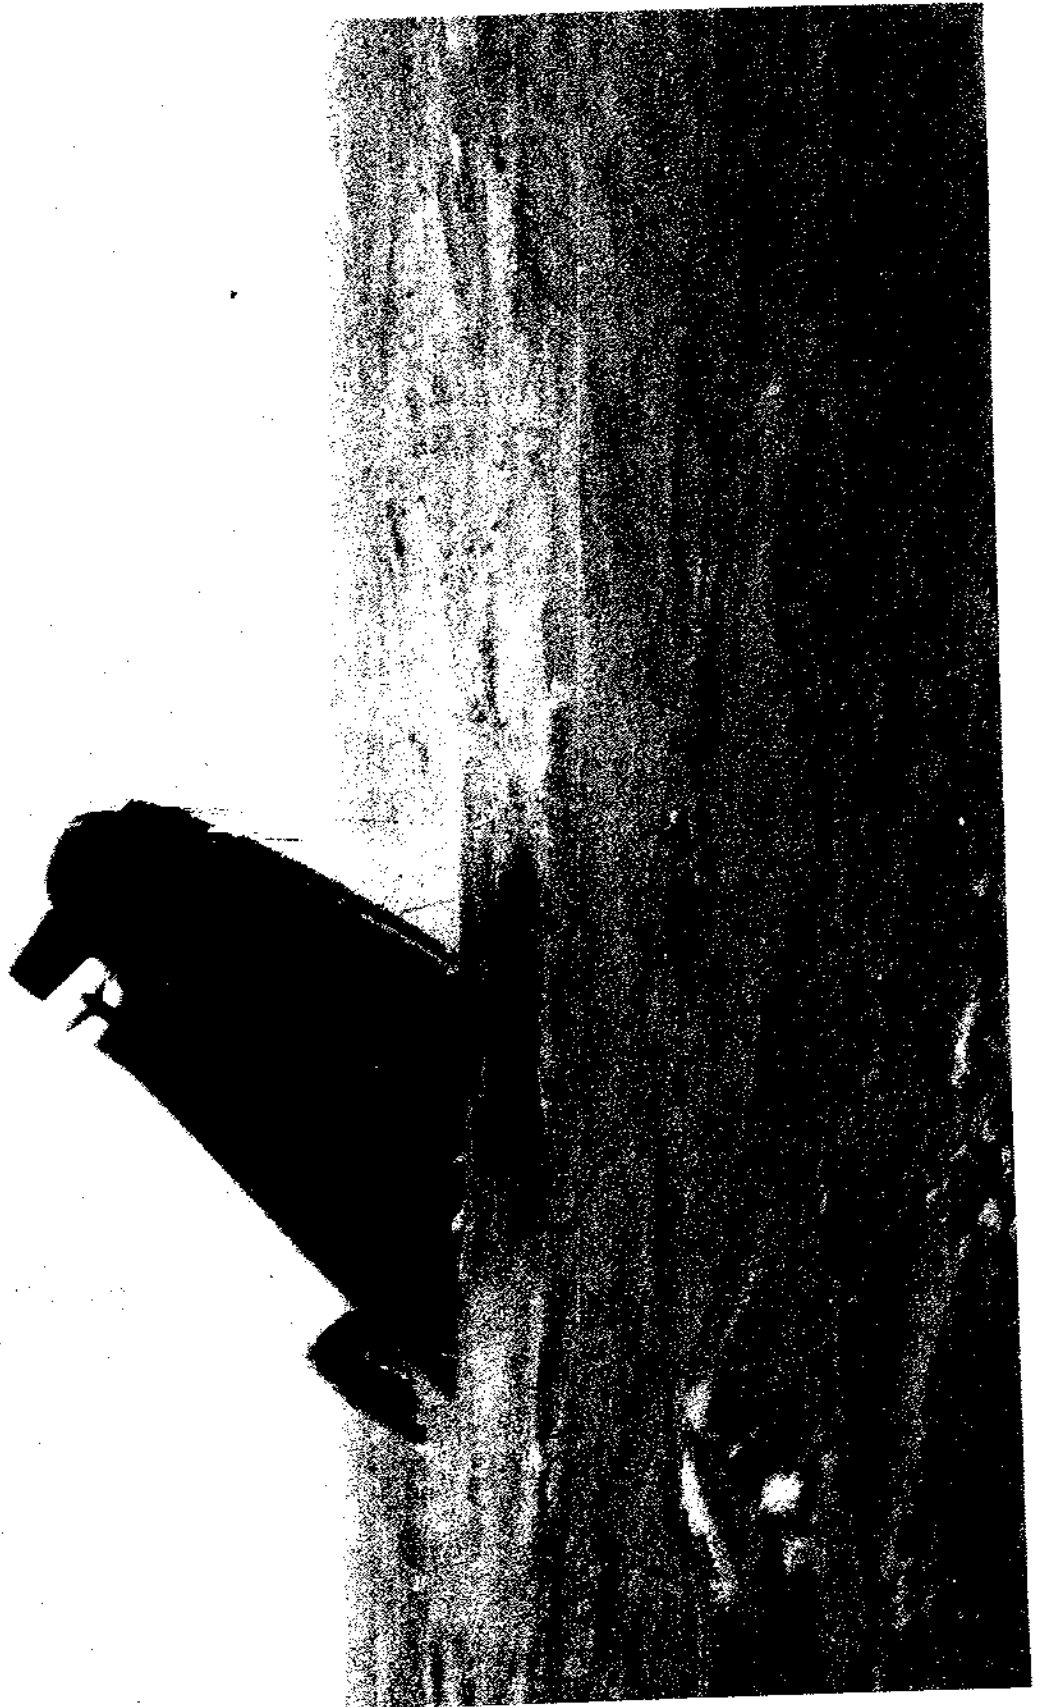
The bow section was initially hinged and then broke away from the remainder of the vessel. The hinge point appeared to be just forward of the midships house, probably at the bulkhead between #2 and #3 tanks.

100. The extent of internal damage is unknown. However, from the extent of external damage visible, it can be presumed that internal damage existed to transverse tank bulkheads and that contributed to the eventual rapid sinking of the vessel.
