MARINE CASUALTY REPORT

CONTINENTAL OIL RIG 43-A
EXPLOSION AND FIRE WITH NO LOSS OF LIFE
GULF OF MEXICO, 24 OCTOBER 1967

U.S. COAST GUARD
MARINE BOARD of INVESTIGATION REPORT
and COMMANDANT'S ACTION

Subj: Continental Oil Company Platform 43-A; explosion and fire in Gulf of Mexico on 24 October 1967, with no loss of life and minor injuries

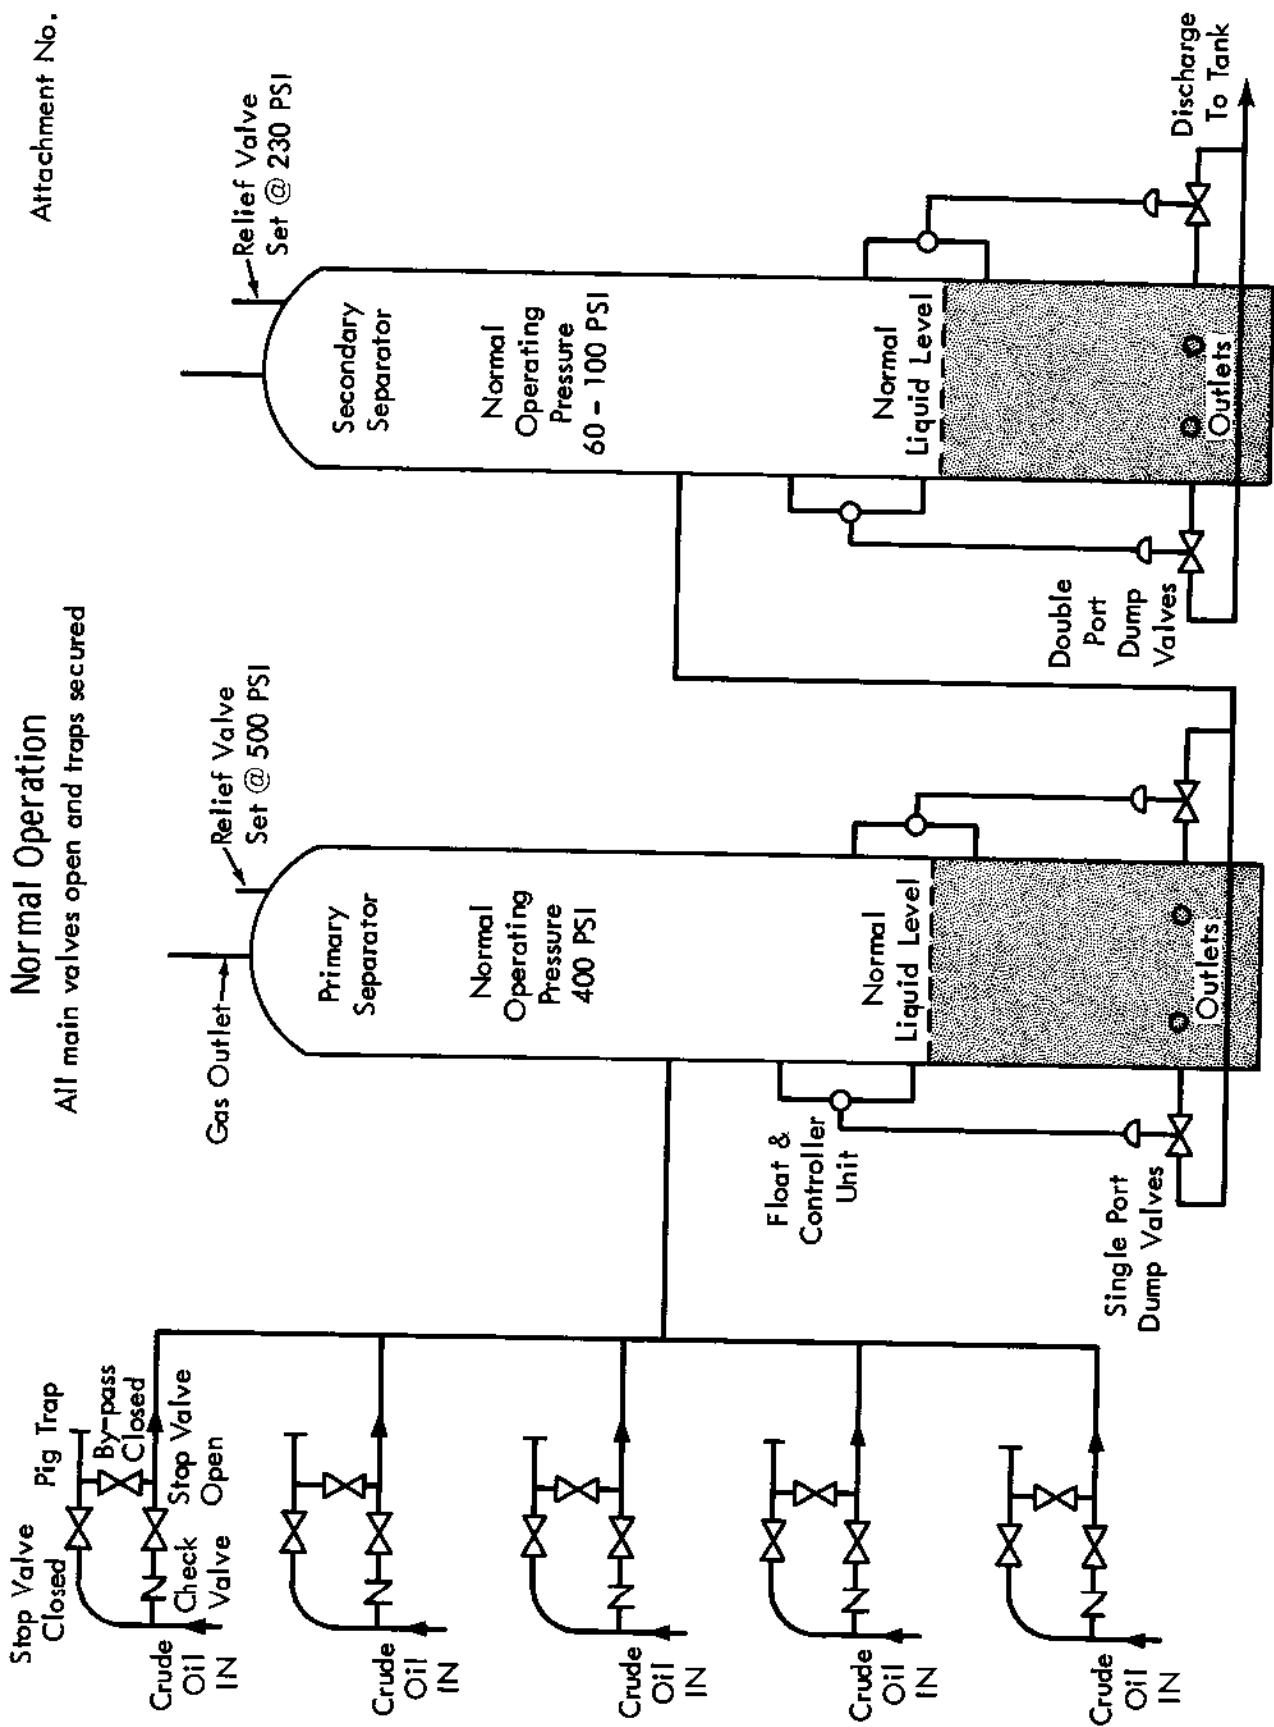
Normal Operation

The function of platform 43-A was to collect and process crude oil produced from nearby wells. The oil and extracted gas were then piped ashore. Attachment No. 1 is a scheme of the main flow components involved in the casualty. The main part of the processing in this type of operation took place in a primary and a secondary separator. The function of these was the separation of the gas from the crude oil, utilizing gravitational and centrifugal forces. Incoming crude oil, at a pressure of approximately 400 p.s.i., was piped directly to the primary separator which had a relief valve set to open at 500 p.s.i. Gas products were taken off at the top of the separator while the oil which collected in the lower part of the separator discharged, by means of level actuated dump valves, to the secondary separator where the process was continued. The normal operating pressure on the secondary separator was 60

All main valves open and traps secured
