MARINE CASUALTY REPORT

**M/V SCANDINAVIAN SEA,
BAHAMIAN REGISTRY O.N. 339313,
FIRE IN THE ATLANTIC OCEAN 9 MILES
SOUTHEAST OF PORT CANAVERAL, FLORIDA
ON 9 MARCH 1984 WITH NO LOSS OF LIFE**

Marine Board of Investigation Report

REPORT NO. USCG 16732/0002HQS 84

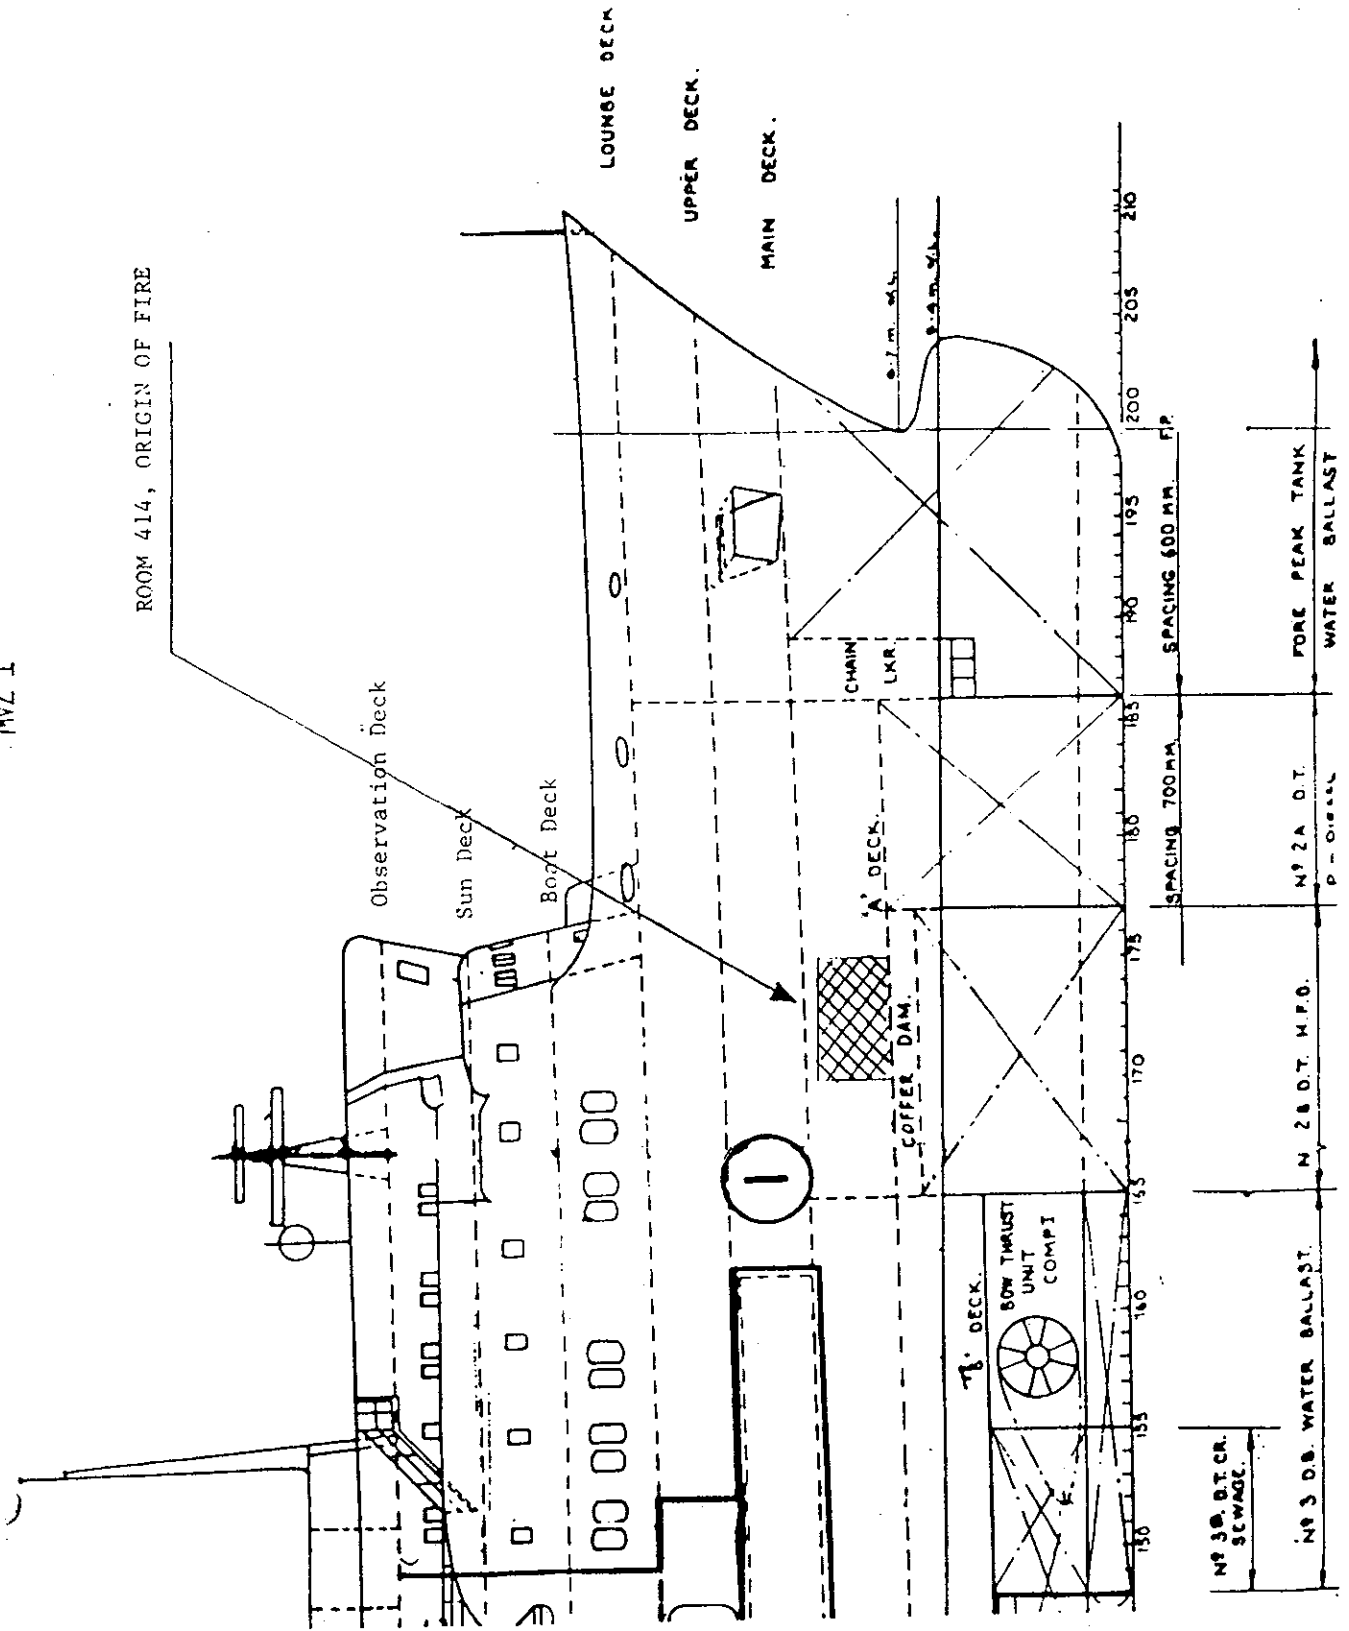
ROOM 414, ORIGIN OF FIRE

The actual cause of the fire aboard the SCANDINAVIAN SEA remains unknown. The most probable cause was the intentional or accidental ignition of combustible material in stateroom 414. The available evidence indicates that the fire began either with the carpet or the waste paper basket or both and that it was aided or accelerated by some combustible fuel. The evidence failed to reveal any electrical or other self-igniting sources. Therefore, the fire was most probably started either intentionally or accidentally by a person or persons unknown.
