**INVESTIGATION INTO THE CIRCUMSTANCES  
SURROUNDING THE FIRE ABOARD THE  
TANKSHIP**

# **SEAL ISLAND**

**ON OCTOBER 8, 1994, IN ST. CROIX, U.S.  
VIRGIN ISLANDS, WITH INJURIES AND  
MULTIPLE LOSS OF LIFE**

**SS SEAL ISLAND, L7326130, ENGINE ROOM FIRE AT THE HESS OIL REFINERY,  
ST. CROIX, U. S. VIRGIN ISLANDS, CARIBBEAN OCEAN ON 8 OCTOBER 1994 WITH  
LOSS OF THREE LIVES AND SIX INJURIES**

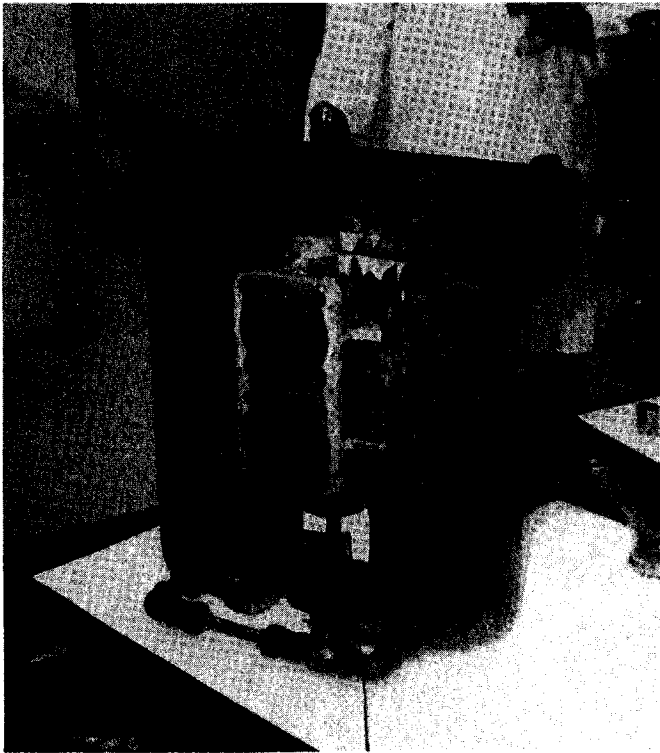
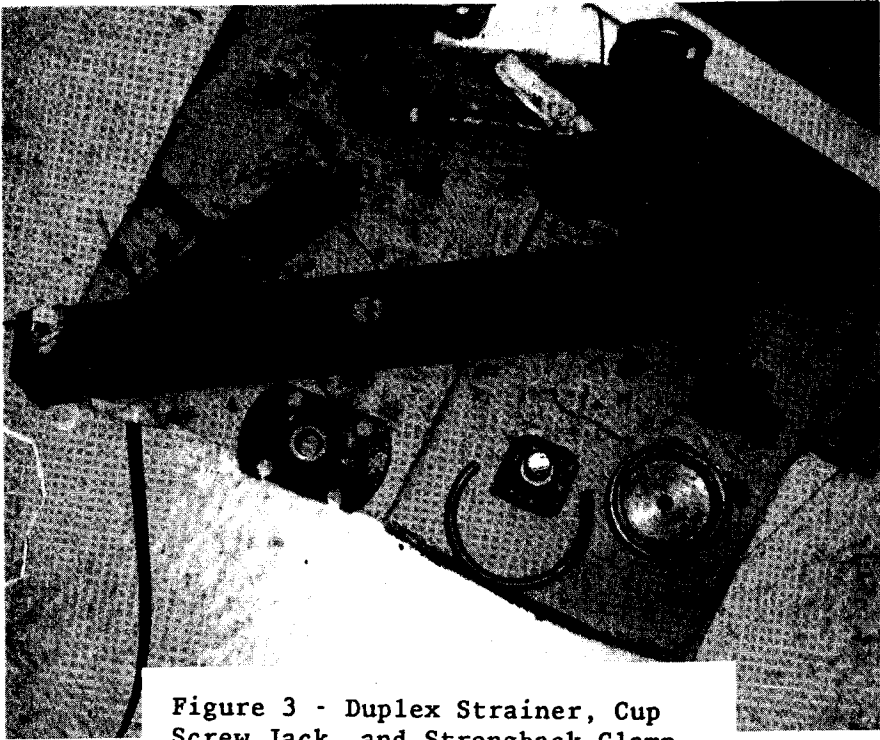
Figure 3 - Duplex Strainer, Cup Screw Jack, and Strongback Clamp

Under the first assistant engineer's direction, three of the crewmembers fabricated a cup with a gasket for placement underneath the bottom of the duplex strainer, where the directional control spindle valve exited the casing, to stop the leak. The crew also fabricated a screw jack made from a small steel plate which they welded to one end of a threaded stud. The free end of the stud (with nut installed) was placed into a pipe flange which held it upright. The cup was fabricated from teflon stock and was machine grooved around the circumference to accommodate the installation of an "O" ring. The center of the stock was machined out to accommodate the installation of the lower end of the directional control valve as it exited and extended over one inch below the casing. When the cup was in position, the nut was turned which raised the threaded stud and the small steel support with the cup, attempting to squeeze the "O" ring between the bottom of the strainer casing and the cup. The cup would not seat properly since the lower securing pin for the spindle valve on the duplex strainer was extending out.

On 12 June 1994, the crew made another cup out of brass stock. They placed the cup on the jack and raised it up until it seated tightly against the duplex strainer casing which effectively stopped the lube oil leak. At this time, the strongback clamp was still in place from the day before. The chief engineer also instructed the crew to make a third cup with a hole drilled out of the bottom so that a relief valve could be fitted. The cup was fabricated by the crew and stored in the lower control room but it was never used. (See Figures no. 3 and 4 which are photographs of the duplex strainer, cup, screw jack, and strongback clamp.)

It was Chief Engineer Pontarelli's and Armuzza's intention to make permanent repairs to the duplex strainer as soon as possible and when time allowed. Since the temporary repairs had stopped the leak, both chief engineers felt it was a low priority to effect permanent repairs and that they had to tend to higher priority repairs and maintenance while they were aboard the vessel.

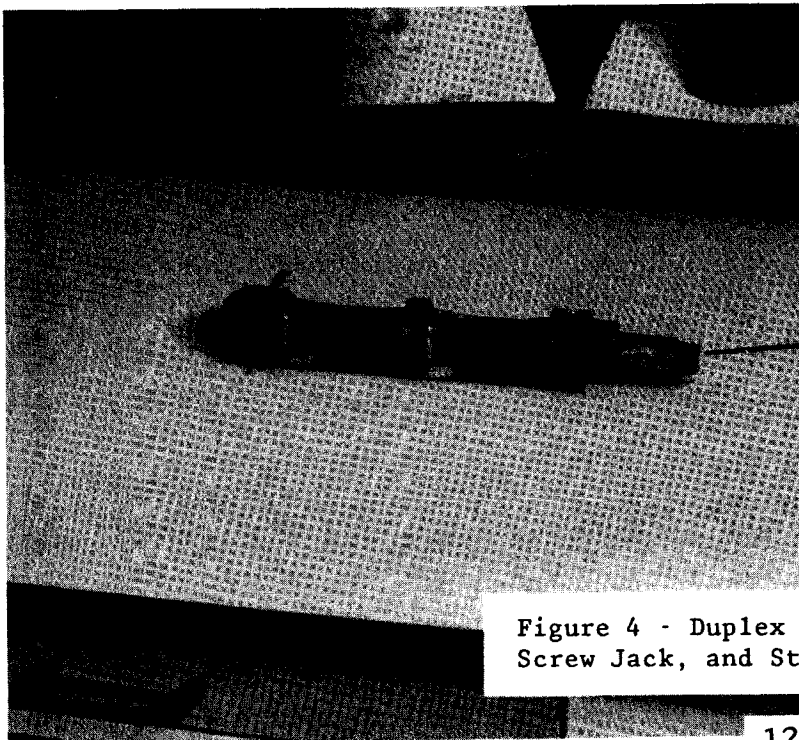
Spindle Valve Removed From Casing

\* Note 'O' ring on bottom and missing 'O' ring on top
