**Worker Injured During Explosion**

**Date of Incident:** 99 04 27

**Type of Incident:** Fatality

## **SUMMARY**

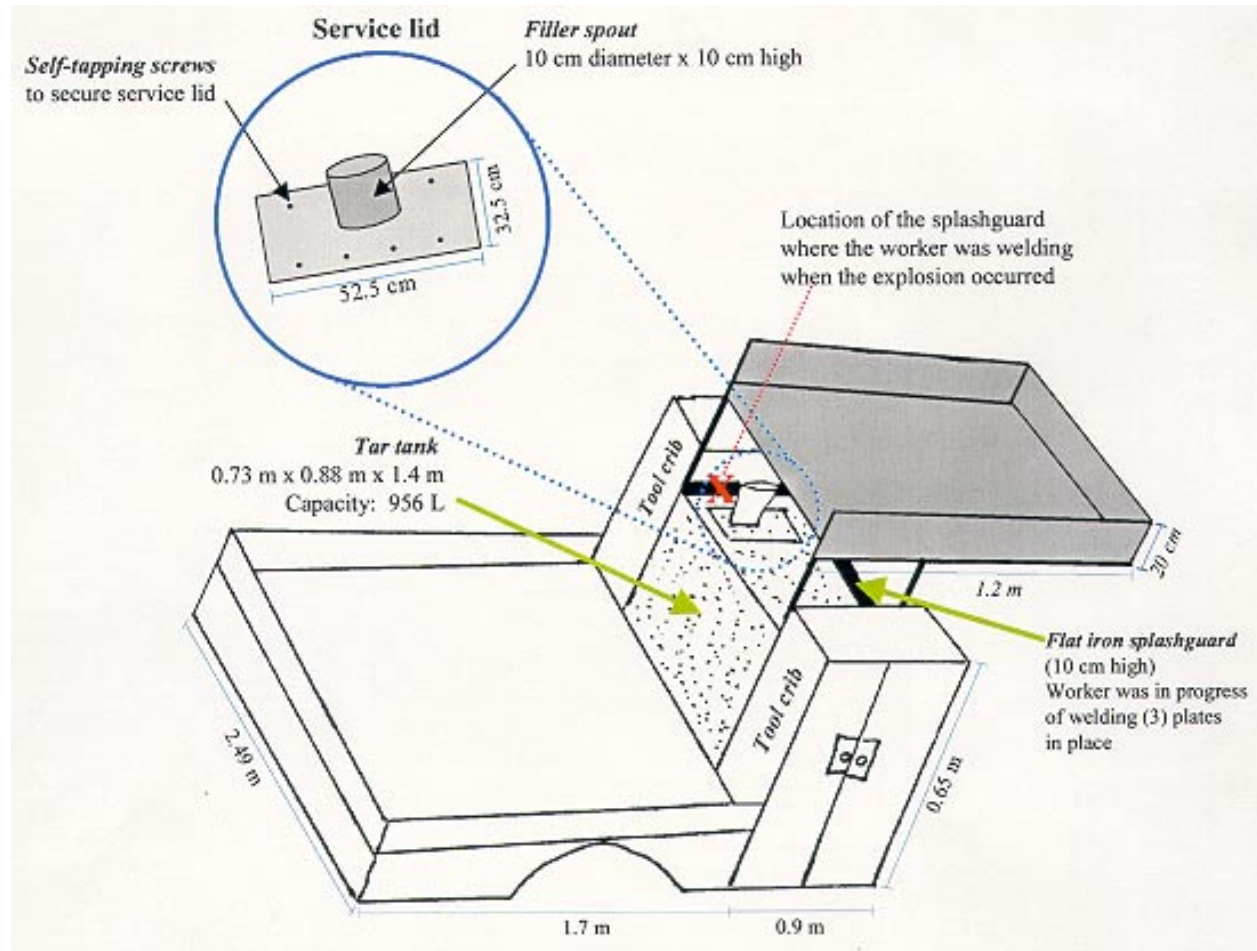
**Sketch 1:** Shows tar tank assembly  
(Not to scale)

10.1 A portable tar tank involved in the incident was 0.88 metres long, 0.73 metres wide and 1.4 metres high, and had a capacity of 956 litres. A service lid about 32.5 centimetres by 52.5 centimetres with a filler spout was installed on the top of the tar tank. About 40.0 litres of RC Special Asphalt liquid residue was left over in the tar tank from the previous use (Refer Attachment B, Sketch 1; Attachment C, Photographs 1 & 2 and Attachment D).

10.3 Three pieces of flat iron, about 10.0 centimetres wide, were used for splashguards (Refer Attachment B, Sketch 1 and Attachment C, Photographs 1 & 2).

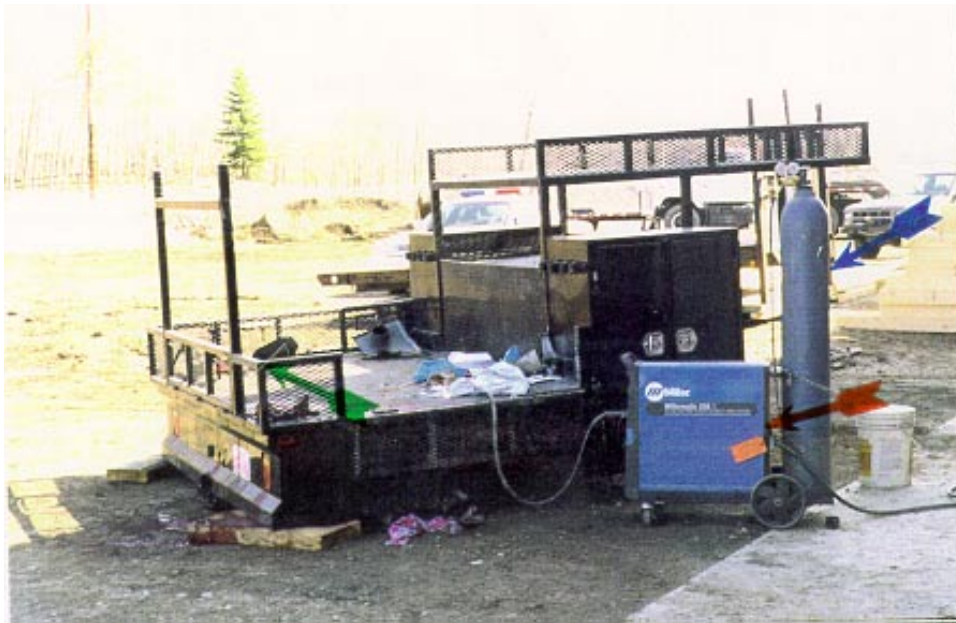
**Photograph #1 –**

Shows an overview of the portable tar tank unit.

- The tar tank unit was built approximately twelve years ago in Red Deer. No information was available regarding specifications and individual who built it.
- Blue arrow [right side, upper arrow] indicates an acetylene bottle used to cut flat iron to build a splashguard around three sides on top of the tar tank. This equipment was not in use at the time of the explosion.
- Red arrow [right side, lower arrow] indicates an electric arc welder that was in use to weld the splashguard at the time of the explosion.
- Green arrow [left] indicates the position of the worker with his face up after the explosion.

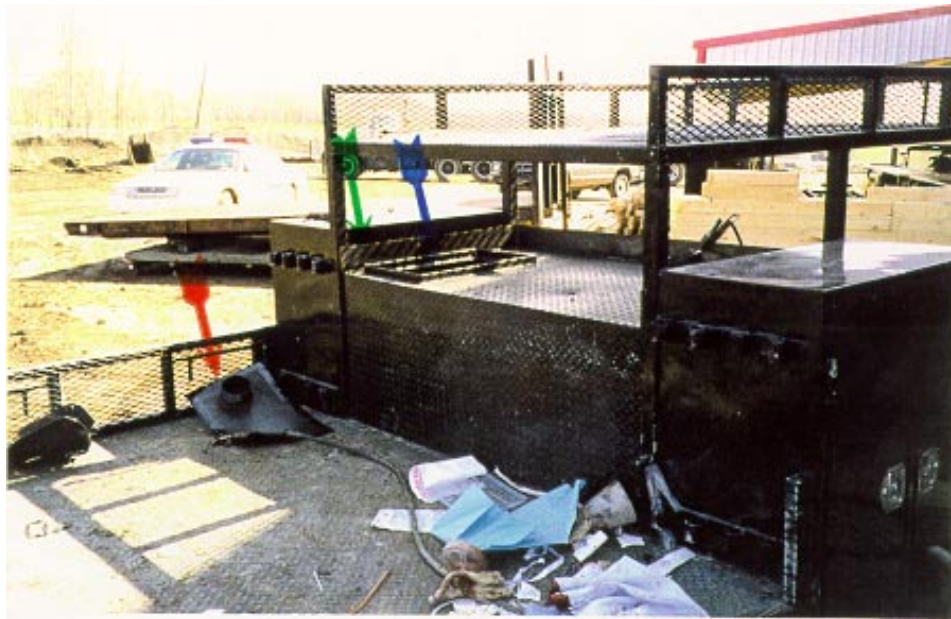
**Photograph #2**

The direct cause of the incident was that the welding was performed on the portable tar tank that contained a flammable liquid residue.

- Green arrow [upper, left] shows the splashguard that the worker was welding at the time of the explosion.
- Red arrow [lower, left] shows the service lid that blew upward from the tar tank during explosion and struck the worker in his facial area. Blue arrow [upper, right] shows the location of opening on the tank where the service lid was secured by eight self-tapping screws.
- It could not be determined whether the filler spout was closed at the time of explosion.
- Approximately 7 cm of tar product was at the bottom of the tank, when the explosion occurred. The capacity of the tank was approximately 956 L.
- The worker was wearing a welding shield, cotton coveralls and work gloves at time of the incident.

- 13.3 The incident may have been prevented if the tank was properly cleaned to remove all flammable liquid residues and purged with air prior to welding.

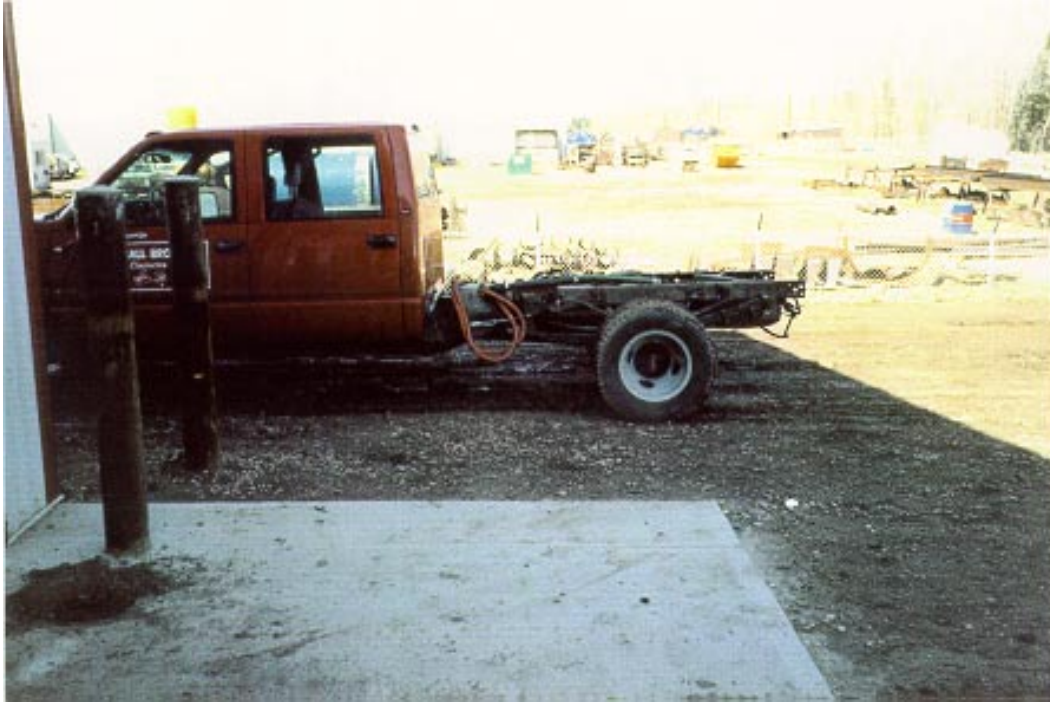
**Photograph #3 –**

The flatbed truck used to transport the portable tar tank to the construction sites. The tank was not mounted on the back of the truck at the time of the explosion.
