Explosion at Battery Site
Date of Incident: 99 07 26
Type of Incident: Fatal

SUMMARY

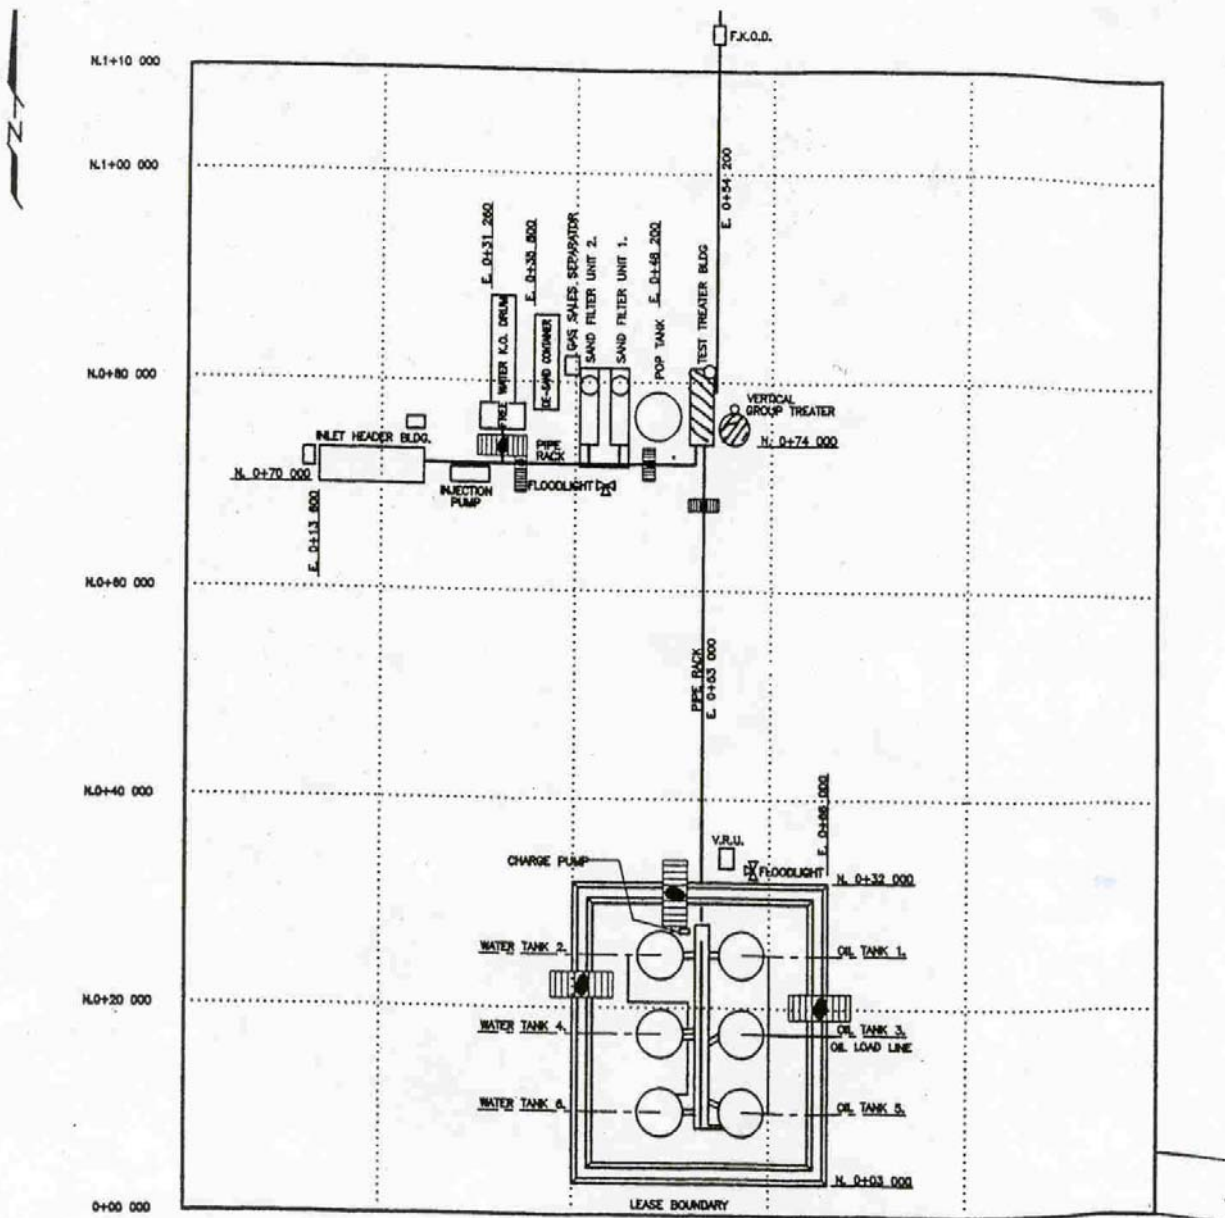
PLOT PLAN
 SCALE: 1:300

9.1 The incident occurred at the Sibbald Battery site of Energy North Inc, Oyen, Alberta. L.S.D. 8-22-272-2W4M (Refer to Attachment A, Plot Plan).

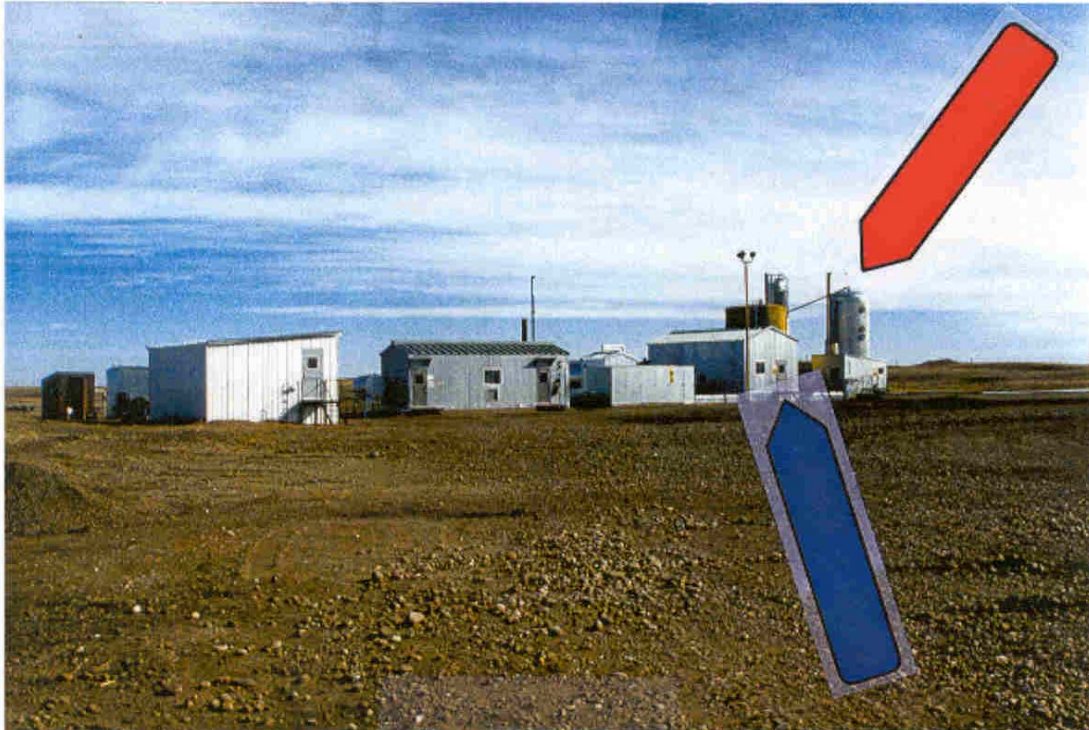
Photograph #1:

10.1 The company serviced eight oil wells at the Sibbald Battery site. The oil wells produced about 90 percent water, 10 percent heavy oil and a small amount of natural gas. The oil, water and gas were separated at the battery site. Produced water was injected back into the ground formation and oil was pumped into storage tanks (Refer to Attachment B, Photograph 1).

10.2 The group treater building was located beside the group treater vessel. The building contained process piping, equipment and valves to control the flow of production fluids (Refer to Attachment B, photographs 1 and 2).

Shows process and equipment buildings. Red arrow [top, right] shows the group treater vessel. Blue arrow [bottom, right] shows test treater building. The photograph was taken prior to the incident.

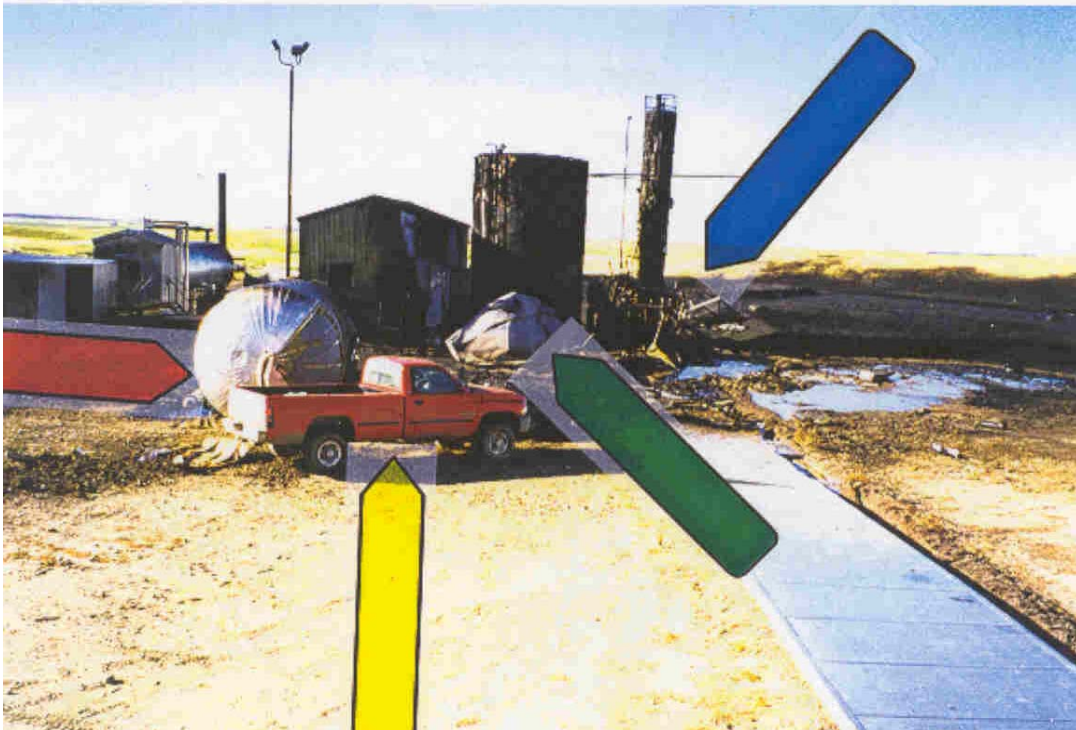
Photograph #2:

10.3 The company purchased the group treater as a reconditioned unit in October 1997. Maffat Tank Company, Edmonton, Alberta, manufactured the group treater in 1966. The group treater was a vertical vessel approximately 3 metres in diameter and 7.3 metres in height. The maximum working pressure of the group treater was 345 kilopascals with a maximum operating temperature of 94° C. The group treater separated oil from water (Refer to Attachment B, photographs 2 & 3).

During explosion, the group treater vessel was lifted and landed about 15 metres from its original location. The failure analysis of the fire tube heater's neck weld, revealed that the group treater exploded.

12.4 When the relief operator entered the group treater building, the group treater vessel located beside the building exploded and an ensuing fire occurred. The group treater building was destroyed.

Shows the extensive damage to the test treater building. Blue arrow [top, right] shows the damaged process pipes and control valves in the test treater building. The green arrow [centre] shows the test treater building's shell. The yellow arrow [bottom, centre] shows the relief operator's truck. The red arrow [left] shows the group treater vessel that was lifted from its original location beside the test treater building.

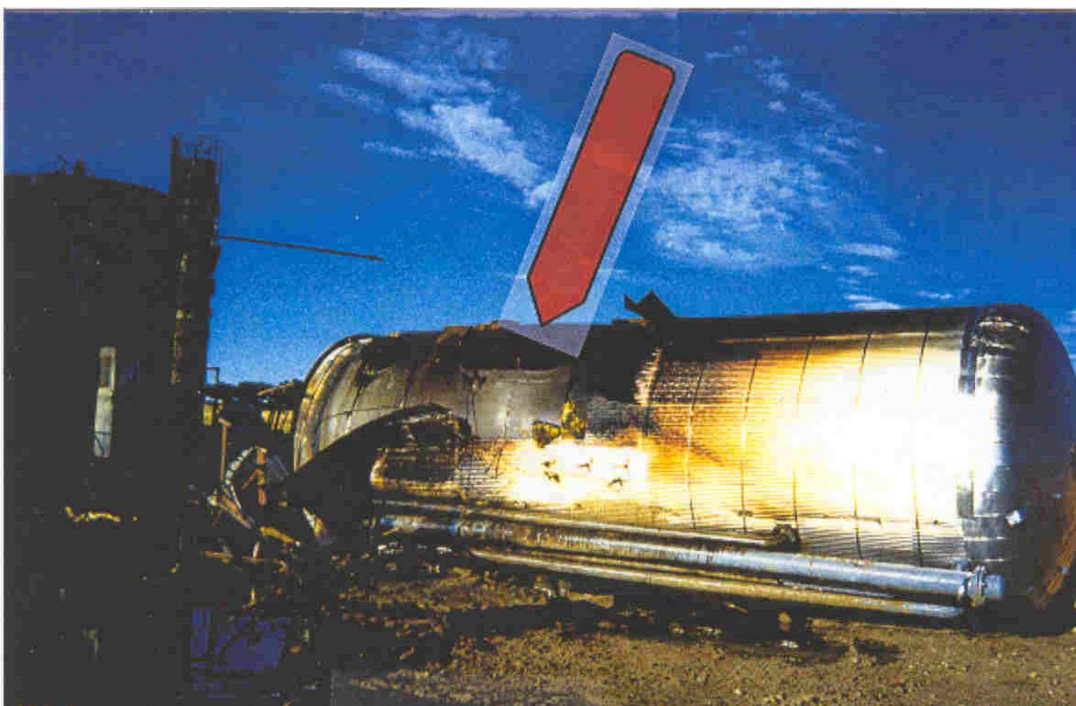
Photograph #3:
Red arrow shows an opening where fire tube heater separated from group treater.

- 13.1 The primary cause of the incident was that the group treater vessel exploded due to high pressure. The exact cause for build-up of high pressure could not be determined as the group treater vessel and process equipment were severely damaged during the explosion and fire.

Anderson Associates Consulting Engineers Inc, concluded that the most likely scenario was that fluid level went down in the group treater. The lower level of fluid exposed the fire tube heater and allowed it to become overheated. Subsequent contact of emulsion oil and/or water with the fire tube heater, created steam and increased pressure in the group treater to cause failure.

- 13.3 To prevent this type of incident from recurring, the company had an engineering consultant redesign the battery site. Several safety features, including gas detection system, ventilation system in the process and equipment buildings, and controls for fluid level and temperature have been incorporated in the installation of the battery site.

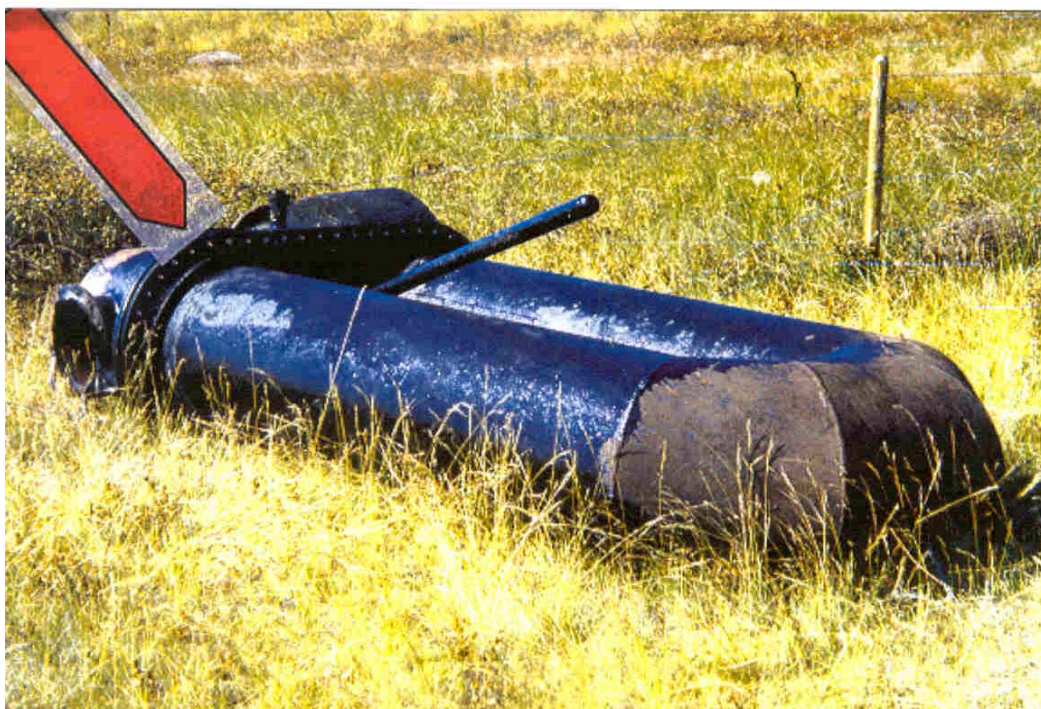
Photograph #4:

10.4 The group treater was equipped with a U-shaped fire tube heater. The fire tube heater was fitted with a fire box flame arrester to prevent the flame from exiting outside the burner assembly. The fire tube heater heated the production fluids during the process (Refer Attachment B, photograph 4).

Shows fire tube heater blown off the group treater. The red arrow shows the flange that separated from the group treater vessel.
