Fire/Explosion

Date of Incident: August 3, 1999

Type of Incident: Fatal

1.1 375144

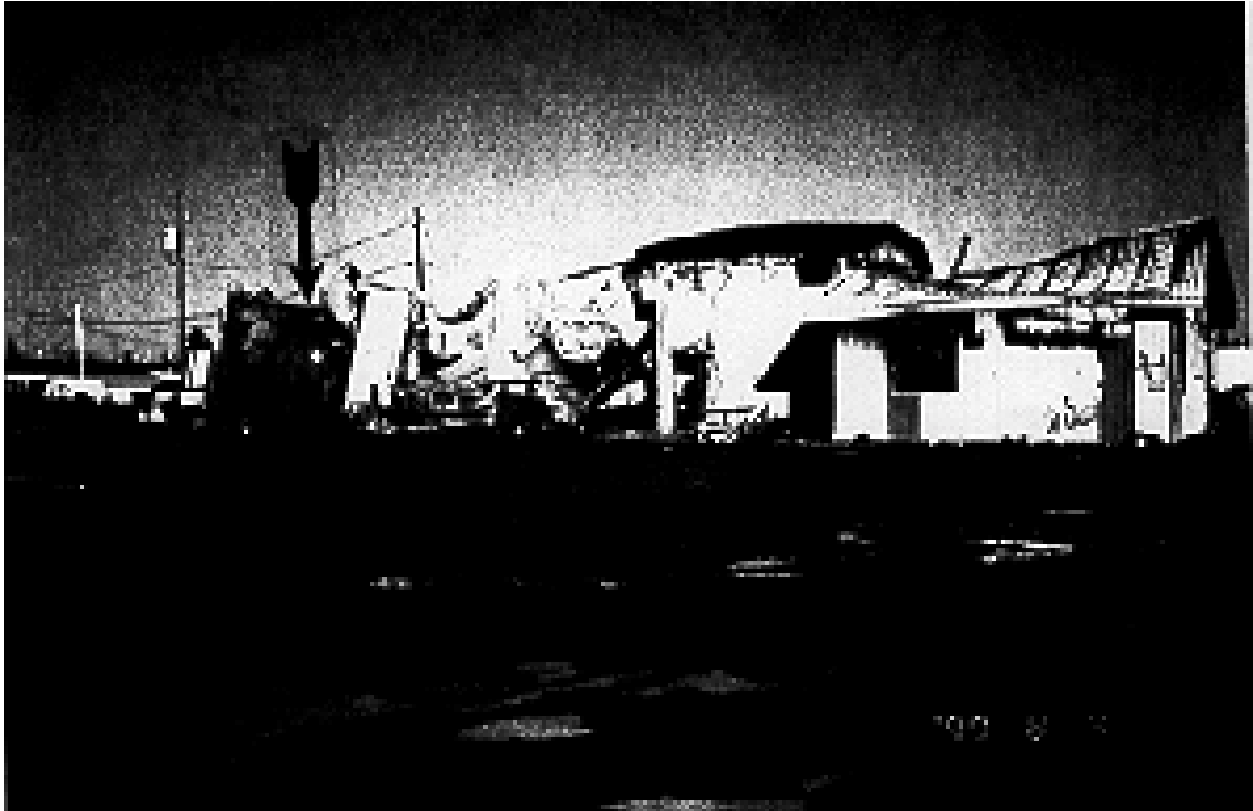
Photograph #1

- 10.4 The building in which the truck was being worked on was 12.2 m x 18.3 m in size (see Photograph #1).
- 10.5 The pressure truck was parked outside the bay that housed the hot oiler unit. Workers were going to move it to allow access to the hot oiler area to allow for ease of suctioning the spilled liquid (see Sketch).

This photograph shows the Cardusty Trucking building on the morning of August 4, 1999. The solid green arrow indicates the area where the mechanic was at the time of the incident.

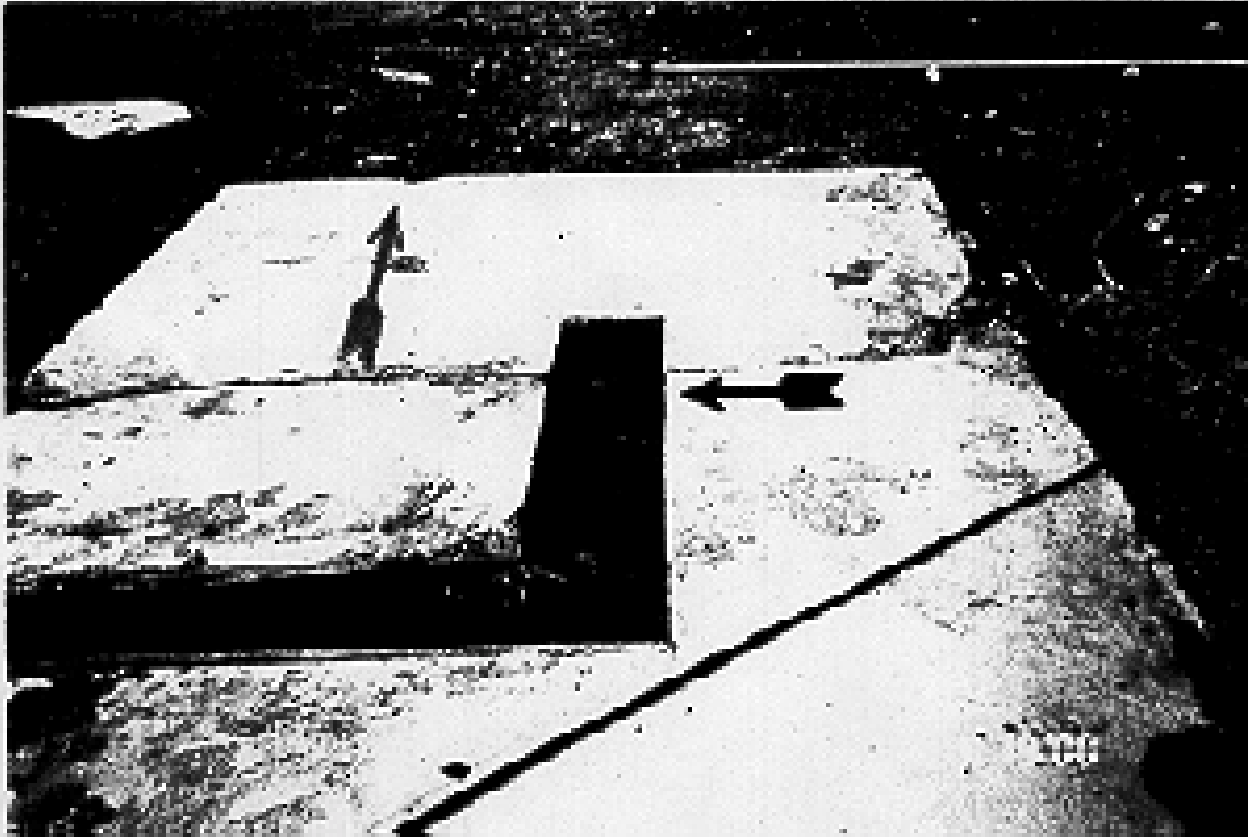
Photograph #5

- static electricity from the mechanic's clothing, or
- a spark from a metal object (such as a dropped tool) striking the metal deck of the hot oiler unit, or
- Ignition of fluid vapours by boiler. The bay did have a trough on the south end of the shop that led into the boiler room. The trough was covered with metal plating and was located approximately 1.5 metres from the centre of the truck. This trough was not connected to the sump located beneath the truck. The floor sloped away from the trough towards the sump.

A view of the trough that housed the in-floor heating system. The blue arrow indicates the approximate location of the wall between the shop and boiler room. The red arrow shows the boiler room.

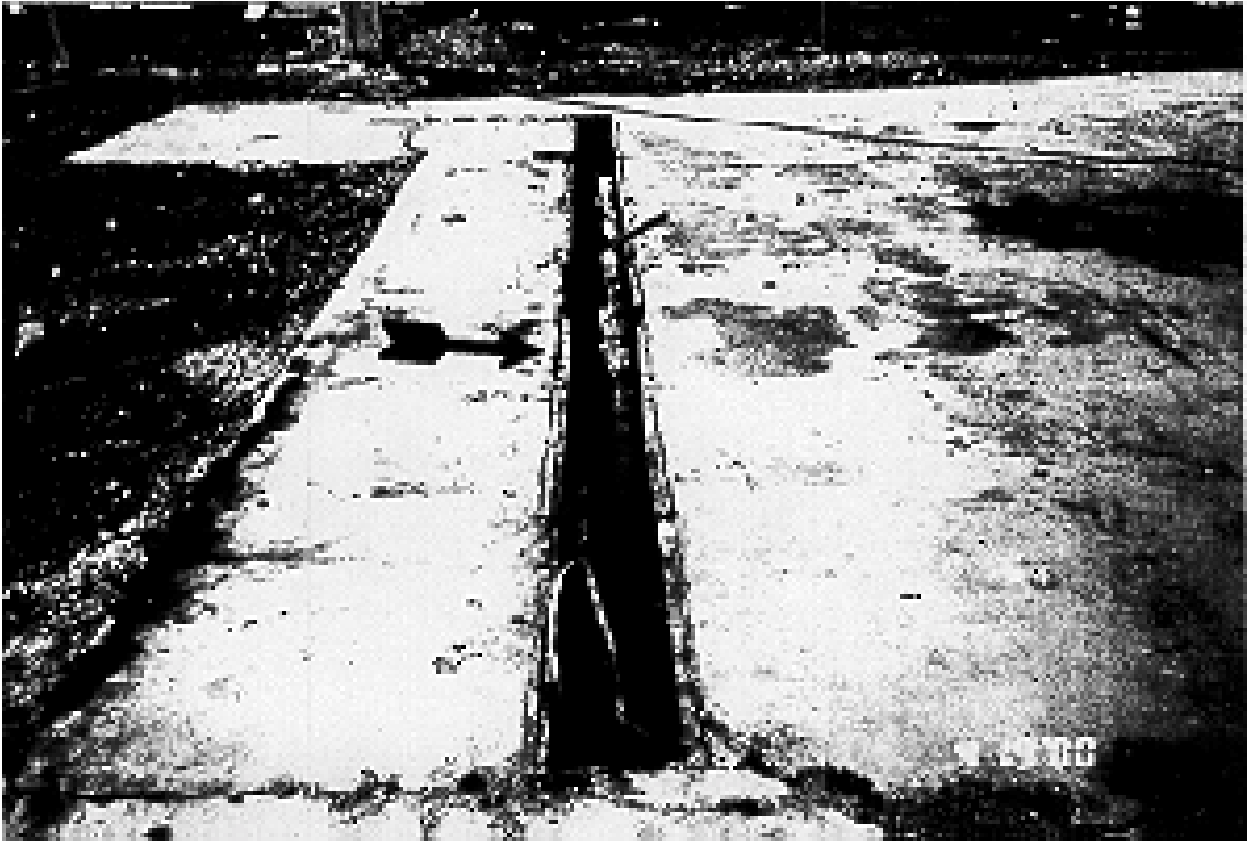
Photograph #6

Another view of the trough which housed the in-Moor heating system. The blue arrow indicates that the trough ran the length of the shop.
