**Worker Exposed to Hydrogen  
Sulphide and Falls from the Top of  
the Truck**

**Date of Incident:** 99 11 02

**Type of Incident:** Fatal

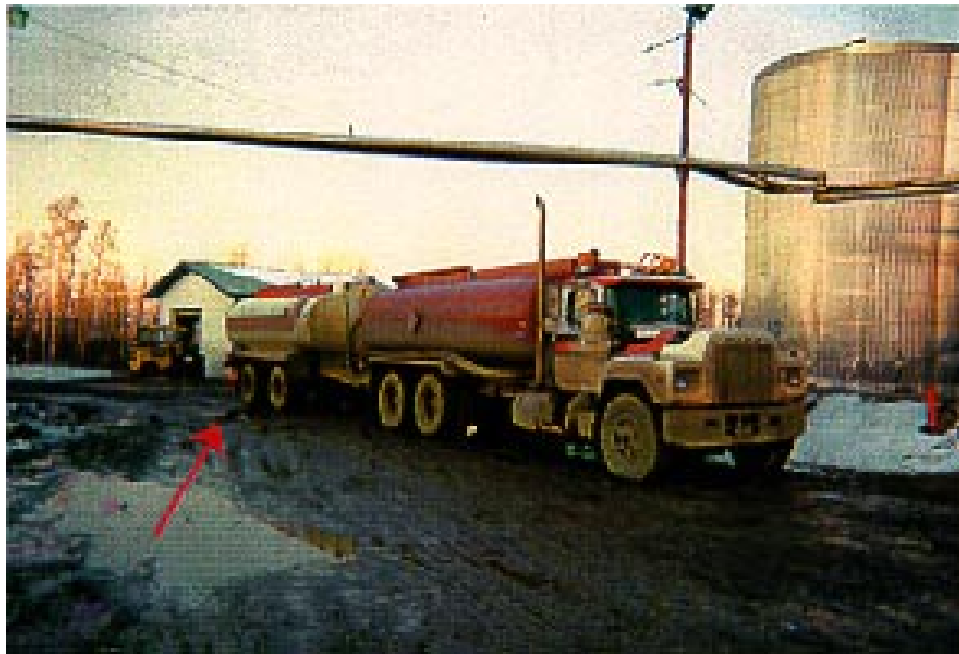
Photograph 1 Shows the tank truck and pup tank involved in the incident.

- 10.1                The equipment involved in the incident included a tank truck and a pup tank. The tank truck and pup tank had the Transport Canada designation of T306. The T306 designation included but not limited to a tank body that can transport regulated fluids and working pressure not more than three pounds per square inch gauge (Refer to Attachment A, Photographs 1 and 2).

- 12.4 When the truck driver opened the pup hatch, he was exposed to hydrocarbon vapours and hydrogen sulphide released from the pup tank. After exposure, the truck driver fell approximately 3 metres to the ground.

- 13.1 The primary cause of the incident was that the truck driver was exposed to hydrocarbon vapours and hydrogen sulphide, and fell approximately 3 metres to the ground.
- 13.2 The secondary cause was the truck driver was not protected from hydrocarbon vapours and hydrogen sulphide with respiratory protective equipment.

- Red arrow shows the location where the worker fell from the pup tank.

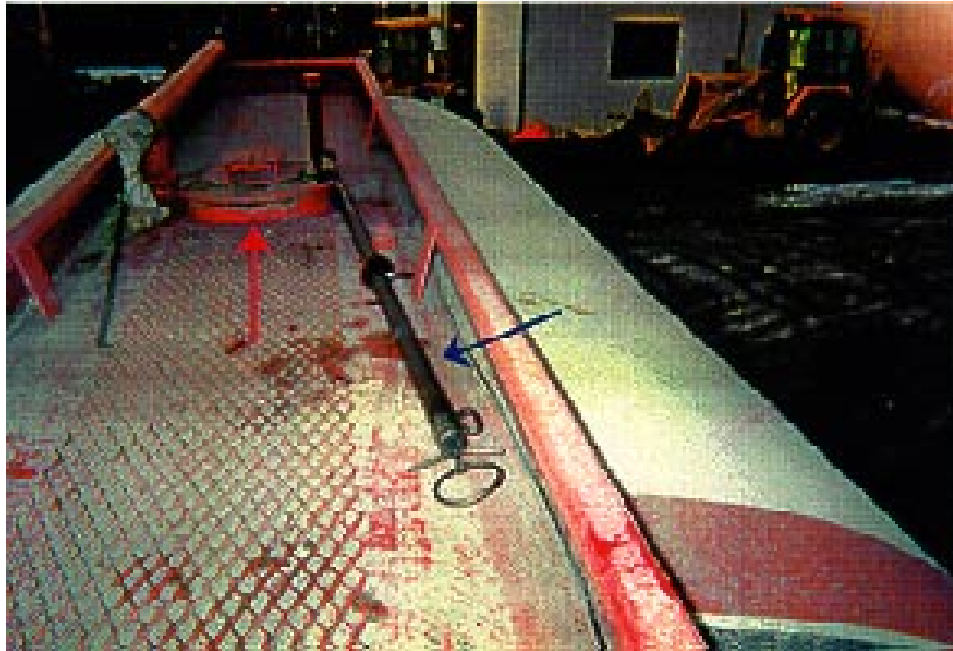
Photograph 2 Shows the top of the pup tank.

- 10.1.2            The tank truck contained produced sour emulsion containing hydrocarbon vapours and hydrogen sulphide. The concentration of hydrogen sulphide was 326 ppm (ppm means parts of vapour or gas by volume per million parts of contaminated air by volume) in the tank truck and 279 ppm in the pup tank. The samples of sour water from the truck tank and pup tank were collected at approximately 22:00 on 99 11 02 (Refer to Attachment B, Laboratory Analysis).

- 10.1.3            The truck driver used an extraction tool to collect samples of produced sour emulsion from the tank truck and pup tank (Refer to Attachment A, Photograph 2).

- Red arrow [left, upper] shows the hatch the truck driver opened to collect oilfield fluid sample.
- Blue arrow [centre] shows the oilfield fluid extraction tool.
