Worker Injured in Explosion

Date of Incident: 1999 11 15

SUMMARY

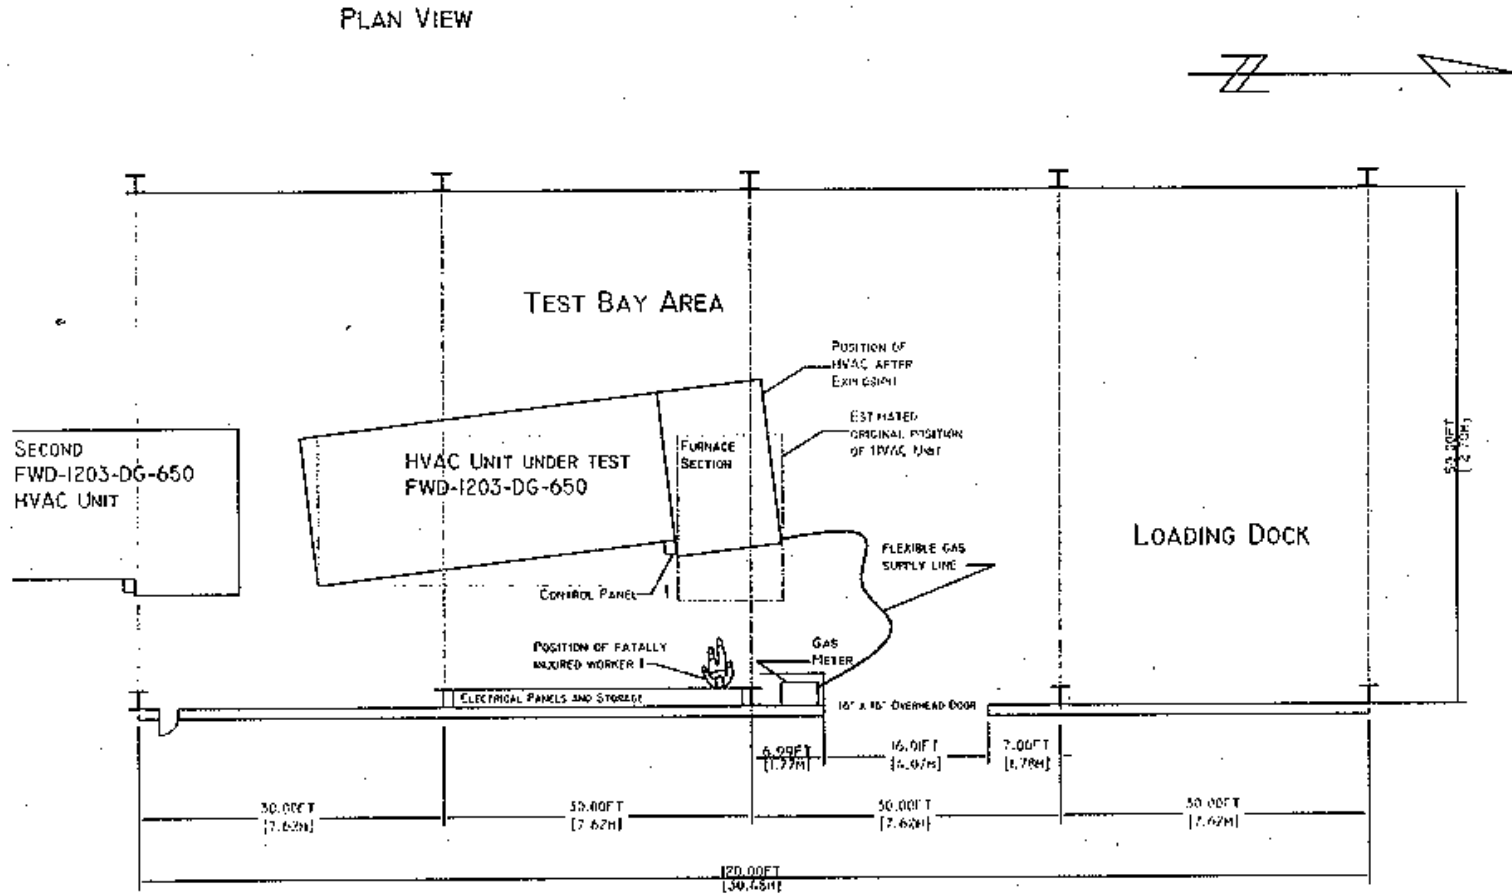
Diagram 1: General Arrangement of Accident Site — Not to Scale

10.1 The HVAC unit involved in the incident, Model FWD-1203-DG-650, consisted of heating and cooling sections. The unit had a heating capacity of 1904 kilowatts and a cooling capacity of 422 kilowatts. (Refer Attachment A, Diagram 1 and Attachment B, Photograph 1)

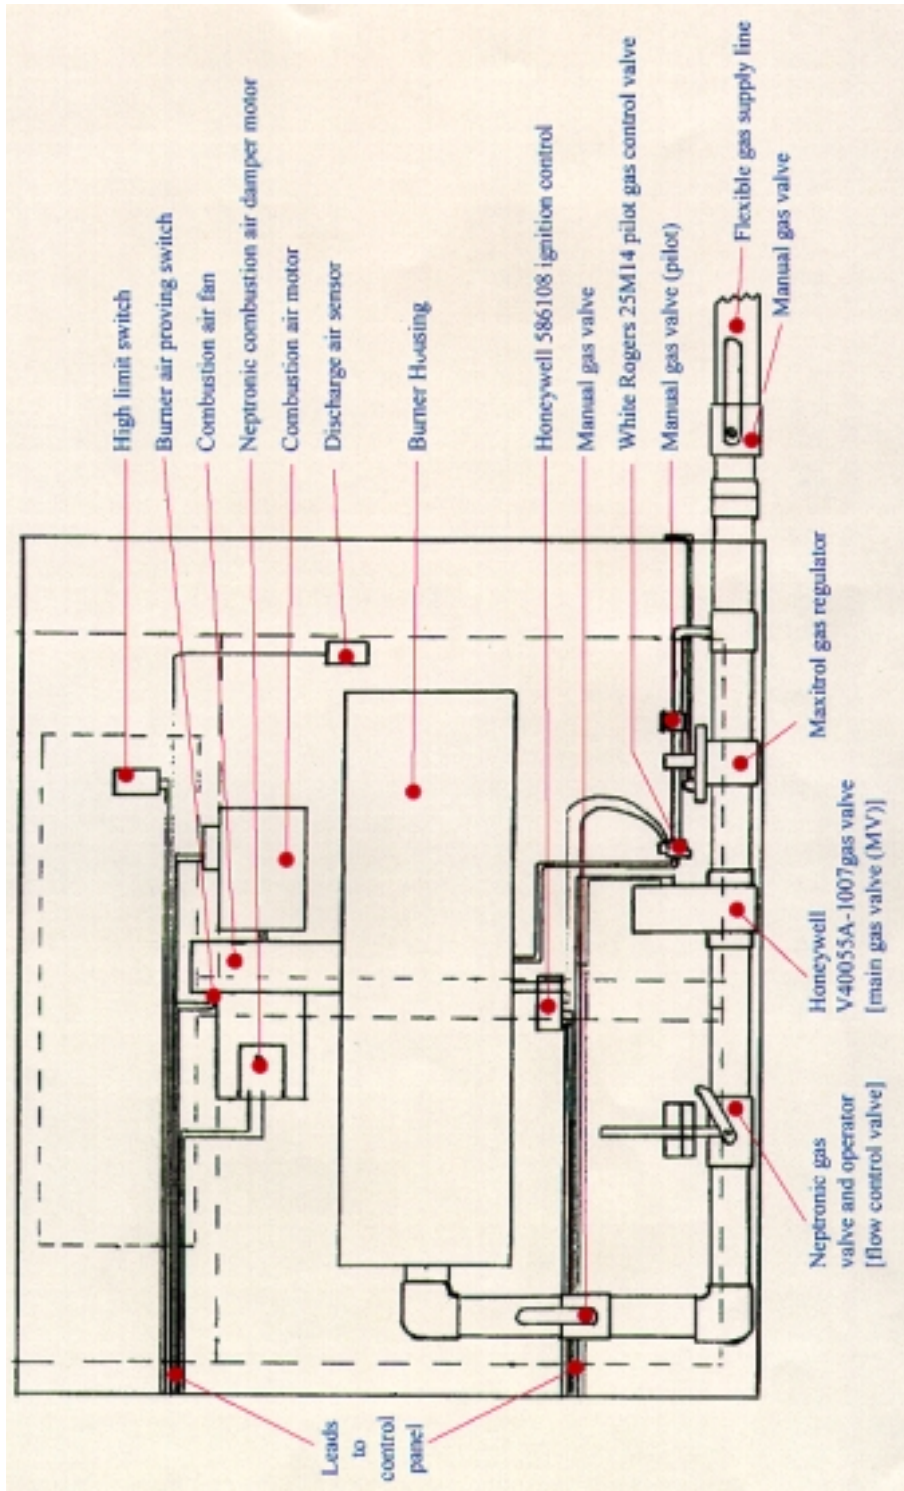
Diagram 2: Front view of burner unit showing approximate position of controls and gas line (not to scale).

10.3 The main gas valve was a Honeywell, Model V4055A-1007. The main gas valve was designed to remain open when power was supplied. The regulator was a Maxitrol gas regulator designed to reduce the gas pressure in the line. The flow control valve was a Neptronic gas valve and operator designed to control the flow of gas to the combustion chamber of the furnace. (Refer Attachment A, Diagram 2 and Attachment B, Photograph 2)

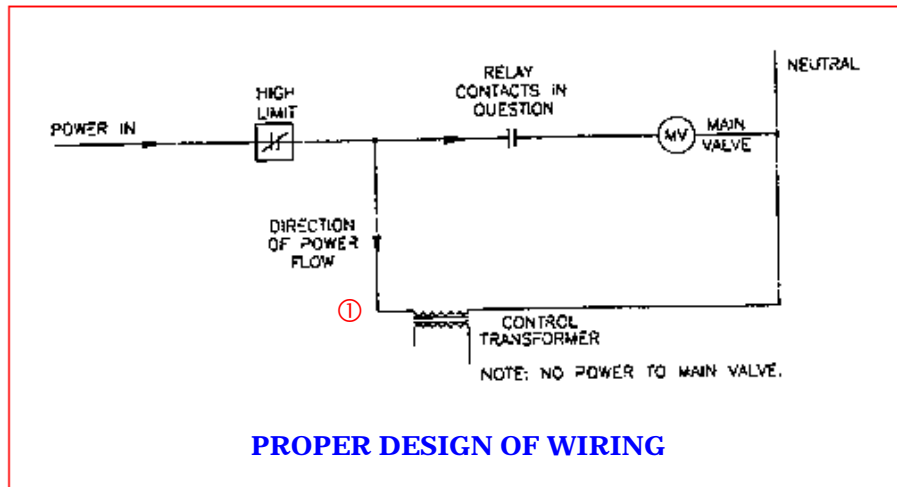
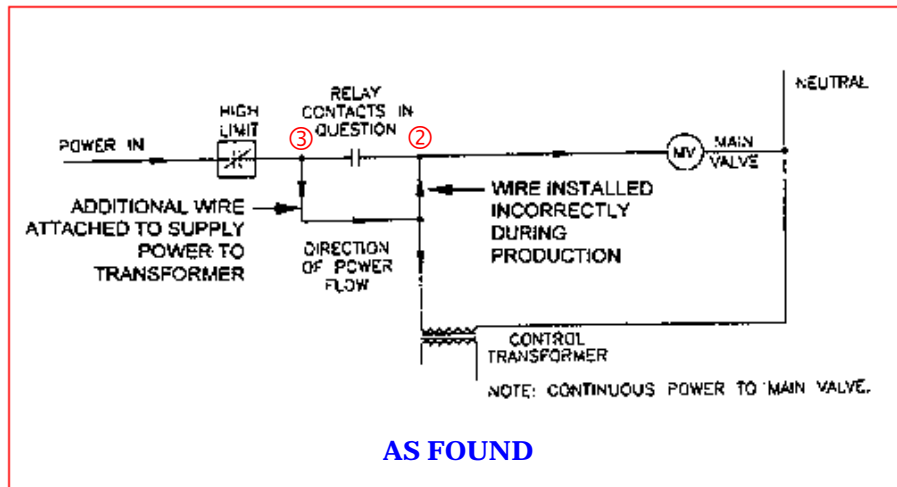
Diagram 3:

- 10.4 The unit had an electrical control panel. Power to the control panel was supplied through a high limit switch. During production of the control panel, the wiring was incorrectly installed putting the relay contact ahead of the transformer. This did not allow power to the transformer. During testing, an additional wire was installed to provide power to the transformer. This additional wire also supplied continuous power to the main gas valve (Refer Attachment A, Diagram 3 and Attachment B, Photographs 3 and 4)

- 13.1 The primary cause of the incident was the build-up of an explosive mixture in the combustion chamber of the furnace when incorrect wiring kept the main gas valve open prior to start-up of the unit. The explosive mixture was ignited and exploded when the unit was started. The exact source of ignition could not be determined.

Shows wiring diagram supplied by Airtex Industries Management Ltd. indicating proper wiring (top) and incorrect wiring on unit at time of incident (bottom). Note extra wire bypassing relay contacts in bottom diagram.

1. Shows proper design of wiring.
2. Shows relay installed before transformer which did not allow power to the transformer.
3. Shows additional wire attached to supply power to the transformer.

- 14.1.1 The employer voluntarily stopped work after the incident. The employer completed an incident investigation and prepared a report. Test procedures were updated to ensure wiring and function of the main gas valves were correct on HVAC units. Training was provided to the workers regarding the new test procedures and electrical wiring in control panels. The employer complied with provisions of the stop work order and stop use tag.

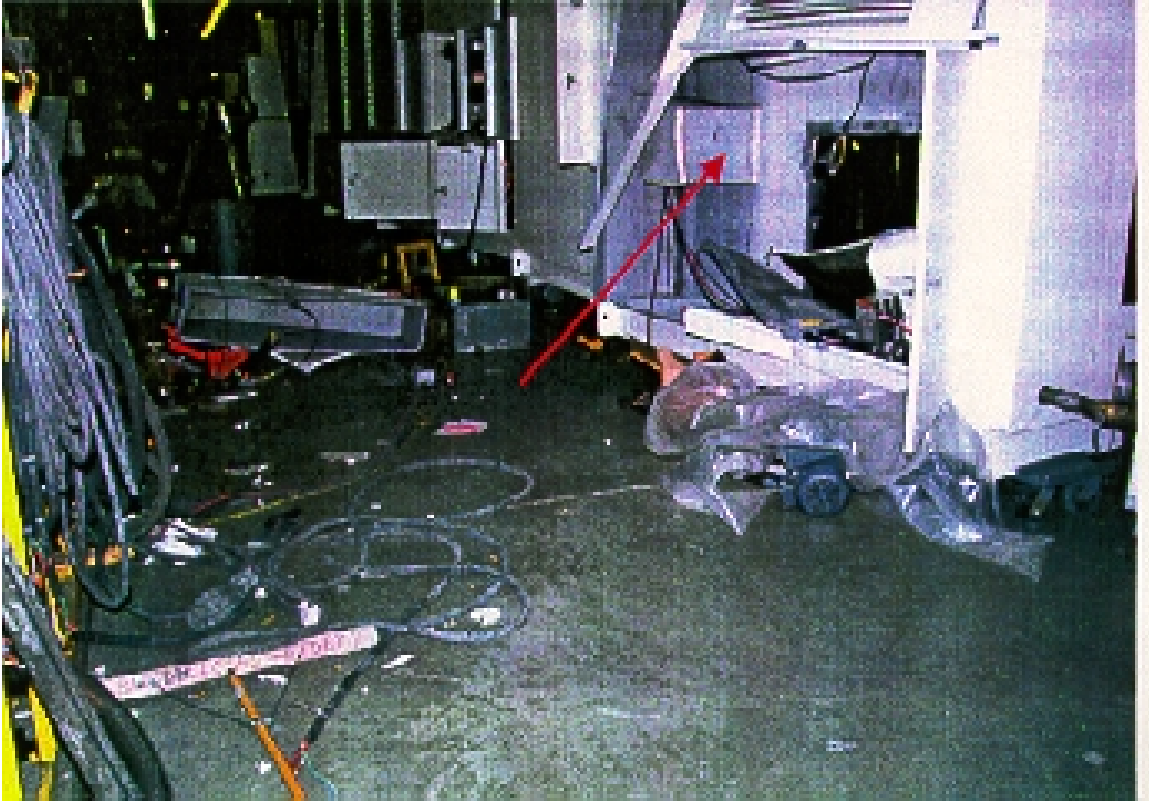
Photograph 1: View of the HVAC unit (model FWD-1203-DG-650) involved in the incident viewed from the North side. Furnace is the lower section in the foreground. Arrow shows damage to front of furnace resulting from explosion.

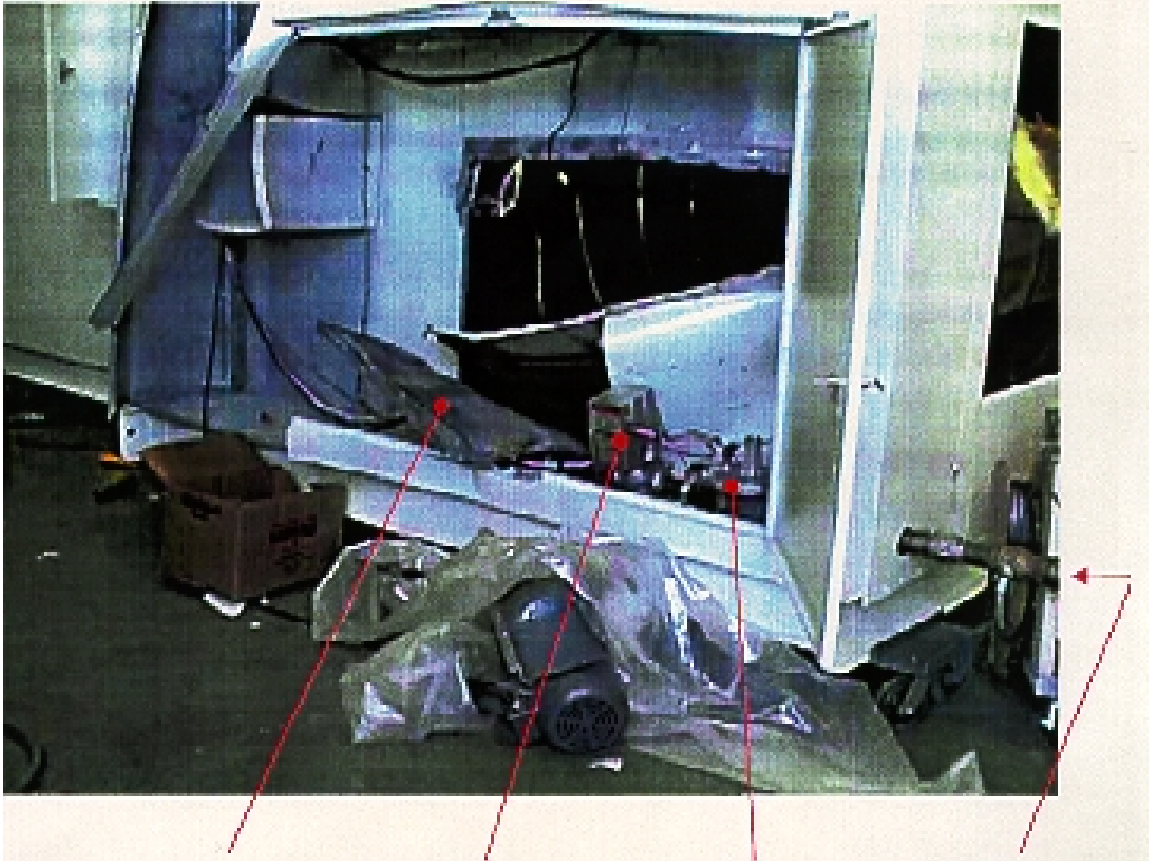
*Approximate position
of Neptronic gas valve
(flow control valve)
prior to explosion*

*Honeywell
gas valve
(main gas valve)*

*Maxitrol
gas regulator*

*Manual gas valve
on flexible supply
line*

Photograph 2: Shows front of the furnace following the explosion viewed from the Northeast.

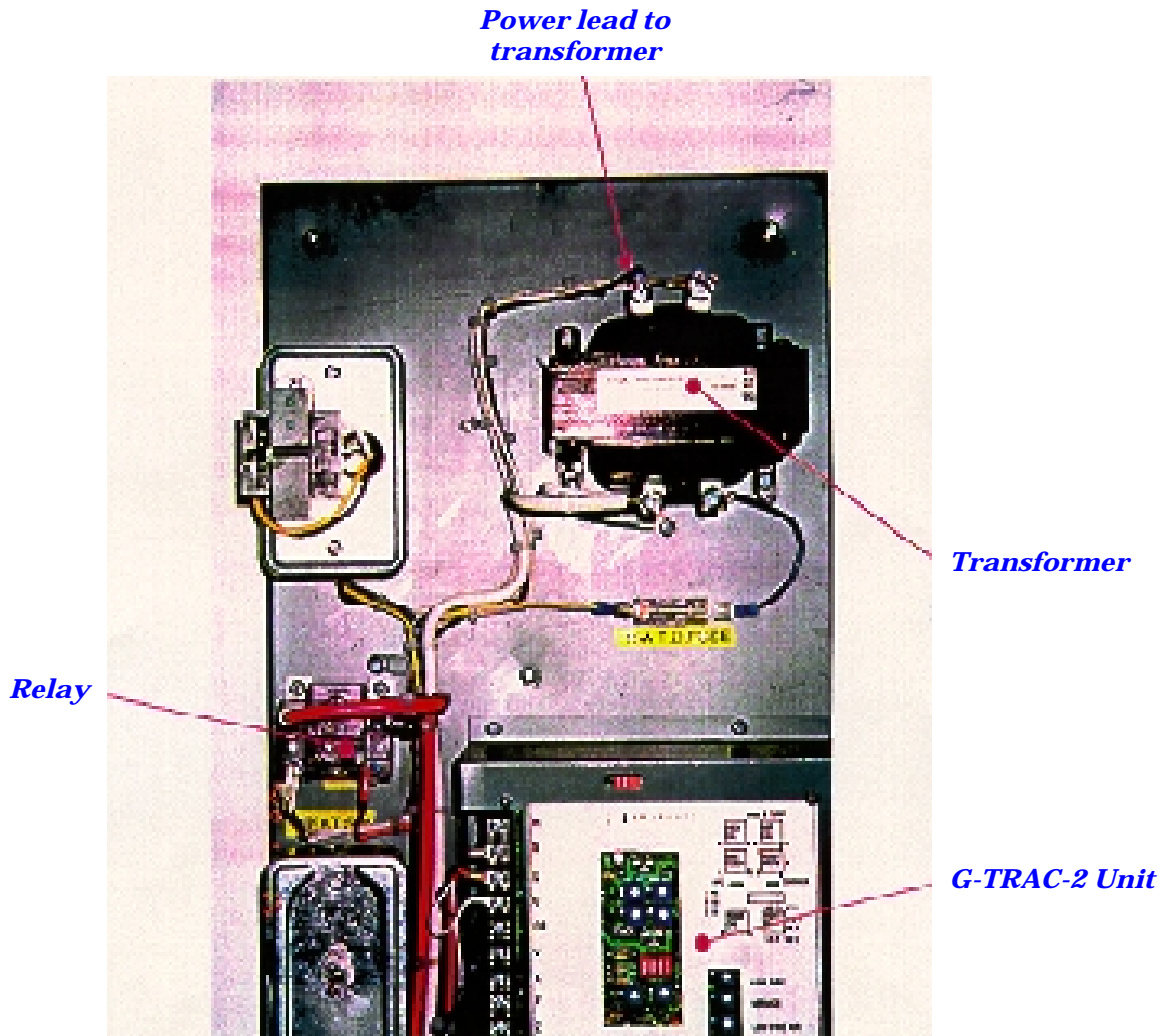
Photograph 3:

Shows properly wired relay. Thin black power lead to transformer travels from top right side of relay to transformer. Main power (thick black) lead to relay also attaches to top right side of relay but is obscured by pink power lead to gas valve. Larger pink power lead to main valve is the only lead attached to opposite (upper left) side of relay.

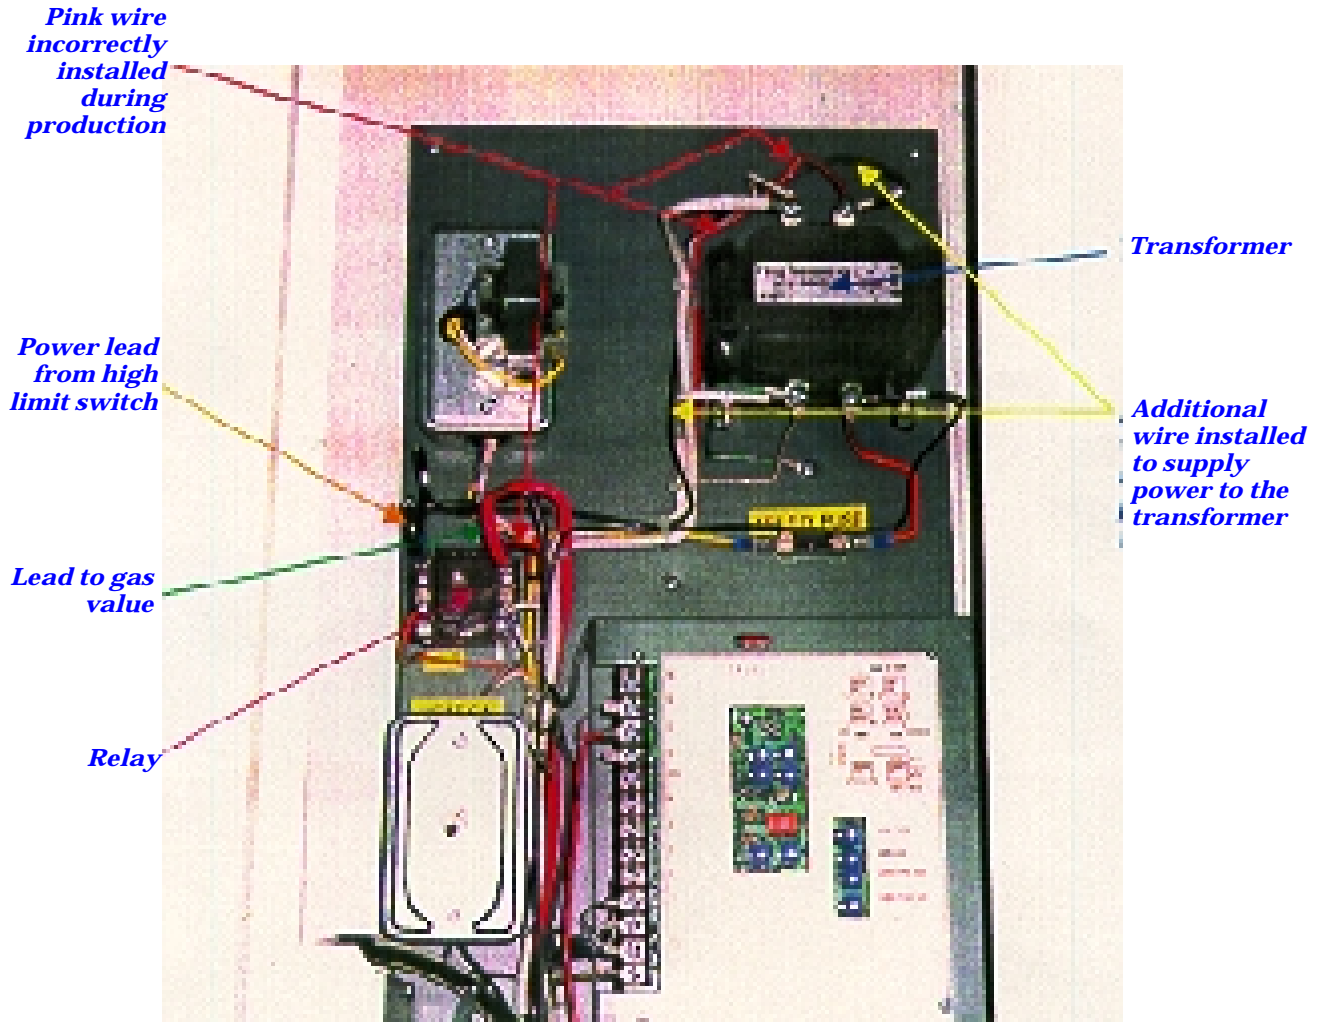
Photograph 4:

- 13.2 The secondary cause was a missed test procedure to ensure electrical wiring was correctly installed for proper function of the main gas valve. The standard procedure of the company indicated that a safety test should have been performed to ensure electrical wiring was correctly installed for proper function of the main gas valve. There was no evidence to indicate the worker performed this test.

Improper wiring showing by-pass of relay. Thin pink wire, incorrectly installed during production, is attached to large pink power lead to gas valve at relay and to transformer. Thin black wire, attached during testing to provide power to the transformer, connects to the same transformer terminal as the thin pink wire and by-passes relay.
