Worker Frozen in Trench

Date of Incident: 1998 09 03

Type of Incident: Fatal

1.1 F-100221

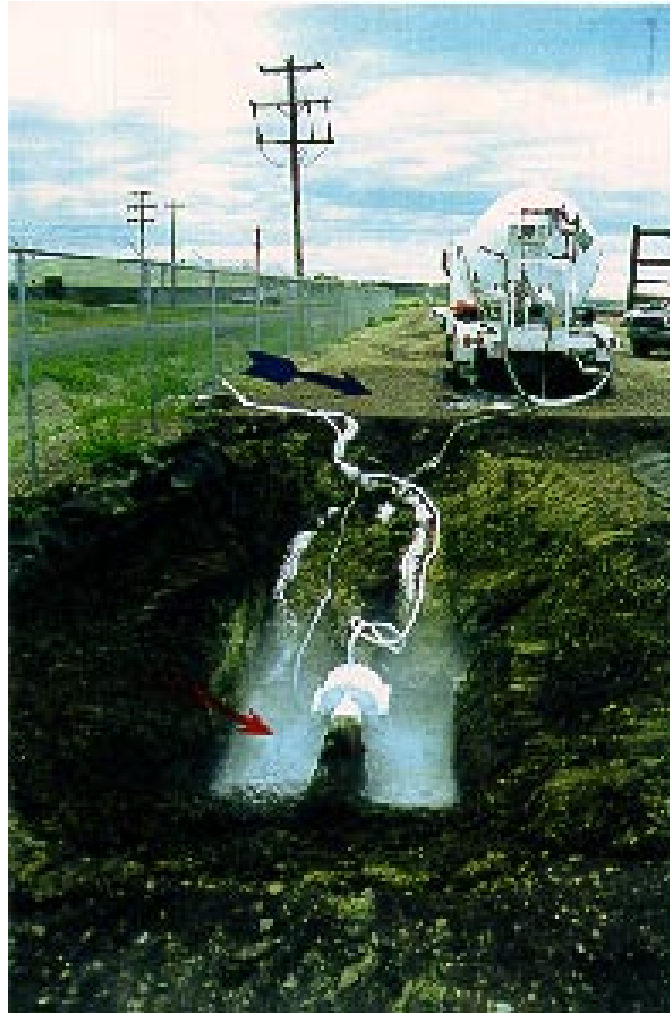
Photograph #1:

Looking north, view of the trench (with fog in base), pipeline, freeze plug jacket, hoses (with frost build-up), nitrogen bulk truck and west fence. The frost line on the west (left hand) side of the trench indicates where the inlet hose was laying at some time prior to the photograph being taken. The red arrow [lower] indicates the location where the fatally injured worker was discovered. The blue arrow [upper] indicates an alteration to this area of the photograph.

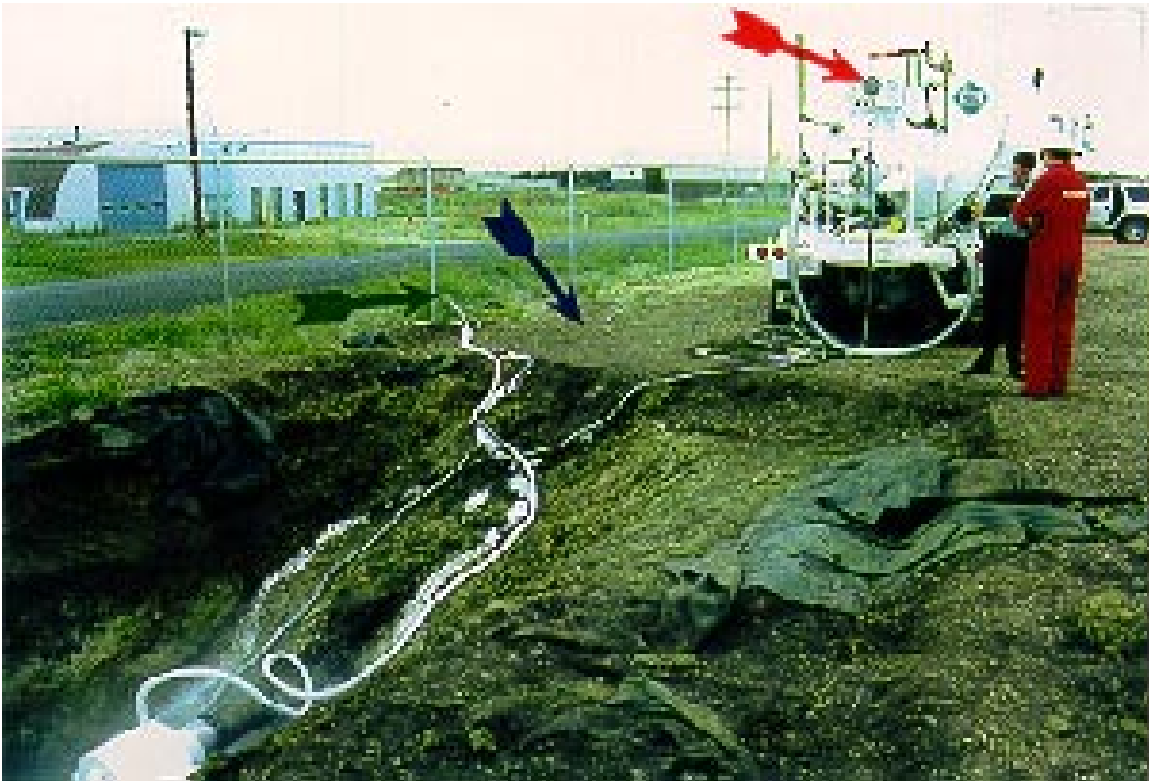
Photograph #2: Incident Location:

- 13.6 Until 20:00 on September 2, 1998, a mixture of nitrogen vapour and droplets of liquid nitrogen, visibly dripped directly out of the open connection on top of the jacket to the ground. No outlet hose was attached to the freeze plug jacket. Between 20:00 and 22:00, the wind decreased, such that the fog was not being carried away. An outlet hose was connected to the top of the jacket and extended to the fence making the nitrogen droplets easier to view.

Looking northwest, view of trench, fence, and rear of nitrogen bulk truck. The green arrow [far left] points to the open end of the freeze plug jacket outlet hose. The red arrow [upper right] points to the nitrogen level gauge at the rear of the truck. The blue arrow [centre] indicates an alteration to this area of the photograph.

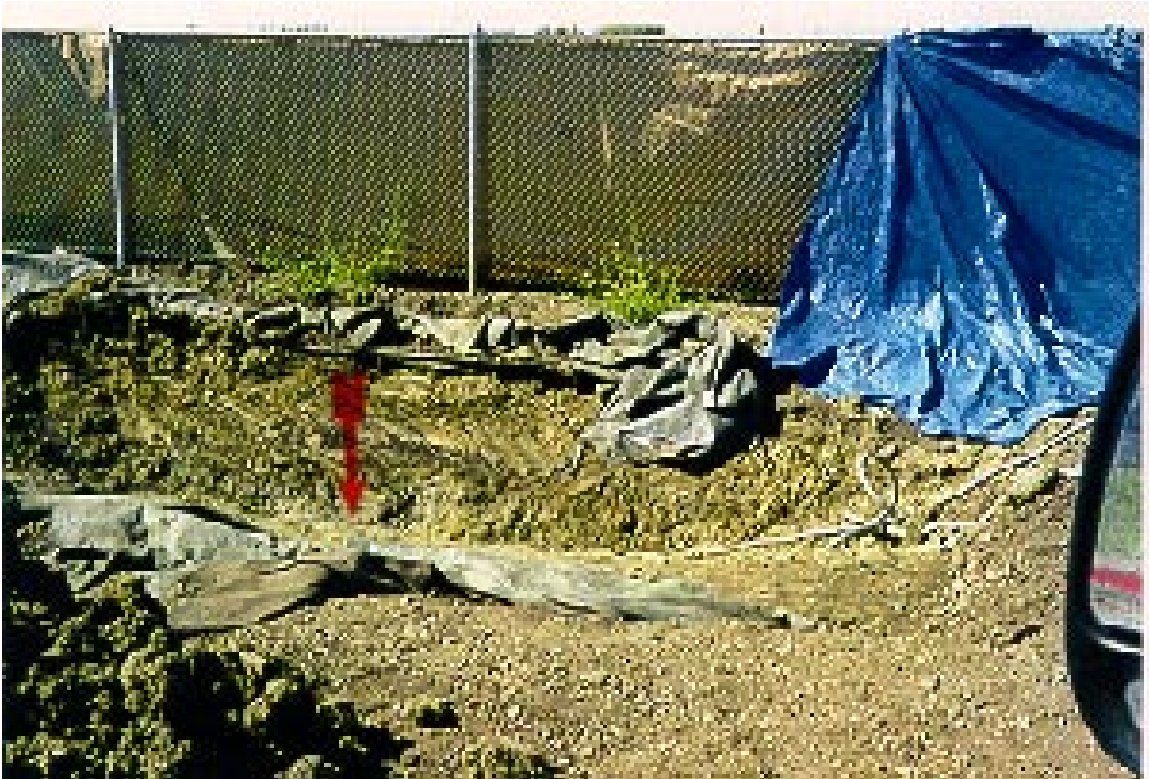
Photograph #3: Incident Location:

- 12.10 The top of the east wall of the trench prevented Worker #2 from seeing down to the level of the freeze plug jacket.
- 12.11 The driver completed the unloading process at 06:40 and briefly looked for Worker # 1 to sign the receipt for the nitrogen shipment. The driver did not see Worker #1 in his pick-up truck and observed Worker #2 sitting in the driver's seat of his truck. The driver approached Worker #2 and awakened him to sign the receipt. The driver drove away at approximately 06:45.

Looking southwest, view of trench by Worker #2 from driver's seat of data van. The hoses are visible extending into the trench. The top of the freeze plug jacket was not visible from the driver's seat. The arrow points to the freeze plug jacket, hidden from view by the east trench wall.

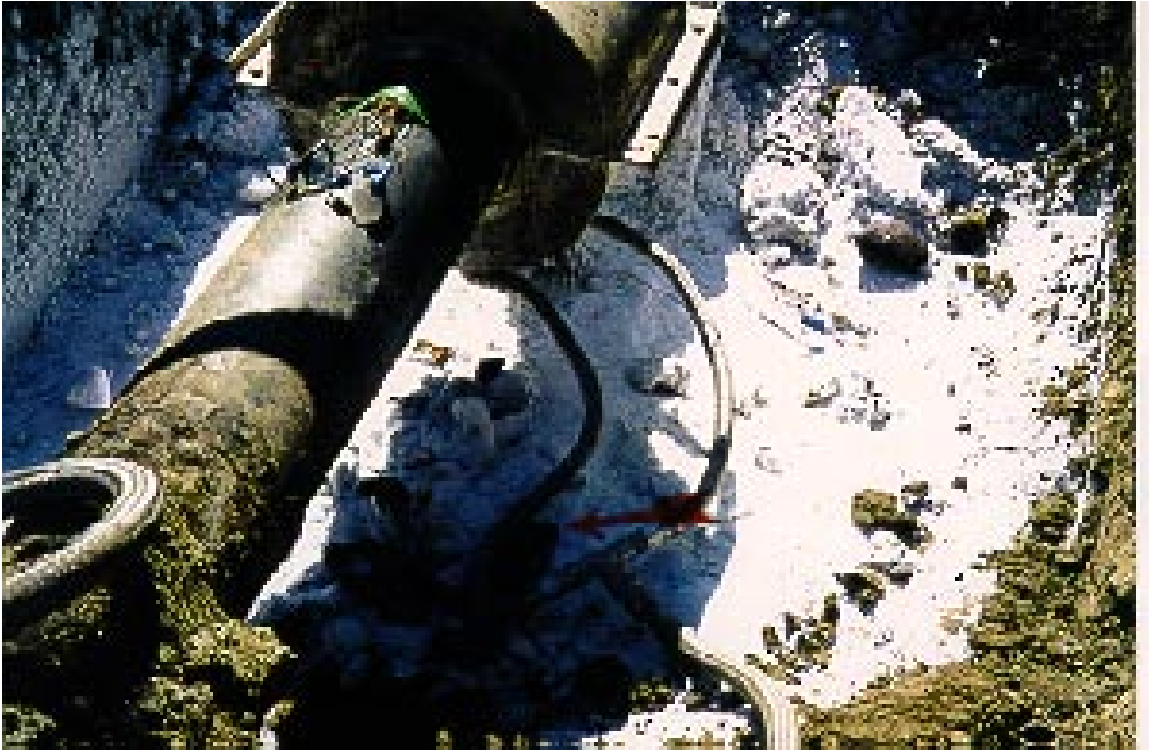
Photograph #4: Incident Location:

- 13.2.5 Worker # 1 was at the site for 23 consecutive hours; some of this time he was sleeping in the truck.
- 13.3 The temperature meter was stored outside the trench between readings. Although it cannot be determined why Worker #1 chose to enter the trench, finding the temperature meter beside Worker #1, led investigators to conclude that he entered the trench to check the readings.

- 13.4 The ground at the base of the trench was covered with overlying frost that had accumulated overnight, creating a potential for slippery footing.

View of frozen ground in trench base, showing cobble and frozen lumps of clay. The frozen nature of these surfaces made them harder, with the potential to cause a concussion type of injury. No physical evidence was observed at the scene that would confirm whether Worker #1 tripped or was asphyxiated. The red arrow points to the temperature meter.

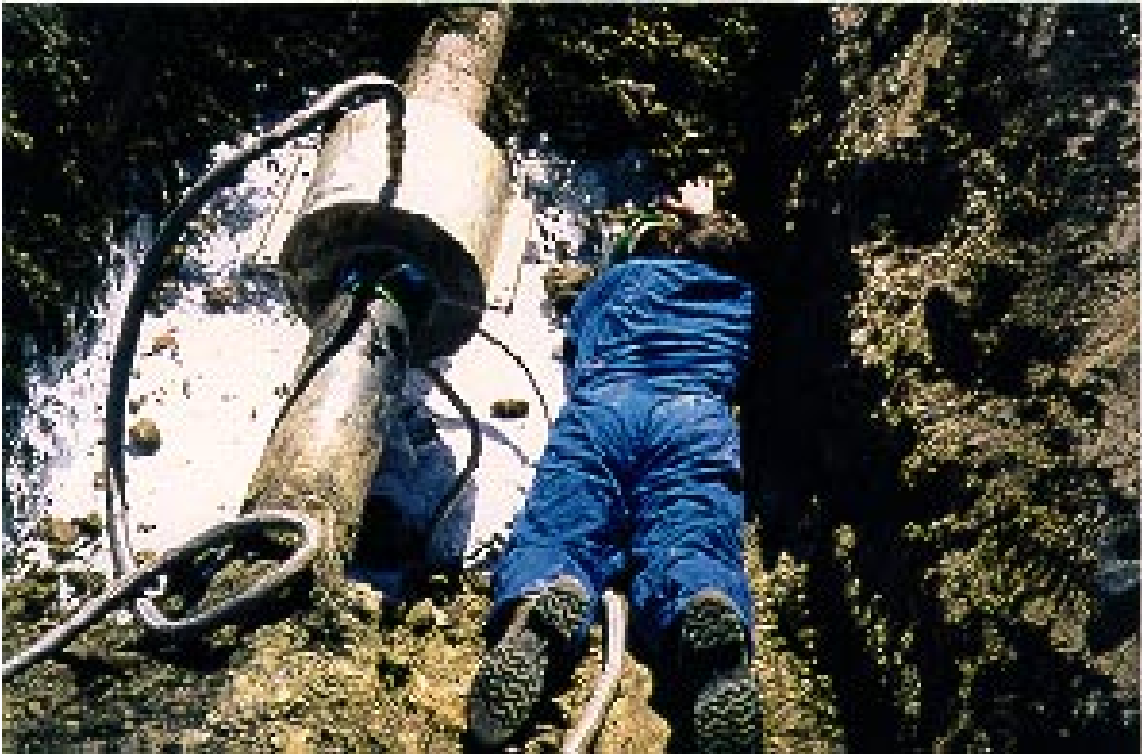
Photograph #5:

- 12.13 At approximately 07:05, Worker #2 discovered Worker #1 laying in the fog, face-down in the base of the trench. Worker #1 was below and to the west of the freeze plug jacket, with his feet situated to the north. The three other workers immediately entered the trench and pulled Worker # 1 out. Worker # 1 was extensively frozen, unconscious and unresponsive. One of the workers immediately called 911 and requested an ambulance. The ambulance and police arrived a short time later.

Simulation by a model to show where Worker #1 was found. The model's placement of his limbs may not precisely reflect the way Worker #1 was found.
