Worker Overexposed to Toluene

Date of Incident: 99 08 10

Type of Incident: Fatal

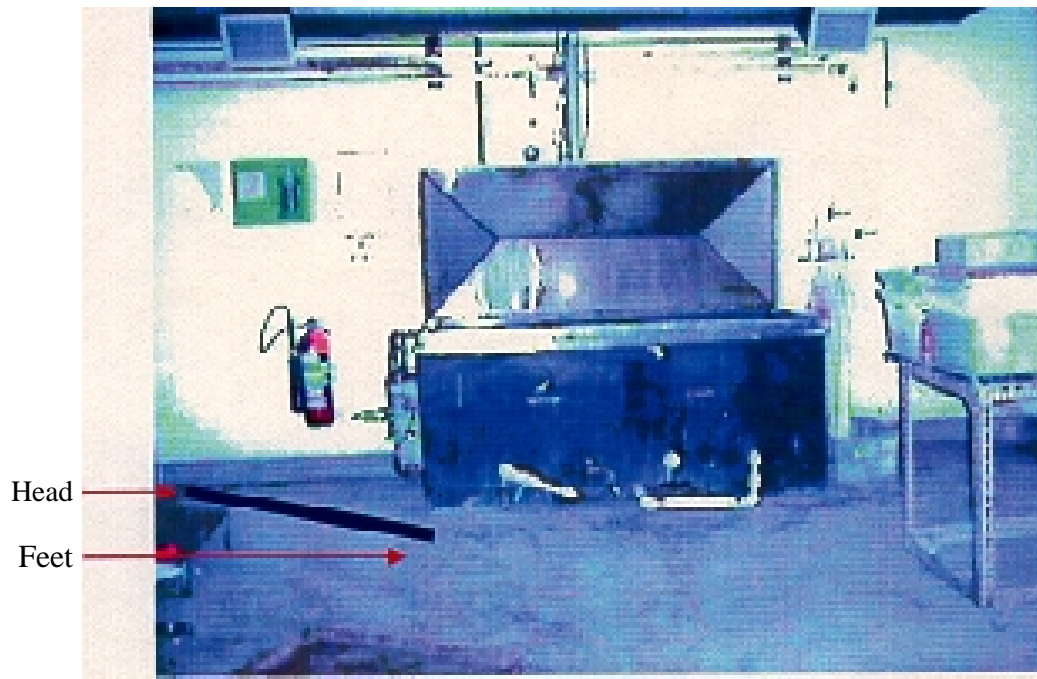
Vapour phase extractor room. Vapour phase extractor shown with lid open.

Position worker was found. Looking southerly

9.1 The incident occurred in the vapour phase extractor room of AGAT Laboratories located at 3801 – 21st Street N. E., Calgary, Alberta (Refer Attachment A, Photograph 1 and Attachment B, Sketch).

10.1 The vapour phase extractor was used to extract oil from rock core samples. Approximately 10 centimetres of toluene were poured into the bottom of the vapour phase extractor. There were numerous rock core samples placed in two baskets on the top of the toluene bath. The vapour phase extractor heated the toluene, the toluene evaporated and bathed the rock core samples with hot toluene vapours. The toluene vapours cleaned the oil and water residue from the core samples. (Refer Attachment A, Photographs 1, 2, 3, 4 and 5).

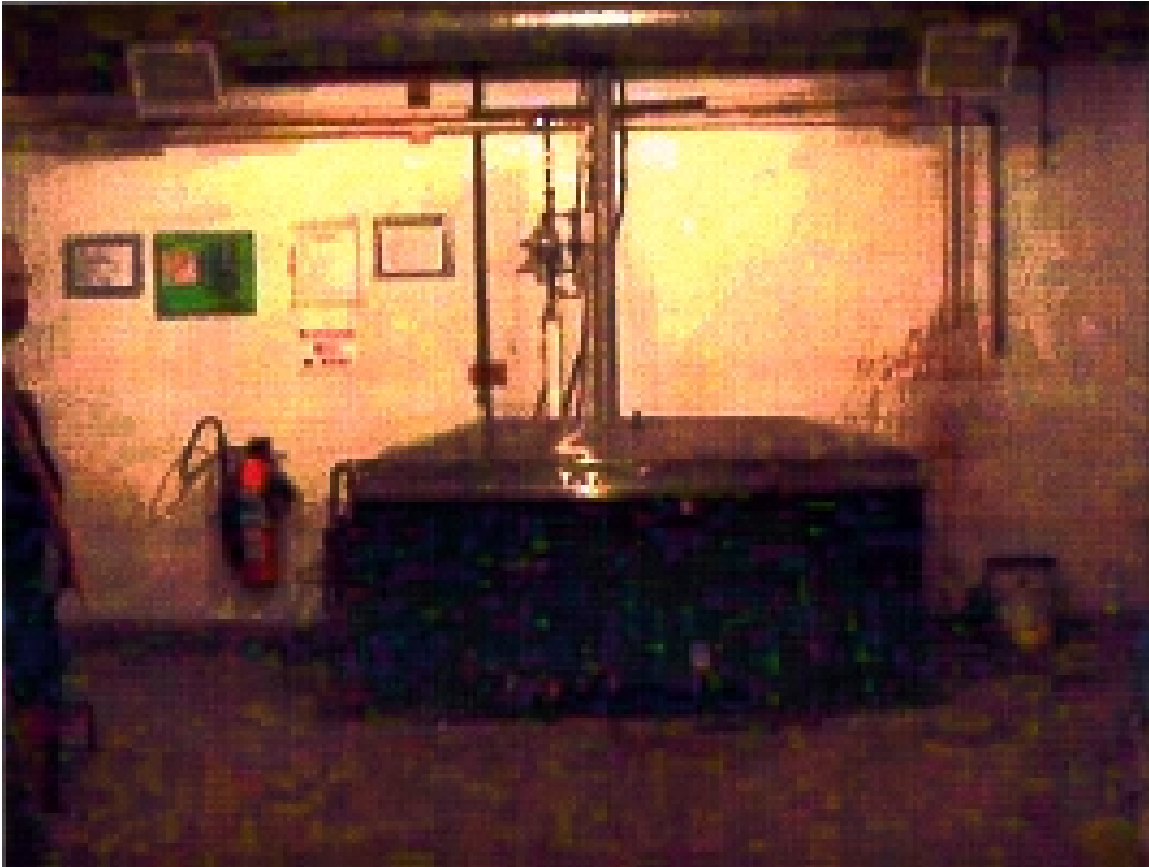
Photograph 2 Vapour phase extractor with lid closed. Looking southerly.

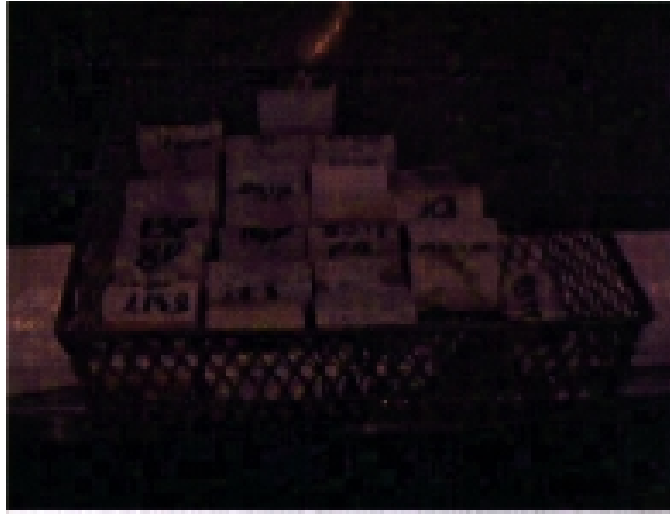
Photograph 3 Basket #1

Rock core samples that were in vapour phase extractor at time of incident.

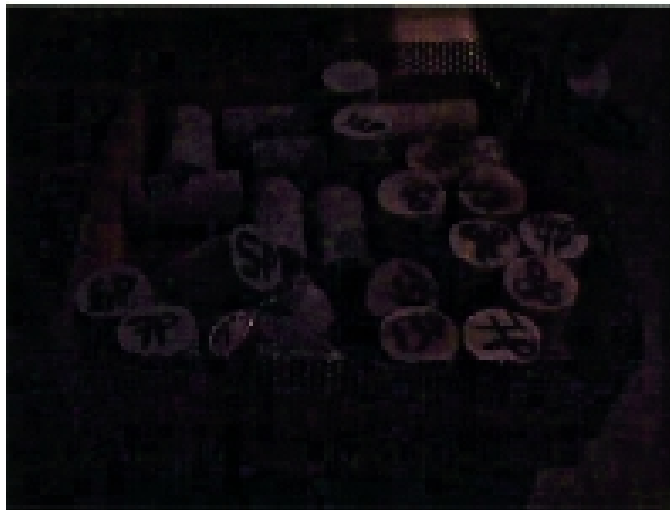
Photograph 4 Basket #2

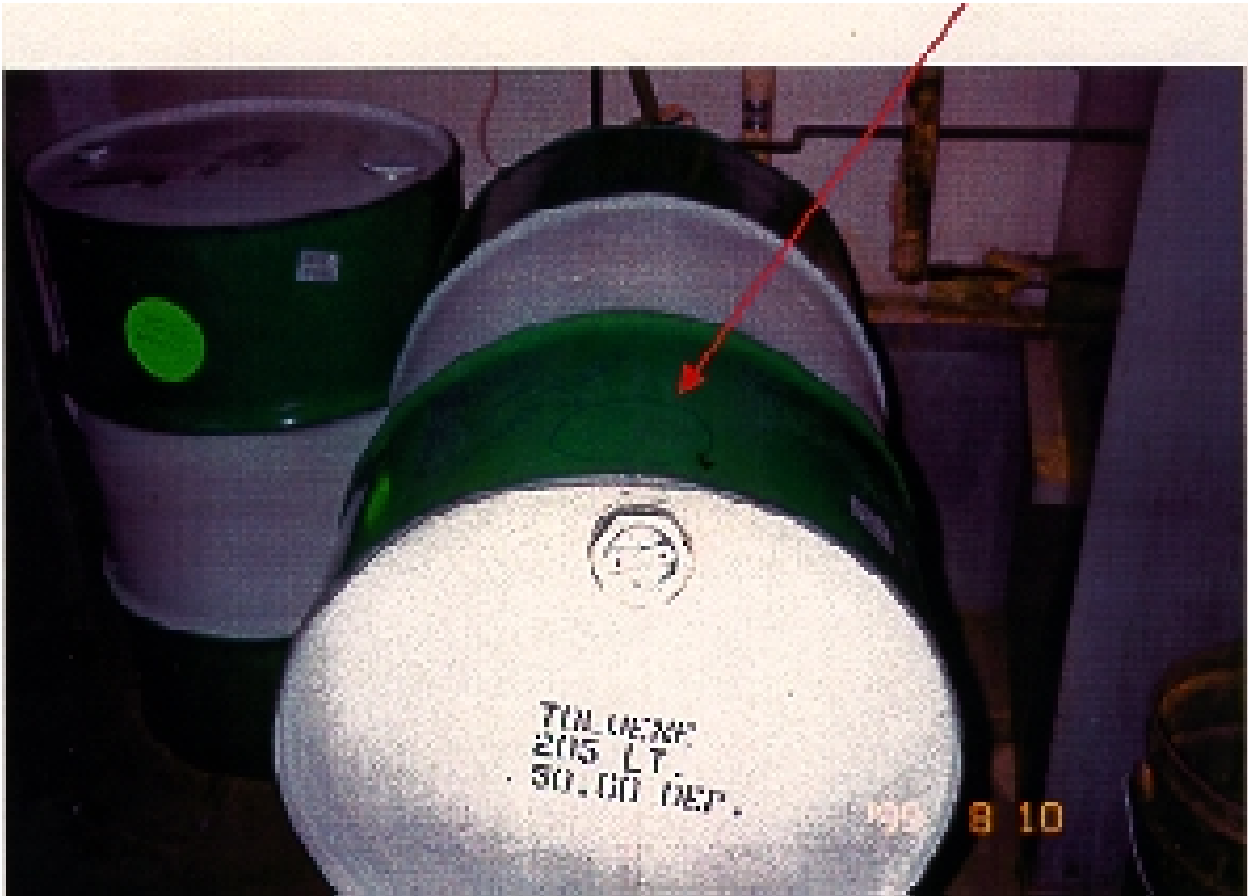
Stopper found here

Photograph 5 Fresh toluene used to fill vapour phase extractor. Looking easterly.

Note: Toluene barrel was open at the time of the incident with stopper placed on top of barrel.

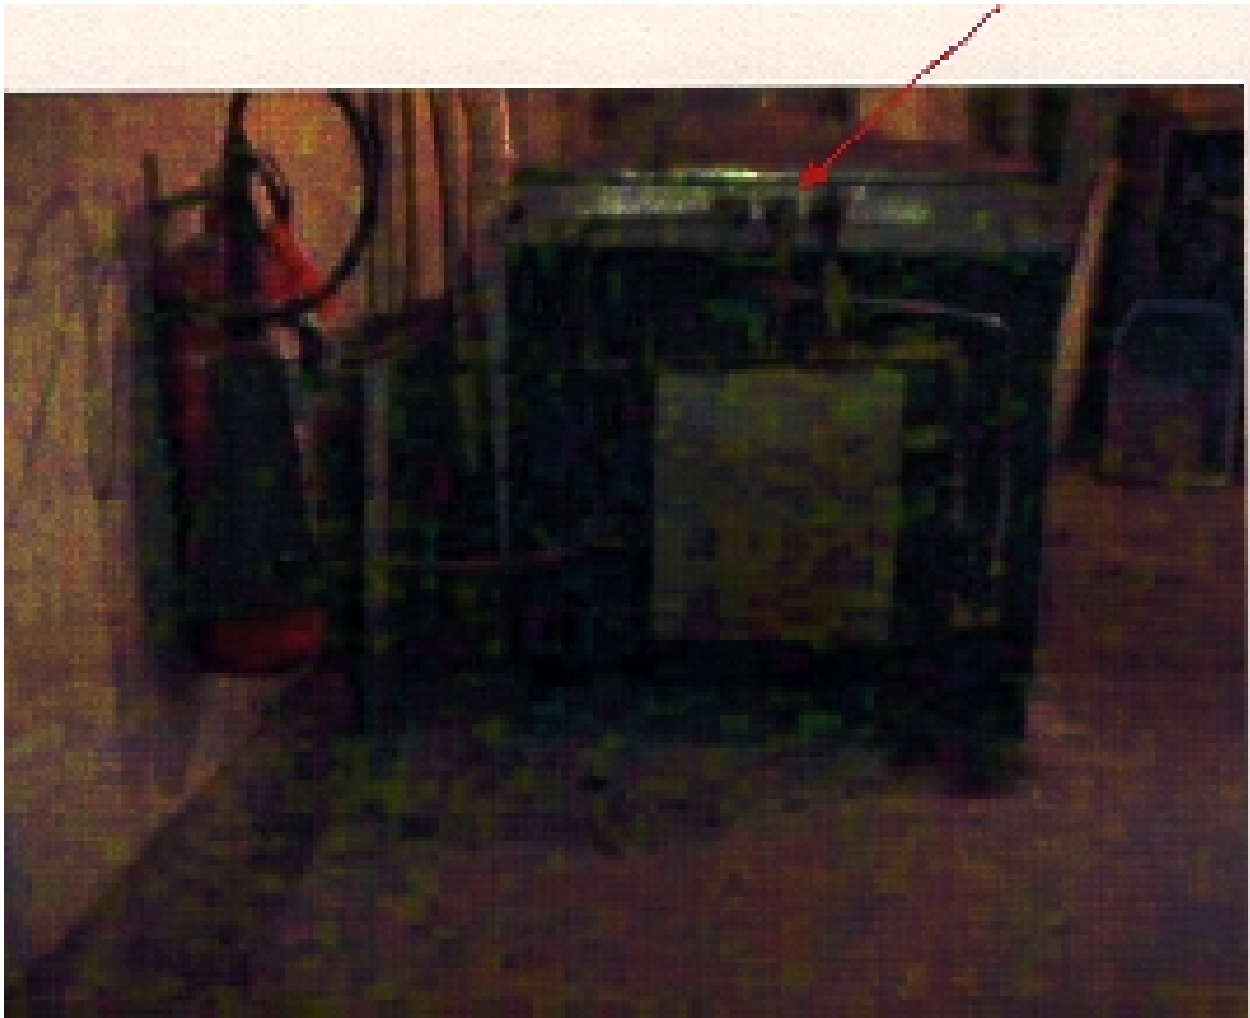
Photograph 6

10.2 The vapour phase extractor had cooling system to condense toluene vapours and prevent accumulation of vapours in the headspace. The cooling system was equipped with an on and off valve. During the incident, the cooling system was turned off. (Refer Attachment A, Photograph 6).

The valve that operated the cooling system was shut off. The cooling system was not operating which allowed high concentrations of toluene to accumulate in the headspace of the vapour phase extractor. The high concentration of toluene vapours was released when the worker opened the lid.

Cooling value

Cooling value that was shut off on vapour phase extractor.
Looking westerly.

14.1.1 The employer stopped work and commenced an incident investigation to determine the cause to prevent a recurrence. The employer checked the vapour phase extractor for defects. There were no abnormalities found. The employer removed the cooling valve handle to ensure the cooling system could not be turned off and the system was left constantly running to prevent a build up of toluene vapours in the vapour phase extractor.

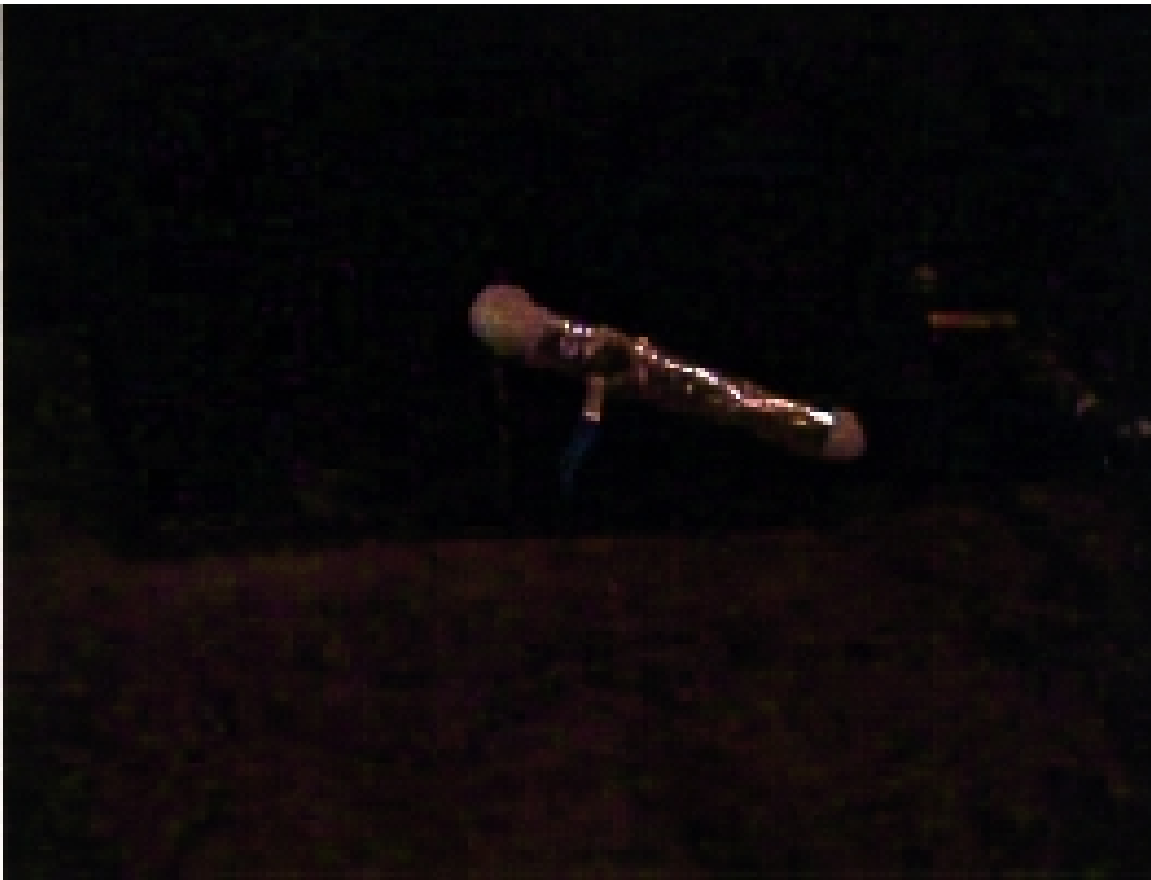
10.3 The vapour phase extractor also had a steam heating system to heat the toluene and create toluene vapours. The steam heating system was equipped with an on and off valve. The steam valve was turned off at the time of the incident (Refer Attachment A, Photograph 7).

Photograph 7 Shows the insulated steam valve of the extractor in the shut off position. Looking southerly.

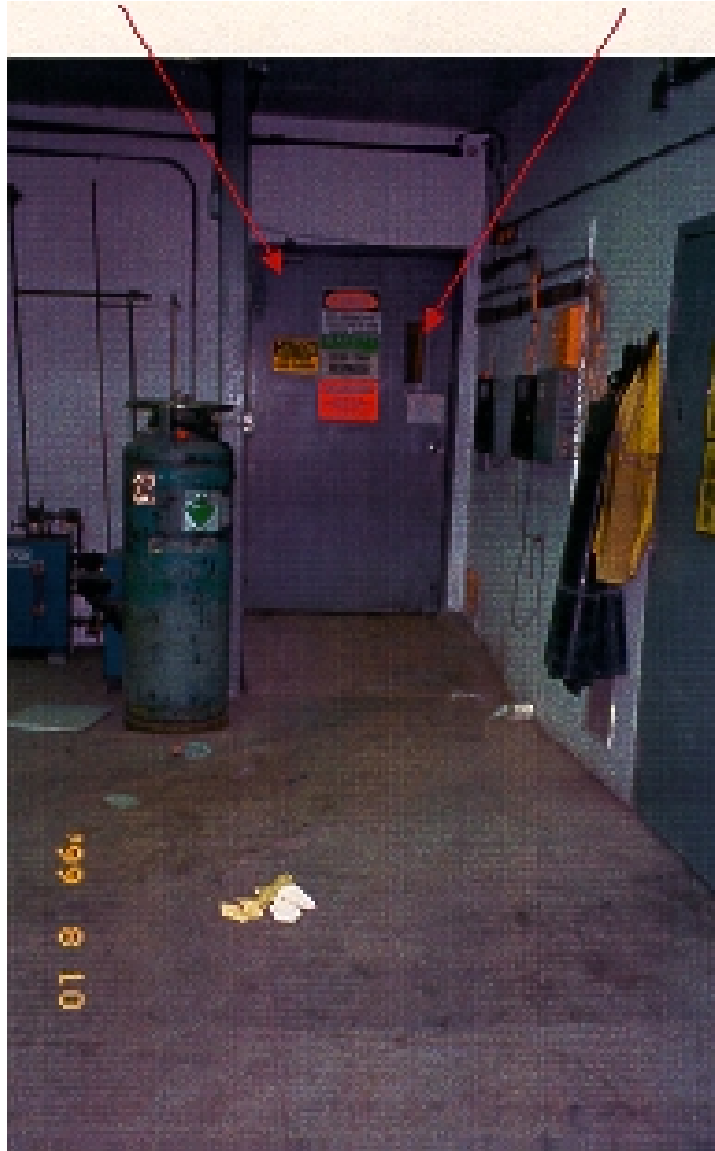
Photograph 8

12.7 The lab coordinator instructed the lab technician to call EMS. The lab coordinator then pulled the worker out of the vapour phase extractor room and began CPR (Refer Attachment A, Photograph 8).

Door to Vapour
Phase Extractor Room

Shows window that lab
coordinator looked through
to see worker

Worker was pulled from Vapour Phase Extractor Room into the main core lab area by Lab Coordinator. Looking westerly.

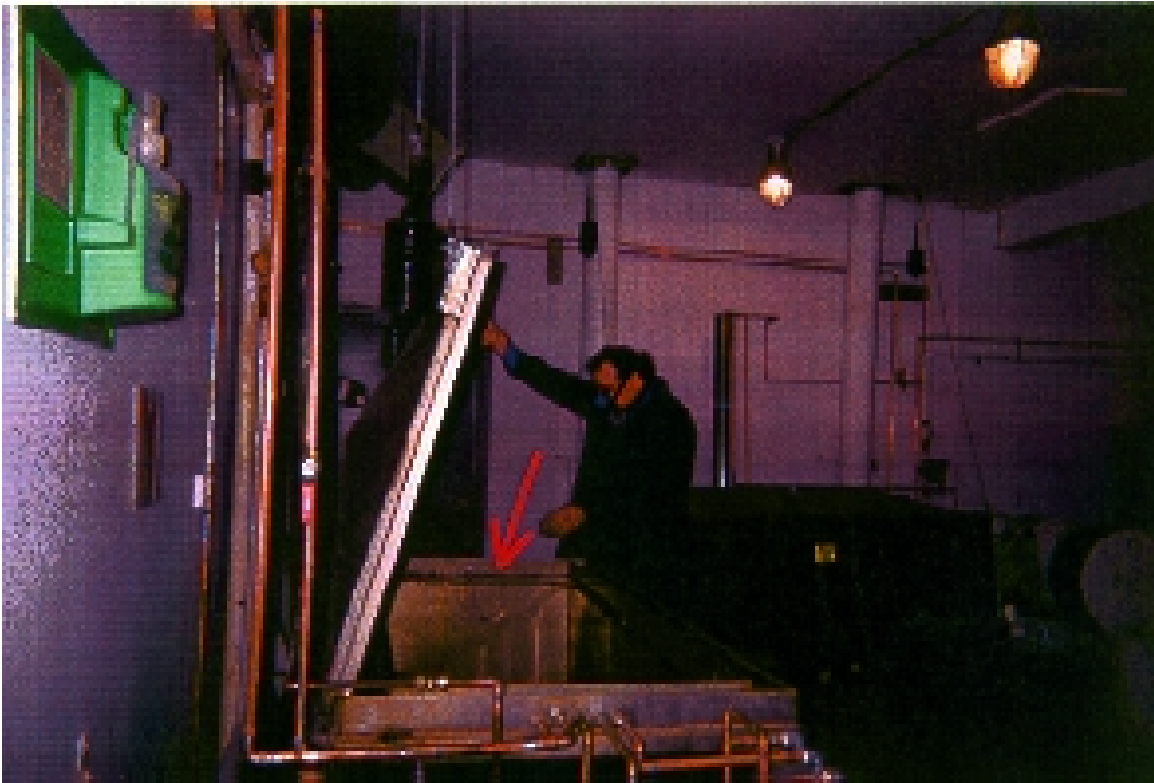
Photograph 9 Shows additional cooling coil installed to increase condensation of toluene vapours. Looking westerly.

14.1.3 The vapour phase extractor was redesigned. An additional cooling coil was installed to improve the condensation of the toluene vapours. A safeguard locking mechanism was installed to prevent the lid from being opened when there is a high concentration of toluene vapours in the headspace. Temperature sensors operate the locking mechanism. The temperature read out is installed outside the room to warn workers of elevated vapour concentrations (Refer Attachment A, Photographs 9, 10, 11 and 12).

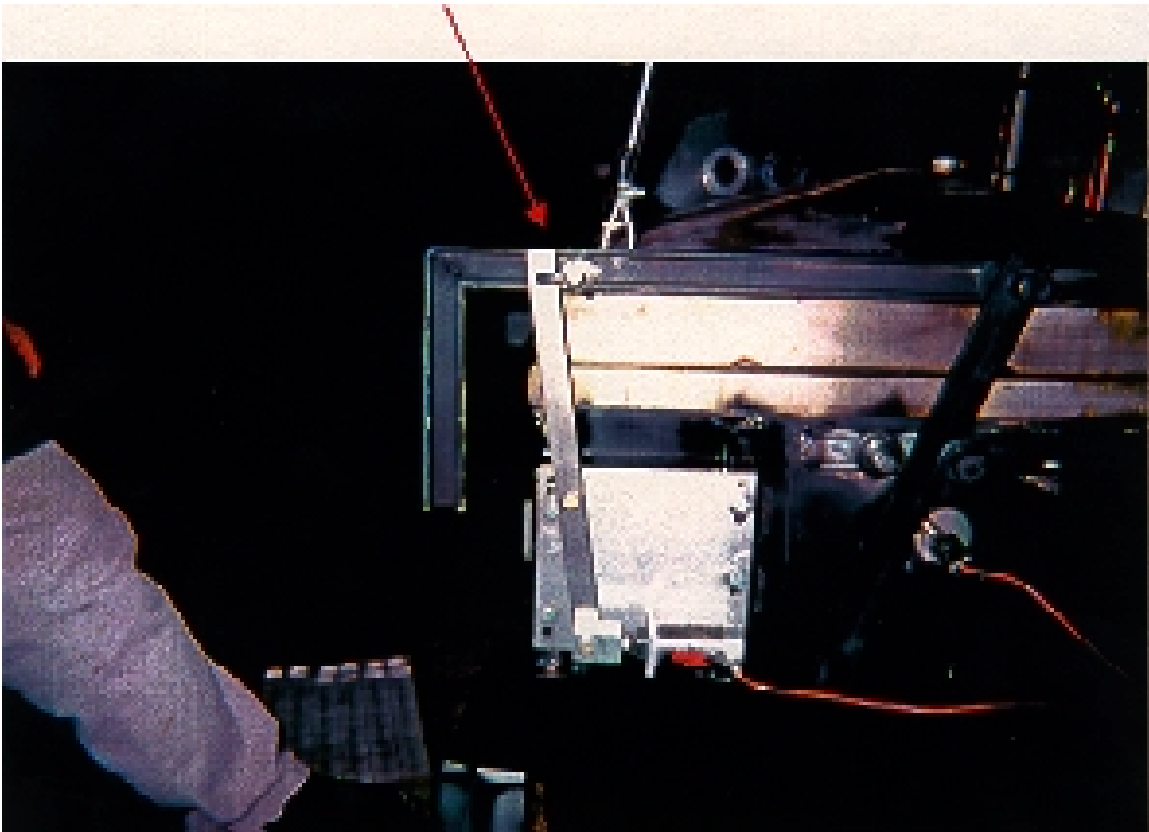
Photograph 10 Shows locking mechanism that prevents lid from being opened when toluene vapour concentrations are elevated. Looking easterly.

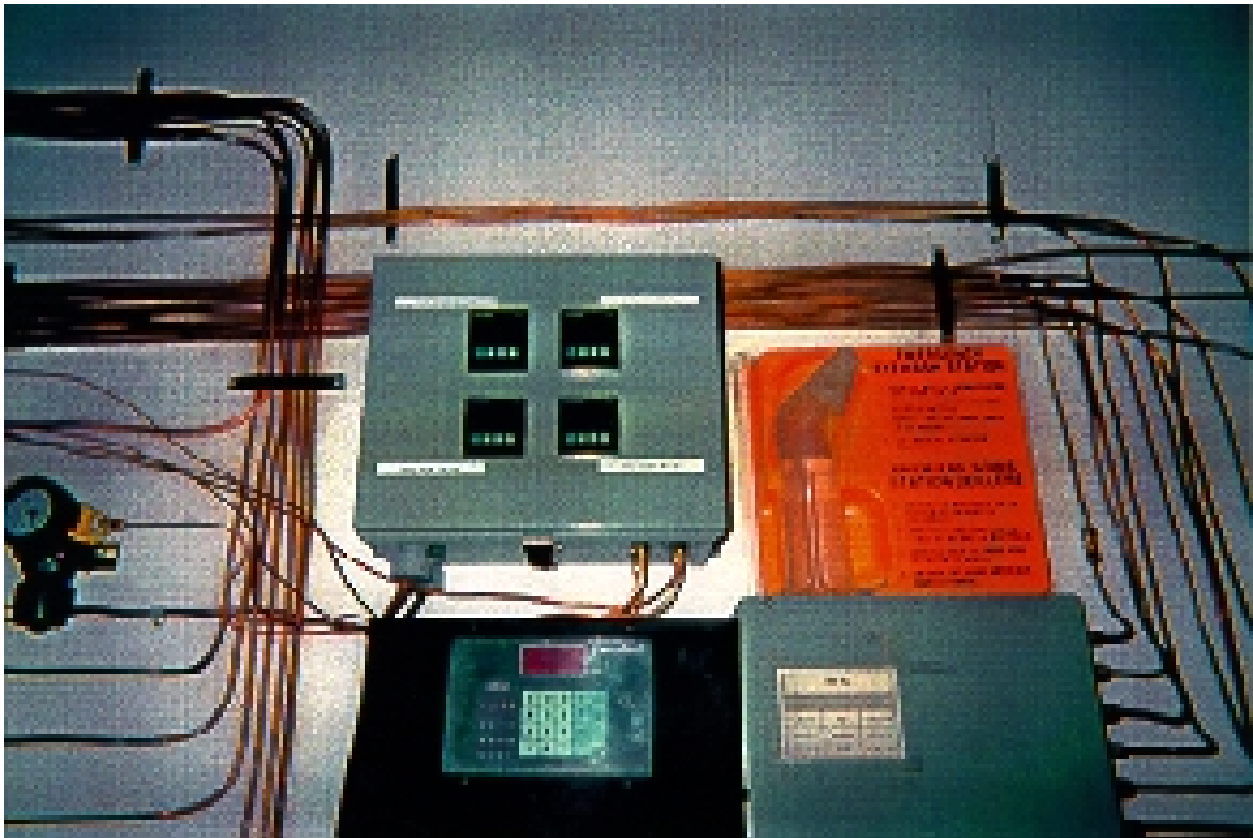
Photograph 11 Shows digital temperature read-out, outside of vapour phase extractor room. Looking northerly.

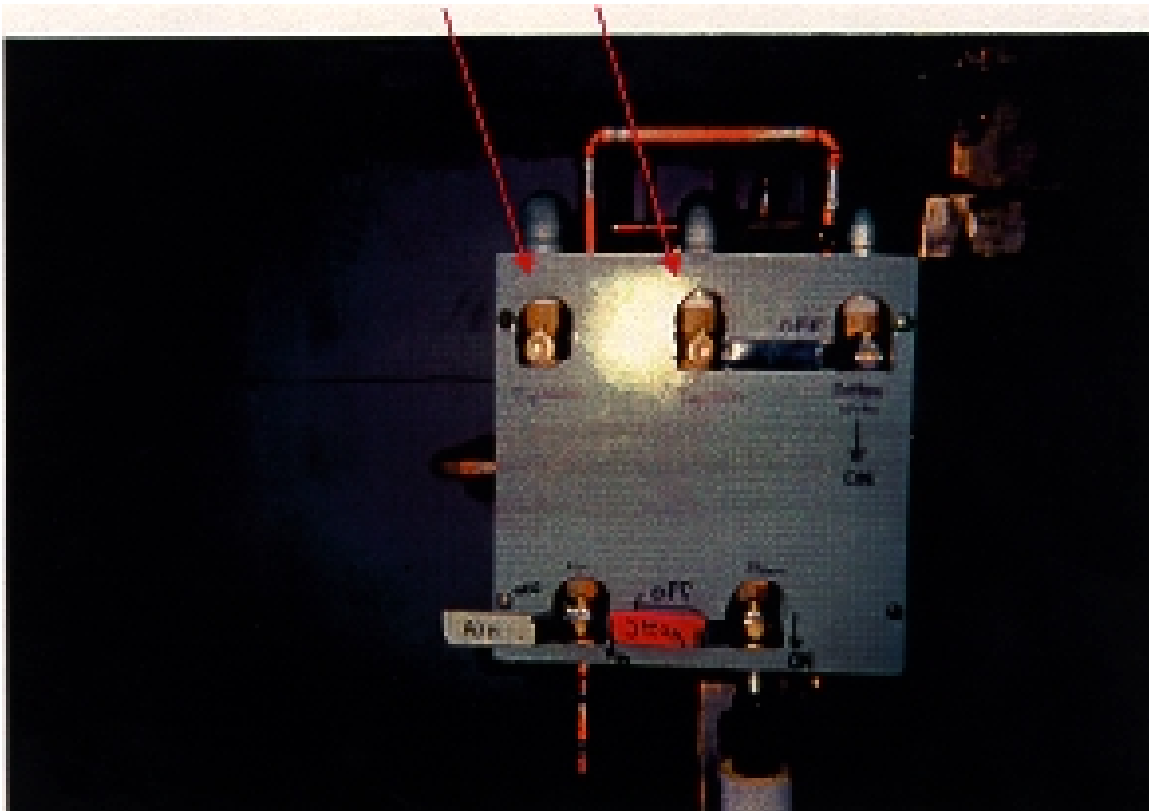
Photograph 12 Shows values of the vapour phase extractor.

Note: The two top cooling coil valves are removed to ensure cooling system is constantly running. Looking easterly.
