MARINE CASUALTY REPORT

TANKSHIP PUERTO RICAN

**EXPLOSION AND FIRE
IN THE PACIFIC OCEAN,
ON 31 OCTOBER 1984**

REPORT NO. USCG 16732/0003 HQS 84

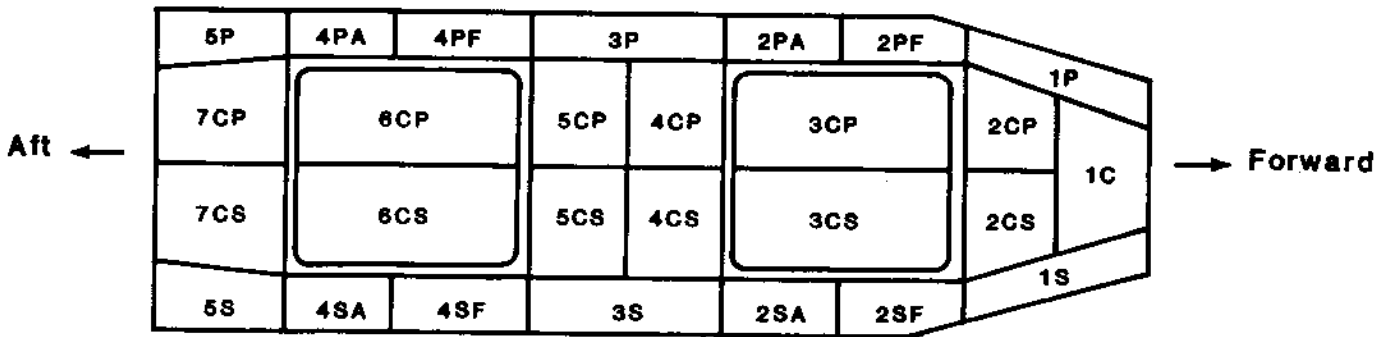
Figure 1. Schematic plan of cargo tanks on the S.S. Puerto Rican.

7. The PUERTO RICAN was a steel tank vessel with special tanks and tank linings for the carriage of specified chemicals and liquefied gases. The deckhouse was located aft and above the machinery space. It contained the navigation bridge, radio room, and quarters for the entire complement of officers and crew. An eductor room, located below the main deck on the centerline of the vessel between the engine space and the aftermost cargo tanks, serviced the double bottom sea water ballast tanks. The cargo control room was located on the port side of the main deck centerline next to the foam room and immediately forward of the deckhouse. The forebody was divided into 27 cargo tanks. The cargo tank arrangement and numbering system is shown in figure 1.

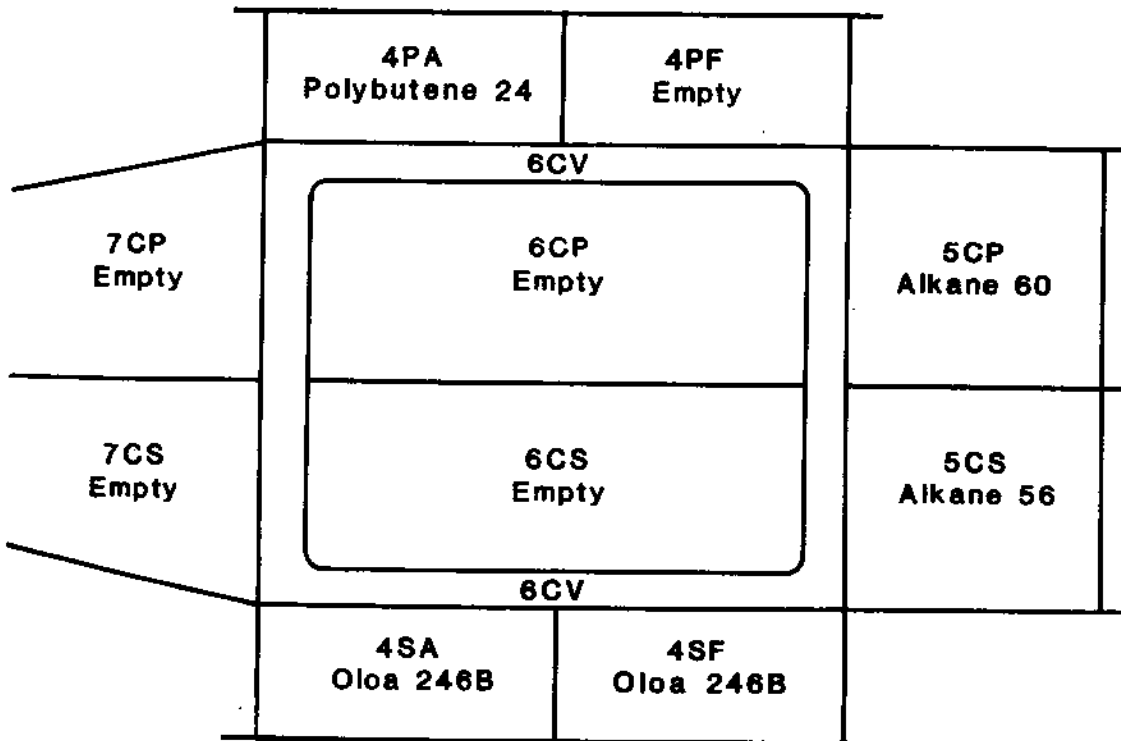
Figure 2. Cargoes in the tanks adjacent to 6CV, at the time of the casualty.

26. The cargoes immediately adjacent to 6CV on October 31, 1984 are shown in figure 2.

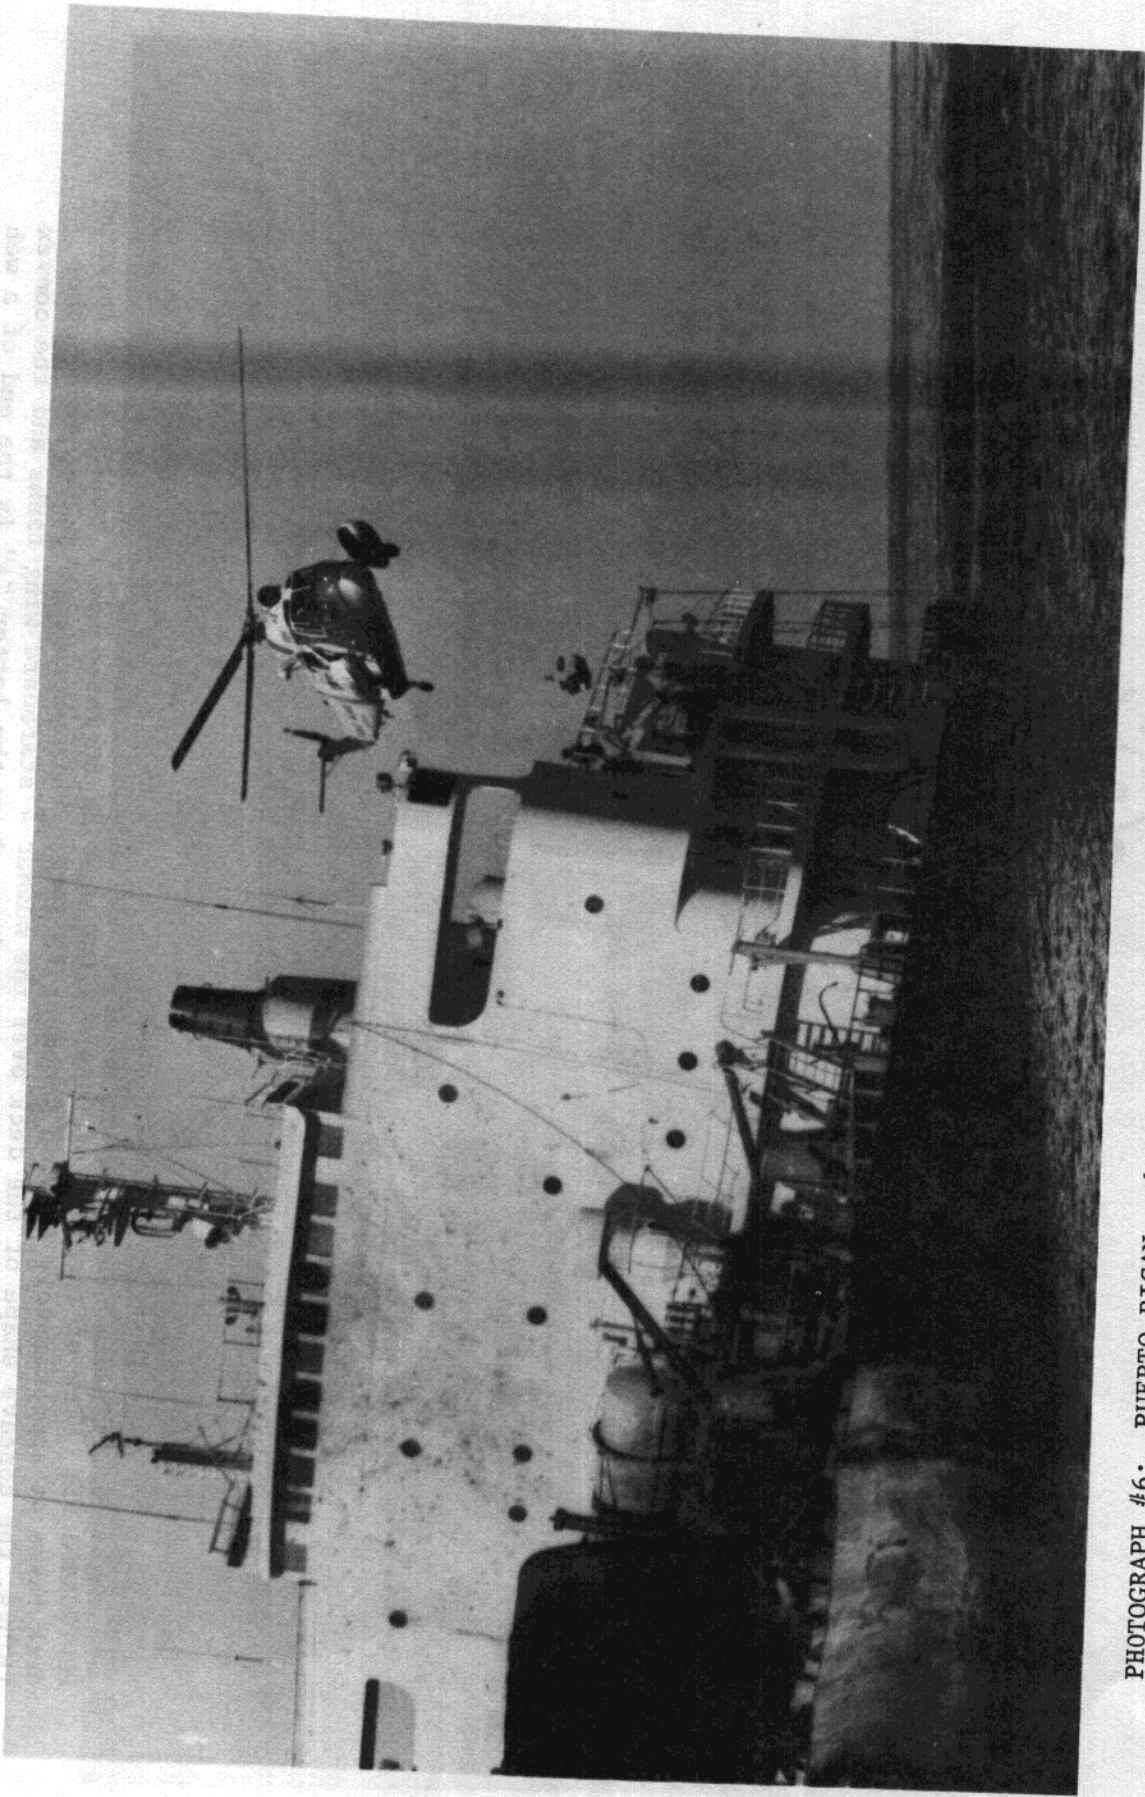
114. Almost immediately after the explosion, Captain SPILLANE re-entered the pilothouse. There were eleven windows across the front of the bridge area. Four of the five center windows were blown out. This is shown in photograph 6. He sounded the general alarm and rang for water on the firemain and the foam systems. The emergency generator had come on-line almost immediately following the explosion. Though the engine order telegraph on the

PHOTOGRAPH #6: PUERTO RICAN under tow on November 1, 1984 at approximately 1000 in position approximately 35.5 miles and 215⁰T from Point Bonita. (USCG Photo)
