MARINE CASUALTY REPORT

SS OMI YUKON, D.N. 5479 19

**EXPLOSIONS AND FIRE ON 28 OCTOBER 1986
IN THE PACIFIC OCEAN APPROXIMATELY
1000 MILES WEST OF HONOLULU, HAWAII
WITH MULTIPLE LOSS OF LIFE AND
PERSONNEL INJURIES**

Report No. USCG 16732/0002 HQS 88

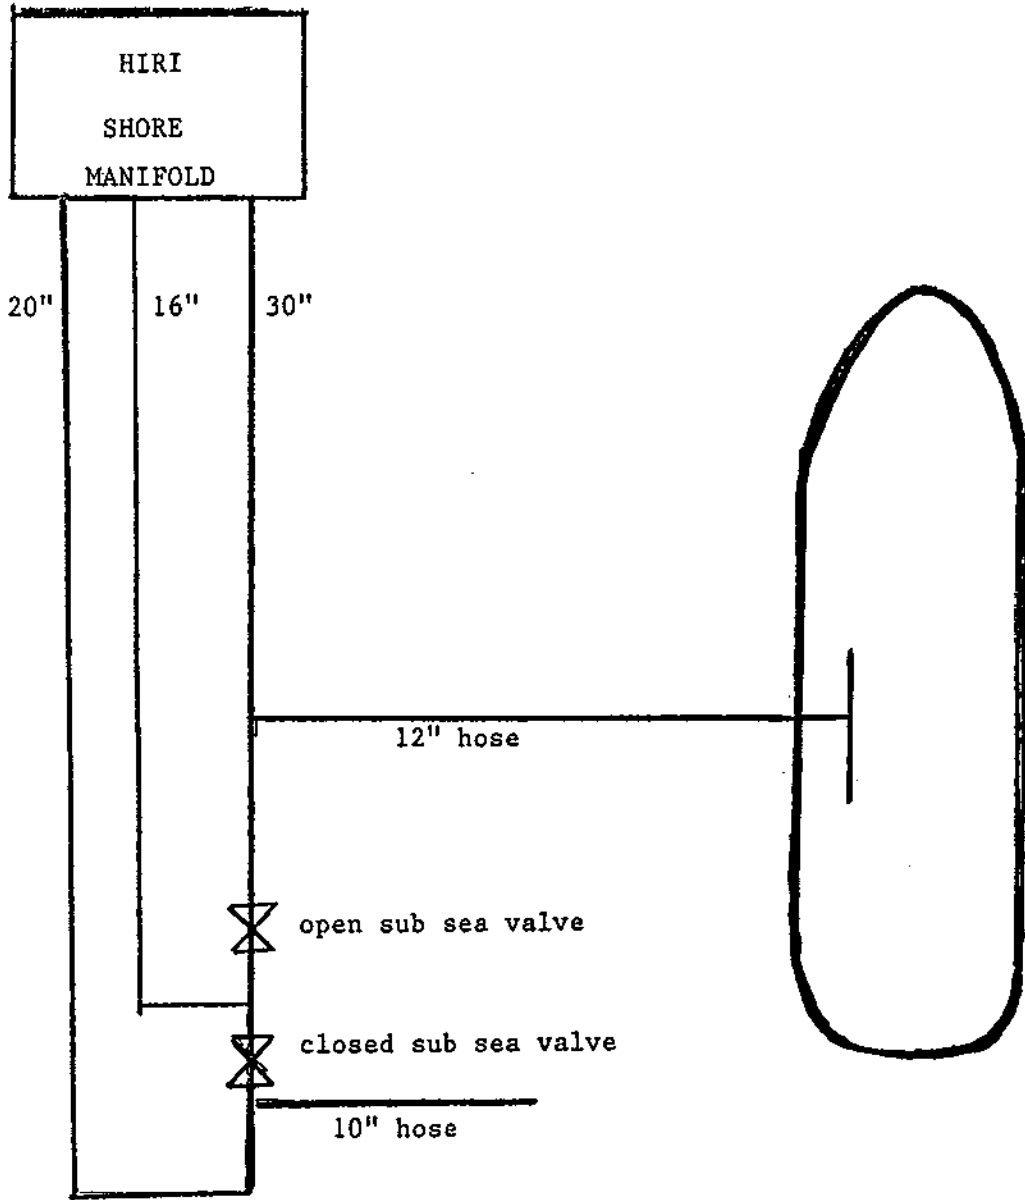
Redrawn from Exhibit #41 originally prepared by Captain Kuntz

24. At 1350 on 23 October 1986, the 30 inch line was reported to be filled with 10,325 bbls of bunkers from tank 307 (the tank used to blend the ordered bunkers for the vessel) and behind that in the 30 inch line was flush oil to push the bunkers out to the vessel. The 30 inch line holds approximately 12,500 bbls. The vessel only ordered 7,950 bbls but additional bunkers were put in the line to insure that the expected mixing of the flush oil with the bunkers at the interface was pushed well beyond the sub-sea hose connection. Refinery personnel determined the locations of the interface between products based on tank gaugings. The refinery pumps the leading interface between the flush oil and fuel oil past the location of the hose connection at the sub-sea manifold recirculating it back to the refinery through the 16 inch line.

25. The first step in bunkering the OMI YUKON was for the crew to hook up a specially manufactured jumper line between the cargo manifold and the midships bunker manifold. Prior to discharging cargo, bunkers were taken aboard using the same facility hose for off loading cargo. The 12" hose from the sub-sea manifold was connected to the cargo manifold. A jumper was connected to the cargo manifold, then to the bunker manifold. The jumper was used rather than transferring the refinery's hose between the two manifolds. Whatever product remained in the refinery's hose from its prior use, was flushed into the slop tank. It was easier to handle the residual product in the hose as part of the cargo discharge, rather than having to deal with it as a separate discharge operation. When good bunkers were observed at the cargo manifold, the valves on the cargo manifold system were changed to direct the flow of bunkers from the offshore hose past the first header through a cross over between cargo manifold lines, out of the cargo manifold header, into the temporarily installed jumper line to the midships bunker manifold.
