Summary

The Australian registered tanker Australian Achiever, of 127,575 tonnes summer deadweight, cleared the New Zealand port of Whangarei for the port of Brisbane at 2030 on 7 November 1992. The ship had part discharged and retained on board about 35,000 tonnes of crude oil.

AUSTRALIAN ACHIEVER

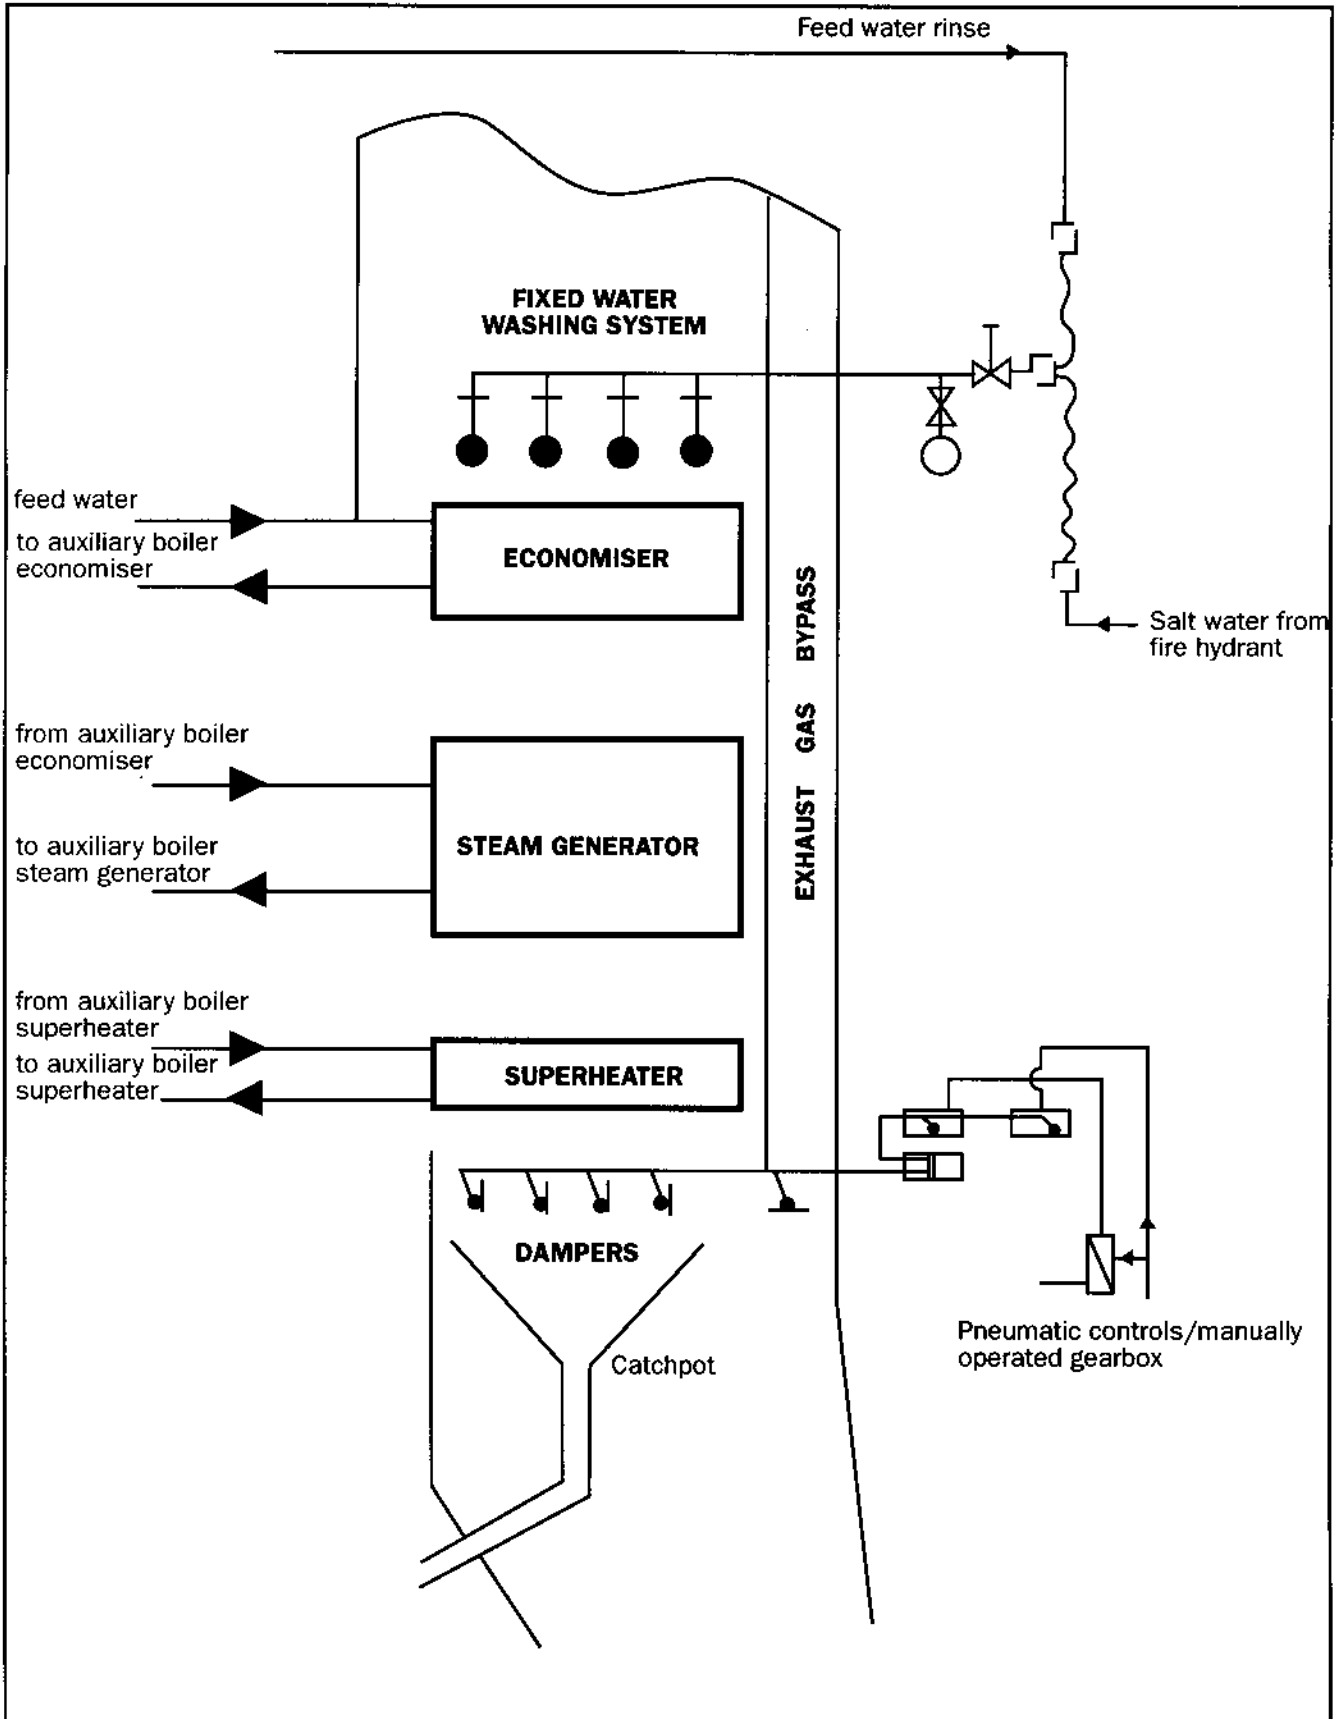
**Waste-Heat Unit
Schematic Diagram**

The upper section of the waste-heat unit, the economiser, consisted of a bank of tubes arranged in a block of

153 tubes 17 wide and nine high in a block about 0.737m in height. The unit was designed so that the engine exhaust gas passing through the economiser was about 190 degrees Celsius (C) on entry and at about 166 degrees C on exit. This section was designed to raise the feedwater temperature from 45 degrees Celsius to 173 degrees Celsius and circulate it back to the online auxiliary boiler steam drum via the boiler's own separate economiser.

The economiser section of the waste-heat unit had been out of commission for about four to six years, because of leakage from a number of tubes affected by extensive wastage. The combined effects of "cold and corrosion" when the unit was in service, and "dew point" corrosion, during idle periods, had an adverse effect on the thickness of the tube walls.
