Iron Flinders general arrangement

Summary

Shortly after berthing at West Swanson dock, Melbourne, on 24 September 1993 the 13280 g.r.t. container and general cargo vessel "Iron Flinders", on charter to BHP Ltd., suffered a fire in the waste-heat unit (economiser) which is situated in the main engine exhaust trunking at the base of the funnel.

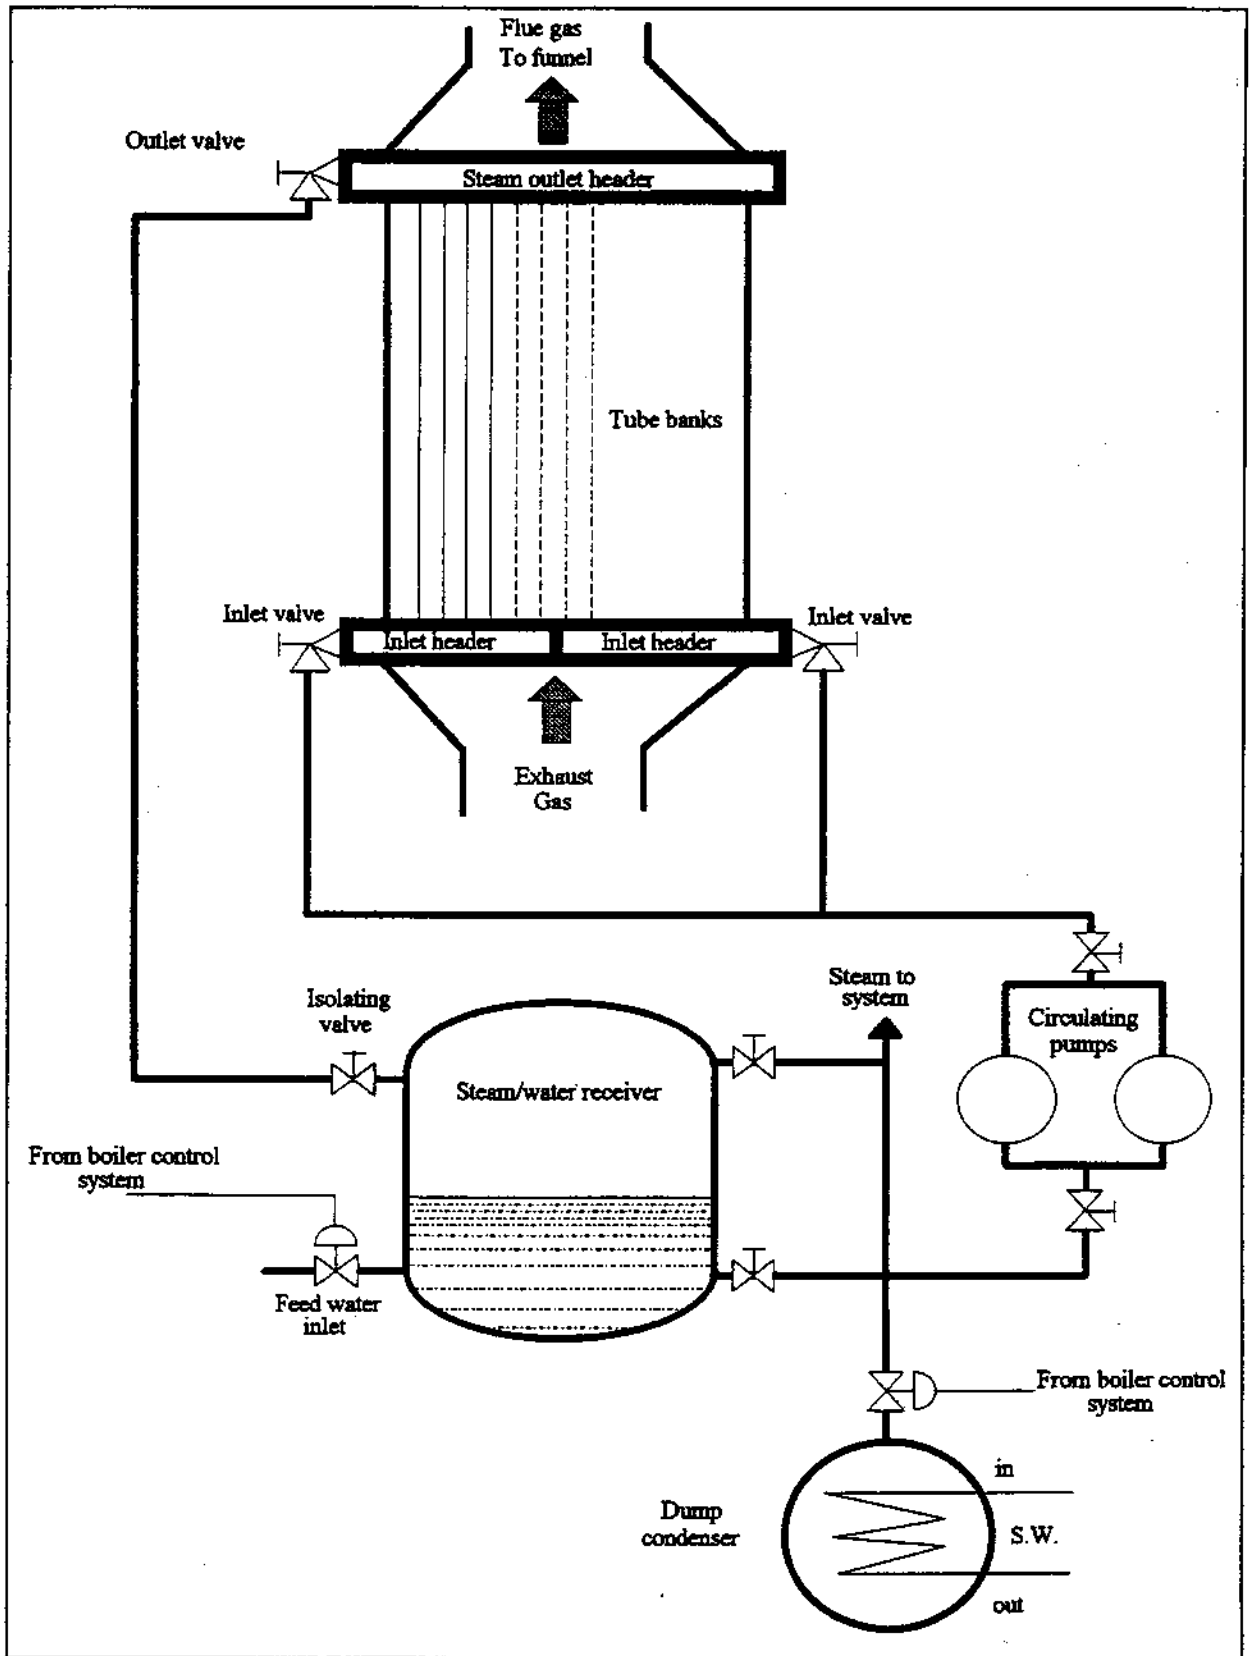
Schematic diagram of waste-heat unit

The waste-heat unit, a VEB type AKSR 2,0-16/16+16 built by Rostock Repair Service, is approximately 4.5m in height, with sides of 3m and 2.4m. It is situated three decks above the main deck level, above and aft of the main engine, on the vessel's centre-line.

the demand for steam and the engine operating condition at the time. The outlet header, however, was common to both sections and was fitted with only one outlet valve. The finned steam generating tubes were designed such that either one, or both, of the sections could be run in the "dry" condition.

Engine exhaust gases contain carbon particles in the form of soot which, in any waste-heat unit, are deposited on the finned tube surfaces during the passage of the exhaust gas through the tube banks, reducing the efficiency of the heat transfer. Under some operating conditions, if there are accumulated deposits of soot in the tube banks, there is a likelihood of the soot reaching ignition temperature resulting in a fire within the unit. It is thus recommended by manufacturers that waste-heat units be cleaned of soot on a regular basis.
