MARINE SAFETY INVESTIGATION
REPORT 174

Independent investigation into
the ballast tank explosion and subsequent fatalities
on board the Hong Kong registered bulk carrier

Nego Kim

Report No 174
October 2002

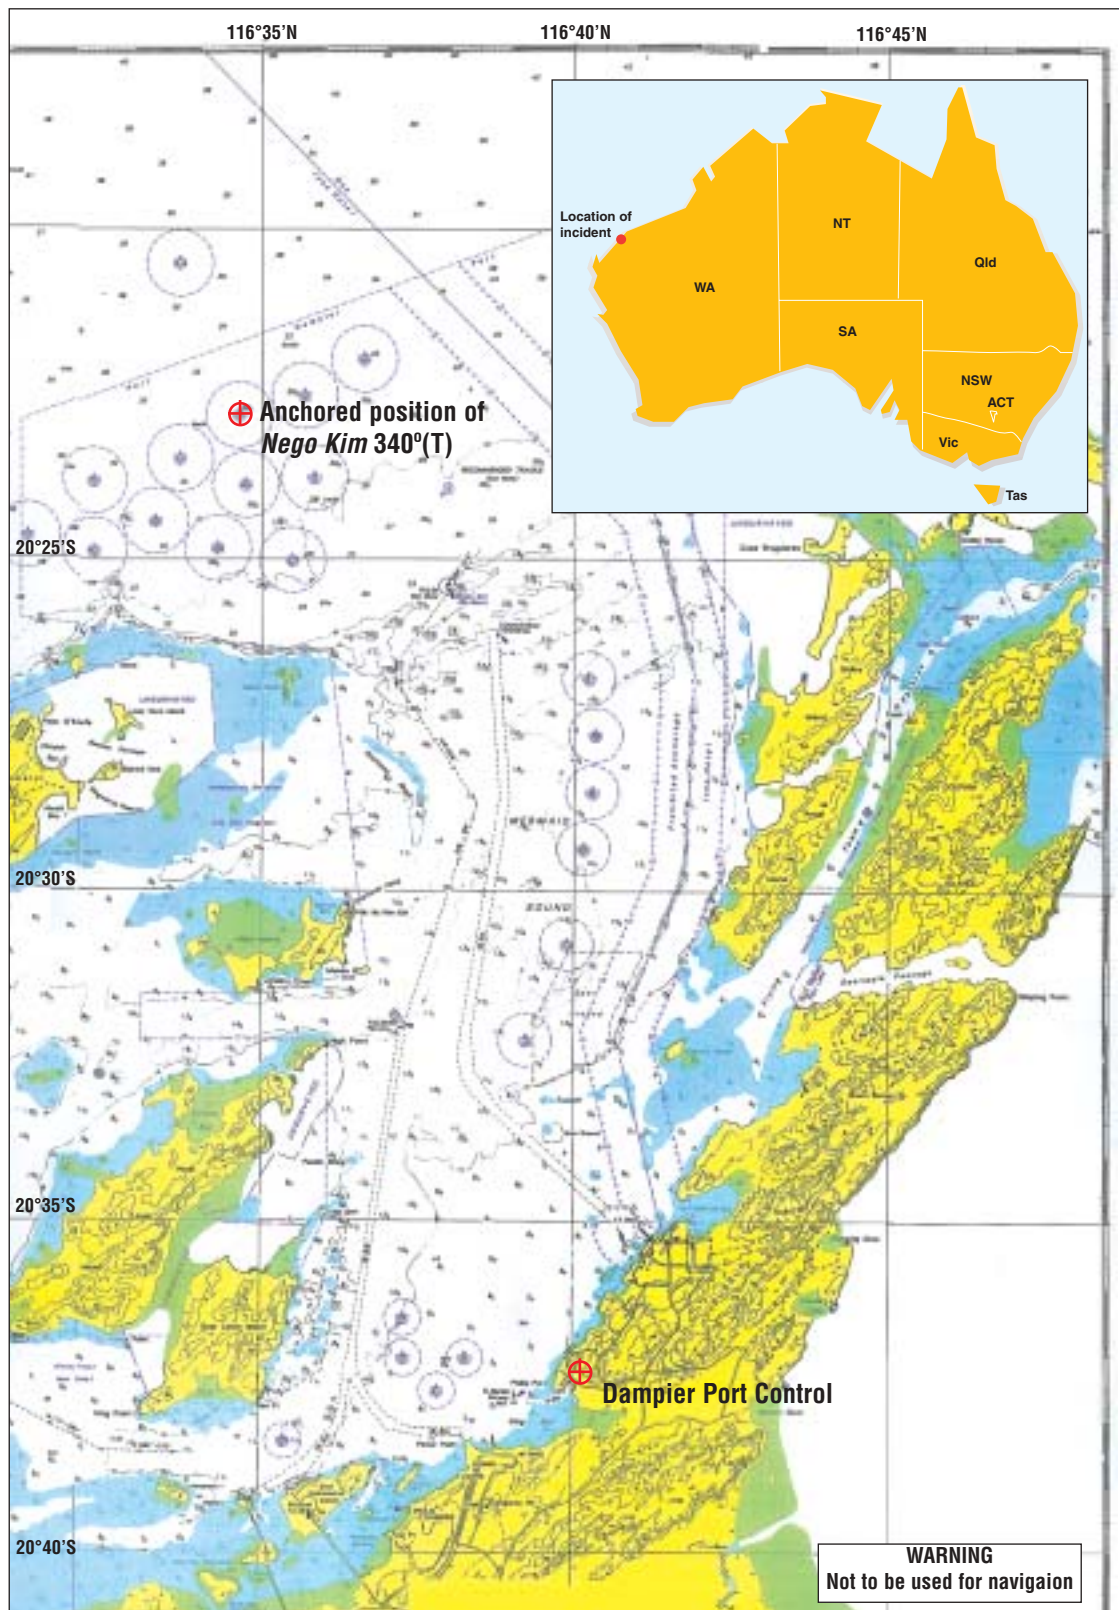
FIGURE 4:
Portion of chart Aus 57 showing anchored position of *Nego Kim* in relation to Dampier Port Control.

The master did not have either the agent's home or mobile telephone number. He anchored *Nego Kim* about one mile within the port limits, in a position 340°(T) by 15.4 miles from Dampier port control tower, previously designated as anchorage A4, to await berthing instructions. The ship remained at anchor through Saturday and Sunday.
