Departmental investigation
into the fire aboard the
Australian flag oil tanker
TASMAN
in the port of Melbourne,
Victoria on
19 December 1998

Navigation Act 1912 Navigation (Marine Casualty) Regulations investigation into the fire aboard the Australian flag oil tanker *TASMAN* in the port of Melbourne, Victoria on 19 December 1998

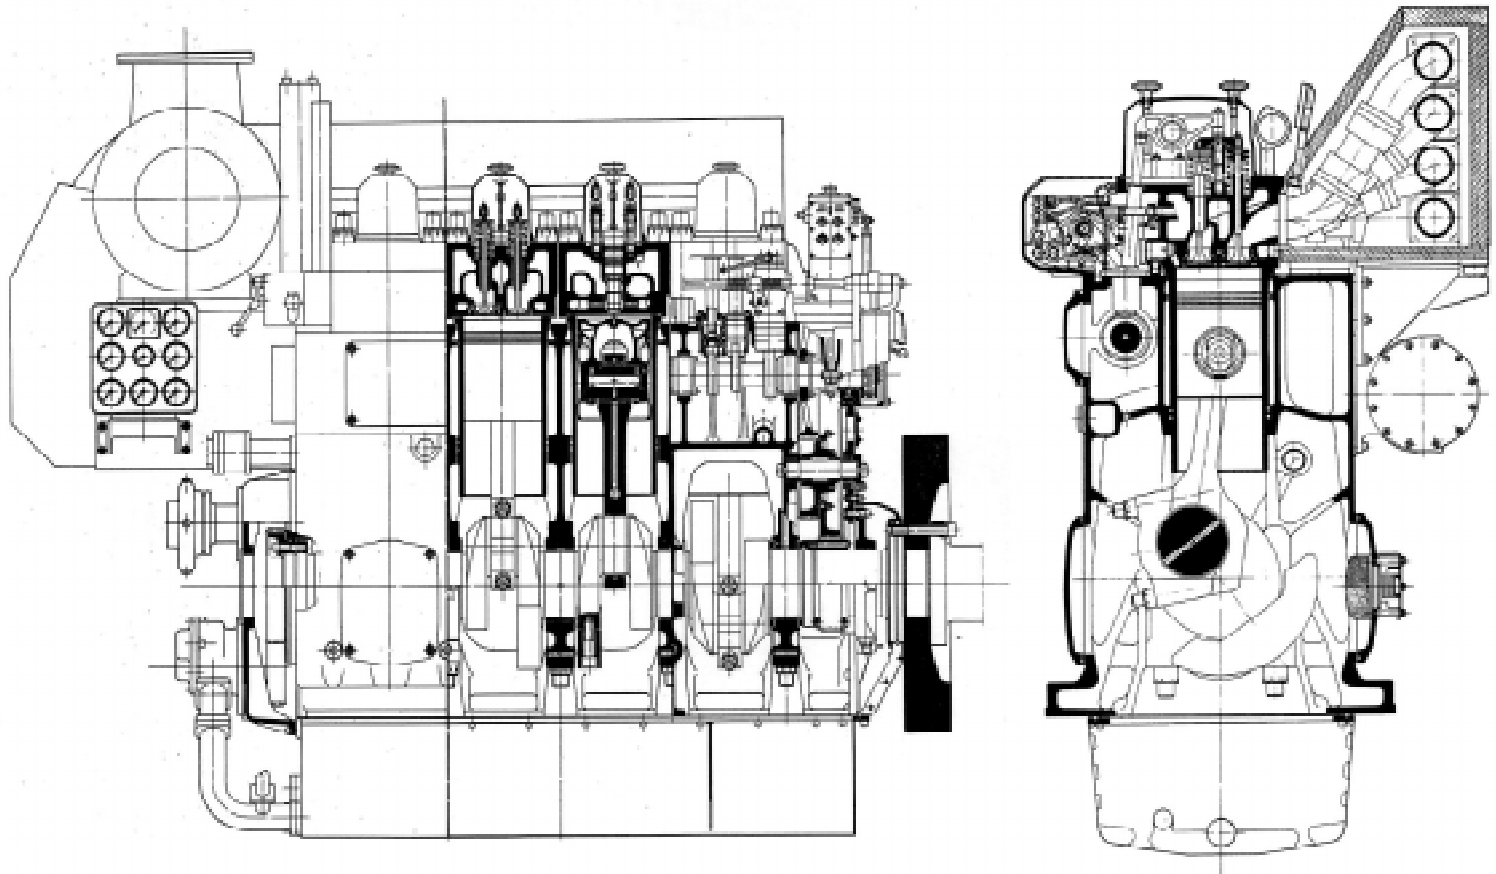
FIGURE 9
Wärtsilä VASA R22 – general configuration

Tasman's no. 1 generator set is driven by a Wärtsilä VASA 8R22HF-D diesel engine. It is an eight cylinder, four-stroke engine of 220 mm bore and 240 mm stroke, having a power output of 1160 kW at 900 rpm. Diagrams showing the general configuration of this engine type are shown on figure 9. All three generators can run on diesel oil or on heavy fuel oil and, at the time of the fire, no. 1 generator was running on heavy fuel oil. In accordance with the DIN numbering system, the units (cylinders) are numbered from the drive (the forward) end.

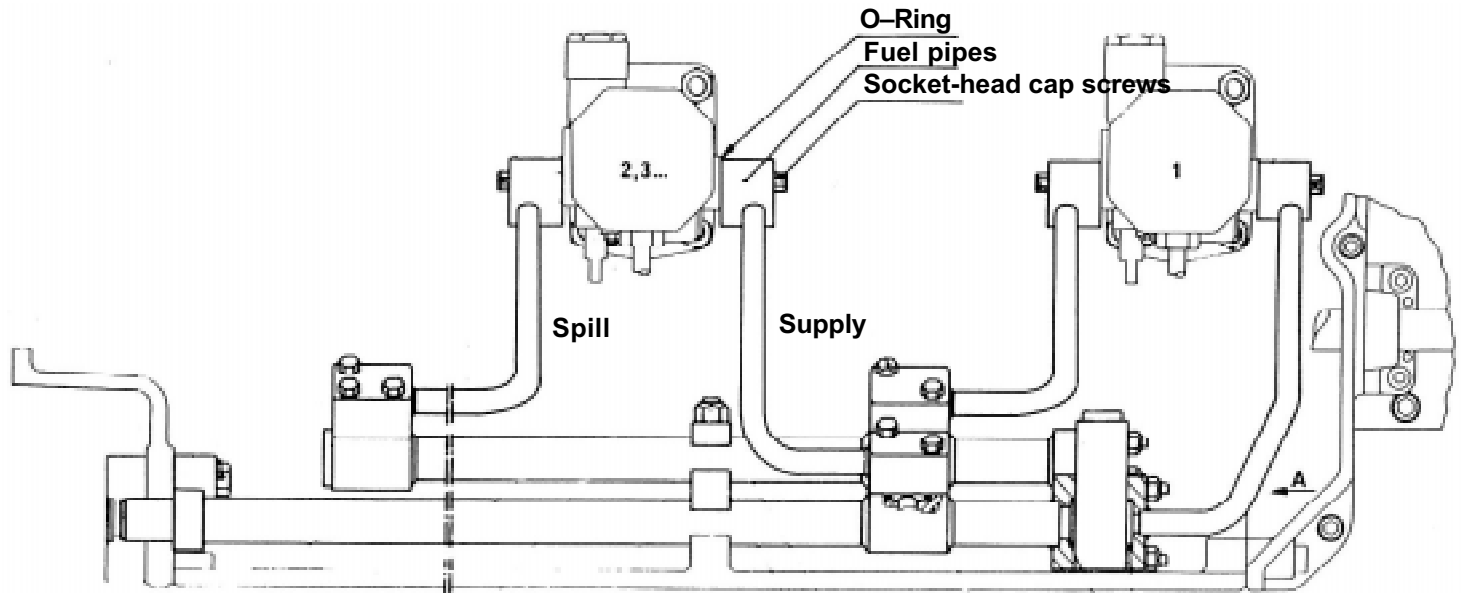
FIGURE 10

Plan of fuel pumps, supply and spill pipework in 'hot box'

The units have individual 'L'Orange' fuel injection pumps. Fuel is supplied to each injection pump via a separate pipe connecting from the fuel supply rail. The end of this pipe is attached to the fuel pump body with a flanged joint, sealed by a 19.2 × 3 mm O-ring, recessed into the flange. (fig. 11). The flange is secured to the pump body by two 8 mm dia. × 45 mm long allen screws. On the opposite side of the fuel pump, the fuel spill port is connected to the spill rail by a similar pipe and flanged joint. A diagram showing the arrangement of the fuel supply and spill pipework is shown as figure 10.

All three generator sets are orientated with the alternator, ie. the engine drive end, forward, and the free end of the engine, with the turbo-charger, aft. With this orientation, the fuel pumps on no.1 generator are on the inboard side and the exhaust manifolds are on the outboard side. The engines are designed such that all the fuel pumps and the associated 'on engine' pipework are enclosed within a 'hot box' – removable covers over the fuel gallery intended to prevent the escape of oil spray in the case of a fuel leak. On the outboard side, the two exhaust manifolds are enclosed in a separate exhaust casing with removable covers. (figs. 11&12).
