Worker Dies from Burn Injuries

Date of Incident: 99 04 01

Type of Incident: Fatal

1.1 F-141816

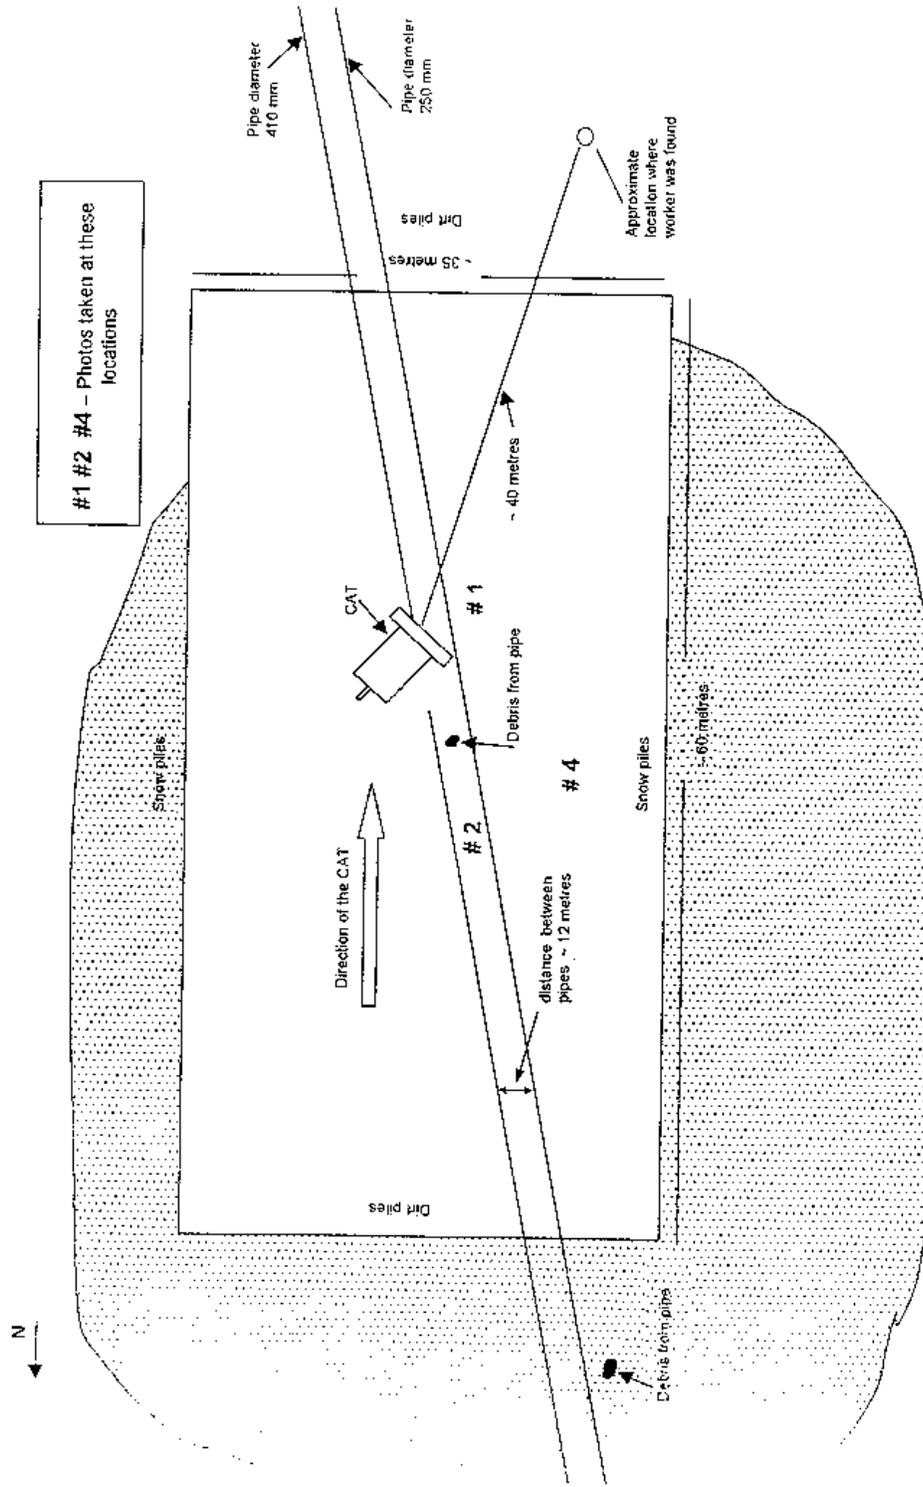
Diagram 2
 Fatality Investigation
 NW5-82-9-W6
 April 1, 1999

Photograph #4: This photograph was taken looking southeast (see diagram #2). The red arrow indicates the area behind the dirt berm where the operator was found. Dirt windrows indicate the cat was working north and south. Yellow flagging at the right center of photograph shows the location of the 250 mm pipeline. This parallels the 410 mm pipe visible near the cat (green arrow).
