MARINE CASUALTY REPORT

SS AMERICAN EAGLE, O.N. 278327

EXPLOSION IN THE GULF OF MEXICO

**Marine Board of Investigation Report
and
Commandant's Action**

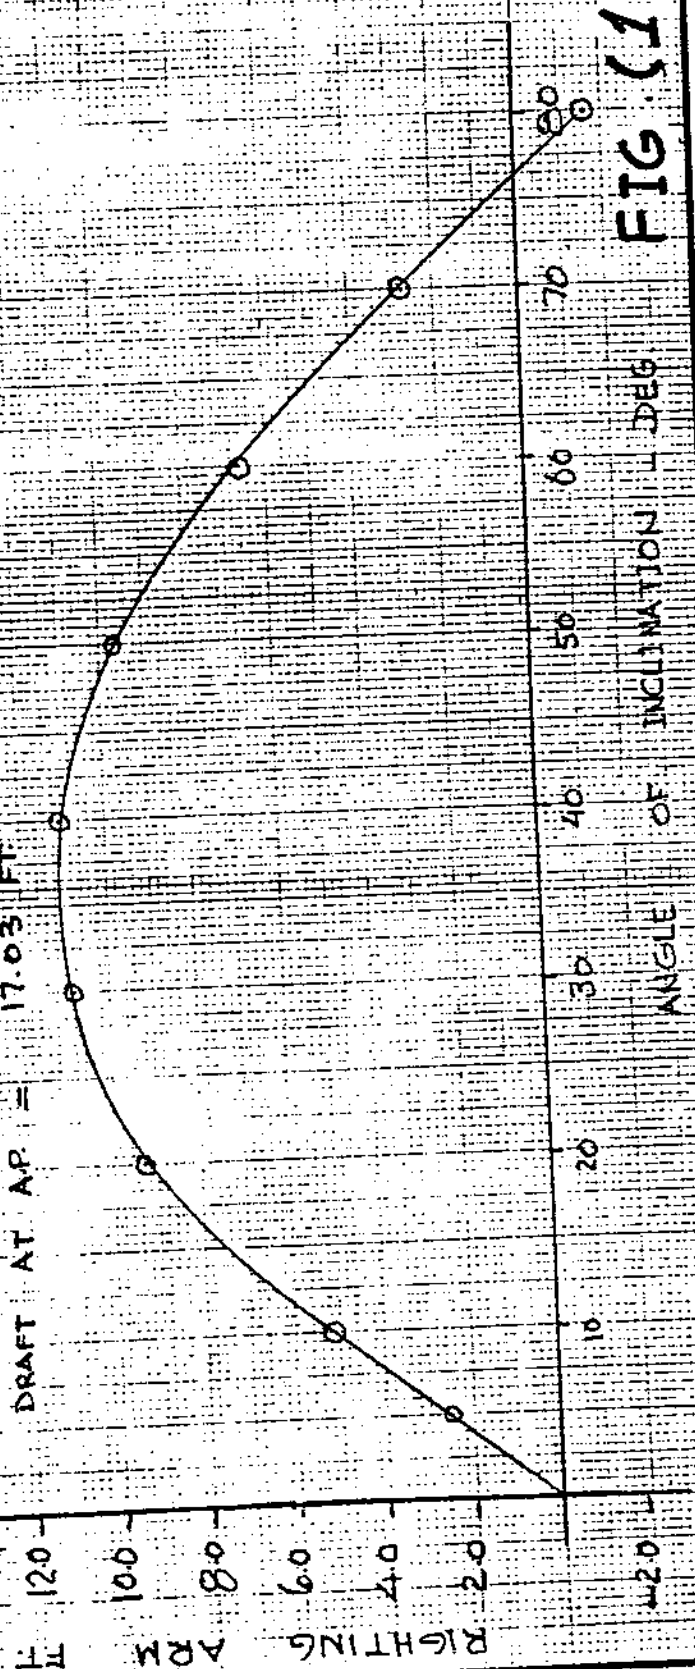
FIG. (1)

The intact statical stability righting arm curve is shown in Figure 1. The analysis indicates that the ship as loaded just before the explosion met U.S. Coast Guard and Marpol 73/78 stability requirements.

AMERICAN EAGLE
 INTACT STABILITY JUST BEFORE EXPLOSION

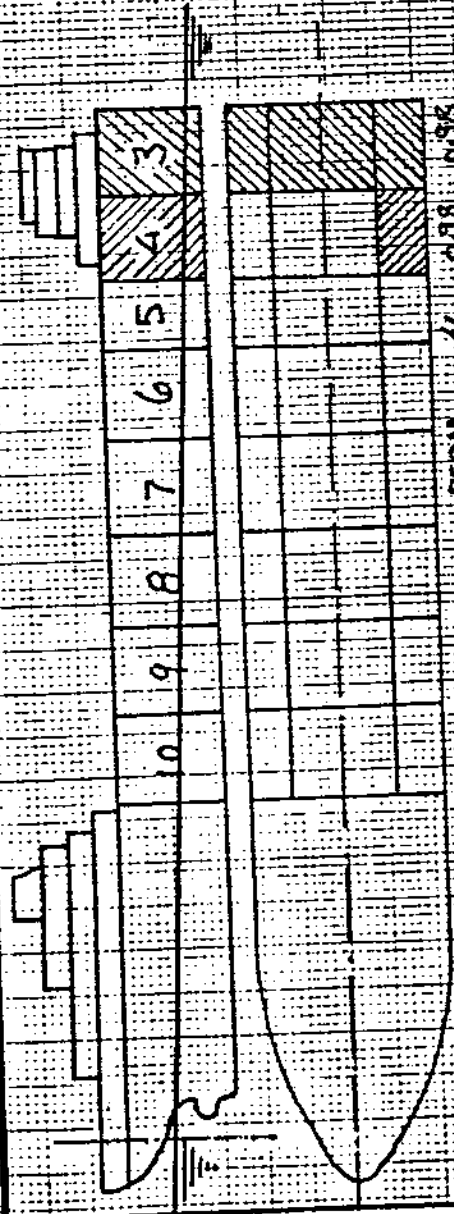
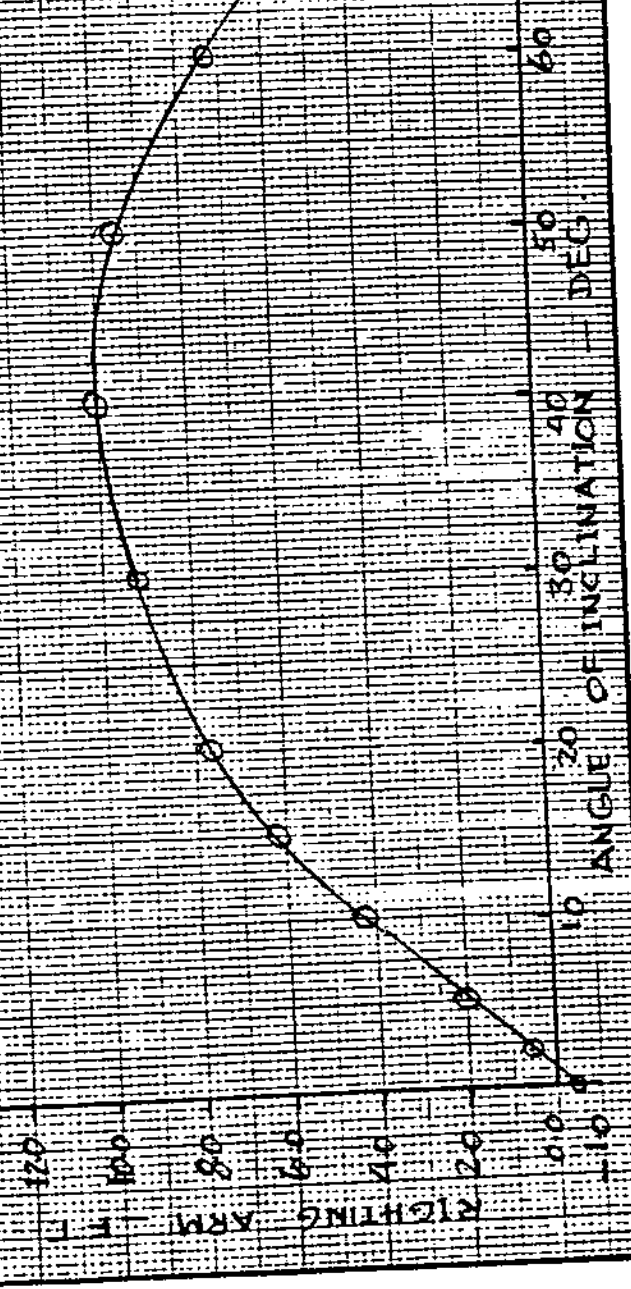
FIG (4)

DAMAGE COND. (2)

BEFORE DAMAGE
 Δ L T C M = 197205
 DRAFT \bar{Q} = 3.2'
 TRIM (H) = 23.45 BY ST
 LCG = -17004 AFT \bar{X}
 KG' = 29.73'

AFTER DAMAGE
 DRAFT \bar{Q} = 13.5'
 TRIM (H) = 21.4 BY ST
 HEEL (STR) = 1.0'

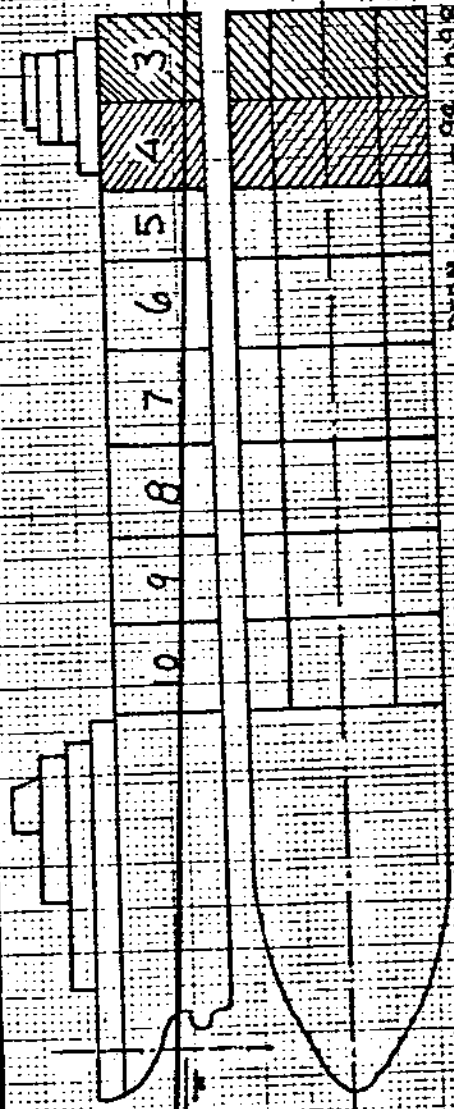
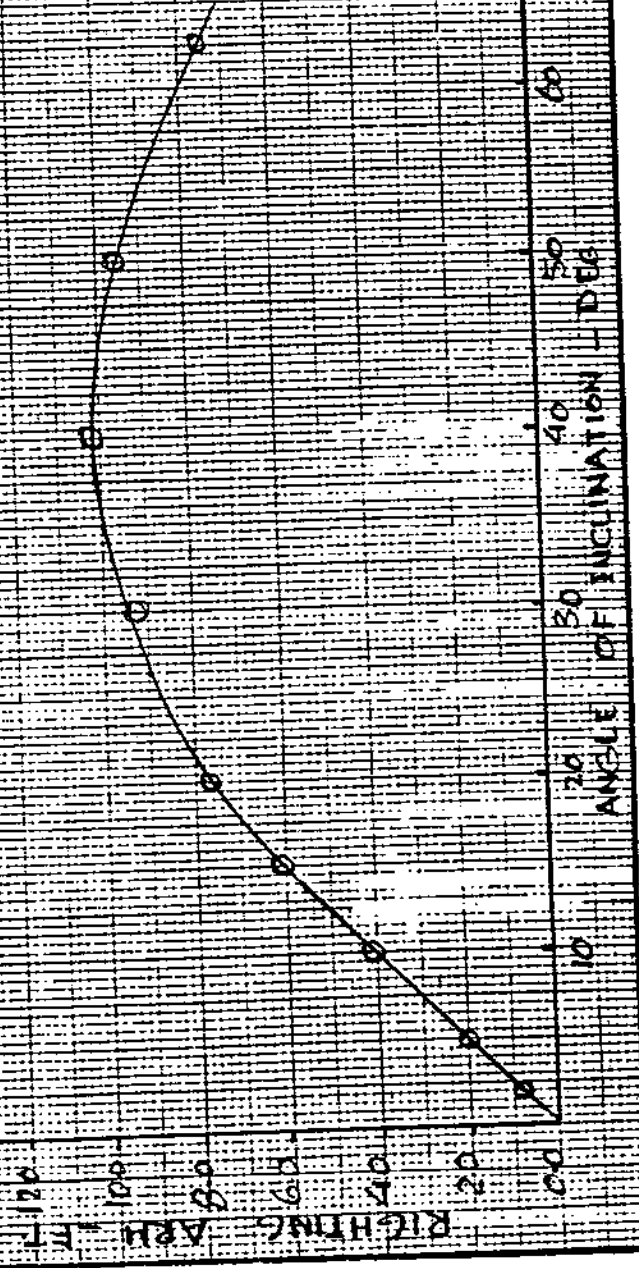
FIG (6)

DAMAGE COND. (4)

BEFORE DAMAGE
 A L T S M = 9972.05
 DRAFT X = 13.2'
 TRM (H) = 28.45' BY ST
 LCG = 17.06' AFTER
 KCG = 29.73'

AFTER DAMAGE

DRAFT X = 14.02'
 TRM (H) = 16.05'
 BY ST

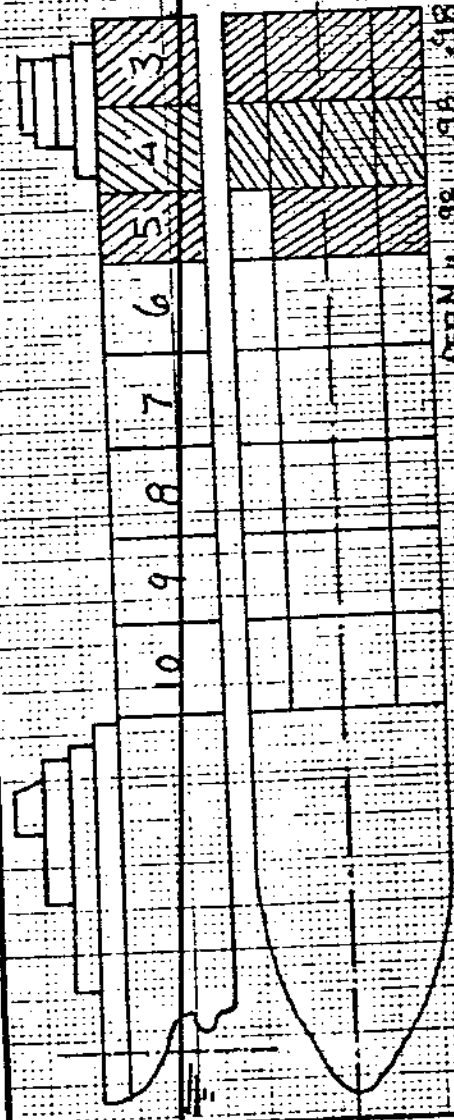
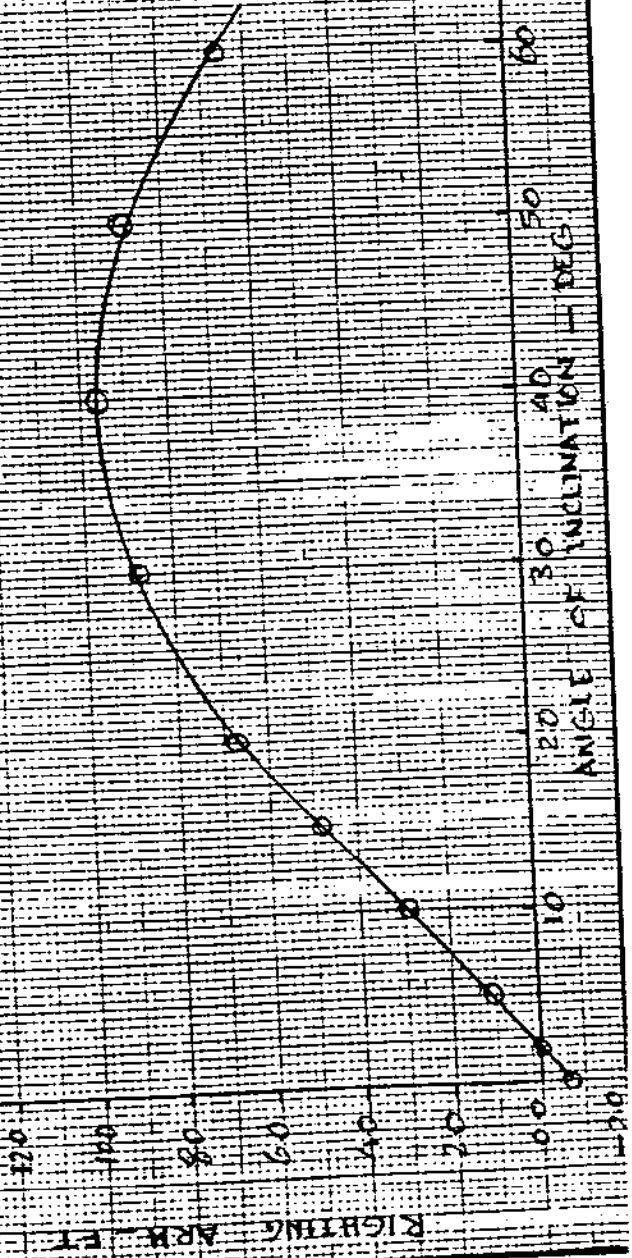
FIG. (8)

DAMAGE COND. (6)

BEFORE DAMAGE
 A.L.T.S.W. = 5972.05
 DRAFT @ = 13.2'
 TRIM (H) = 23.45 BY ST
 LCG = 17.94 AFT 00
 K.G. = 29.73

AFTER DAMAGE
 DRAFT @ = 14.92'
 TRIM (H) = 4.03 BY ST
 HEEL DISTB = 2.0°

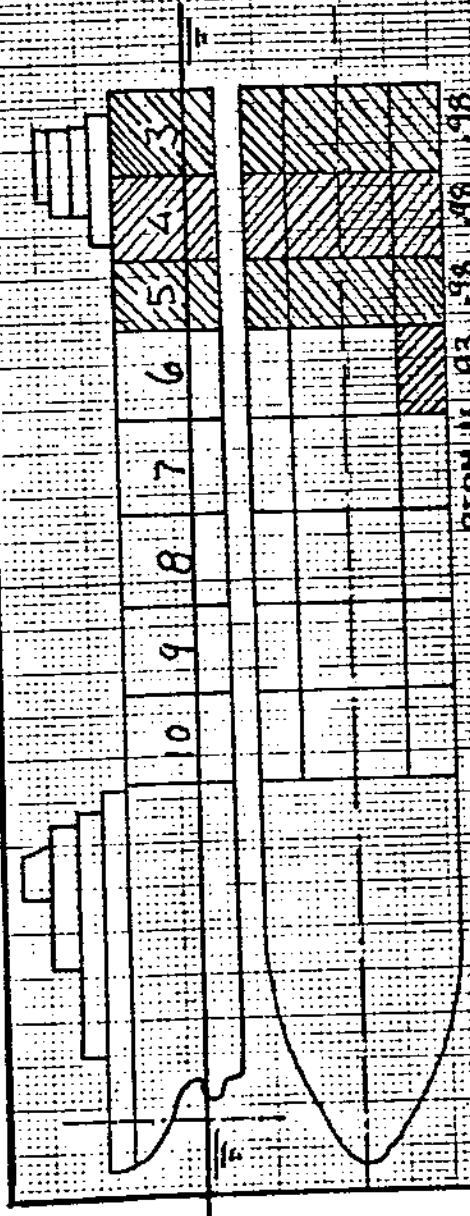
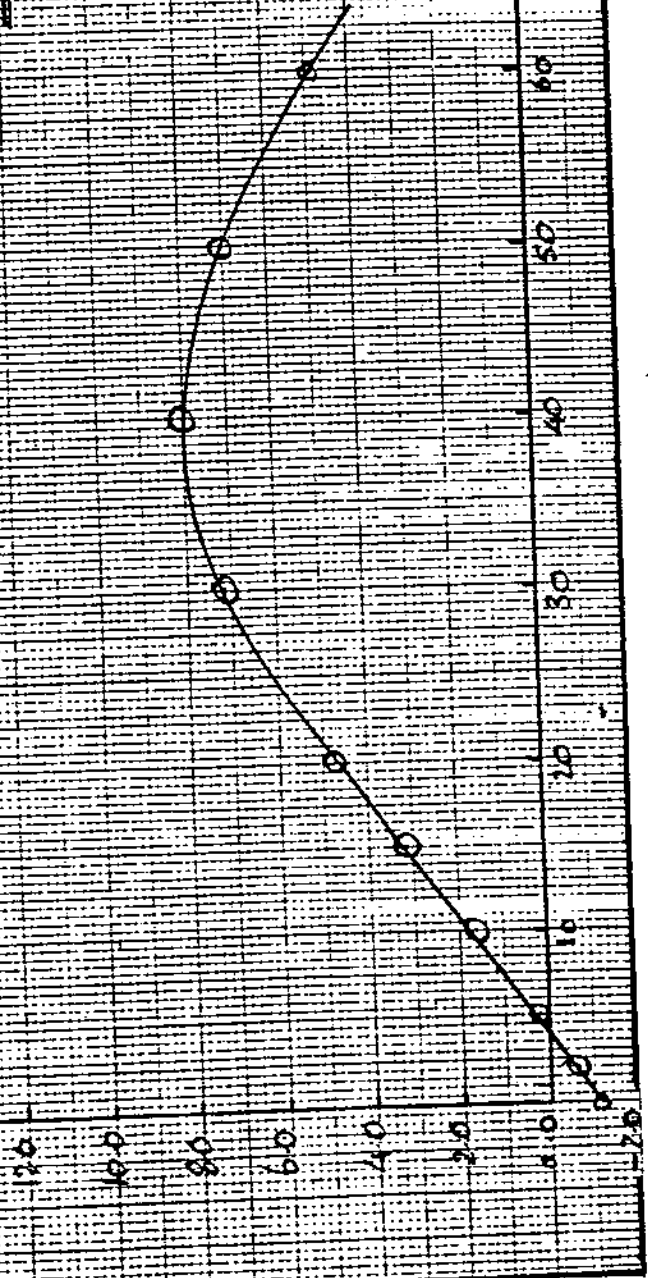
FIG. (10)

DAMAGE COND. (8)

BEFORE DAMAGE		AFTER DAMAGE	
Δ LT SW	9972.05	DRAFT (ft)	16.05
DRAFT (ft)	13.27	TRIM (ft)	0.91 BY ST
TRIM (ft)	23.45 BY ST	HEEL (DEG)	0.0
LCG	17.06 AFT Δ	HEEL STBD	0.0
KG	29.73

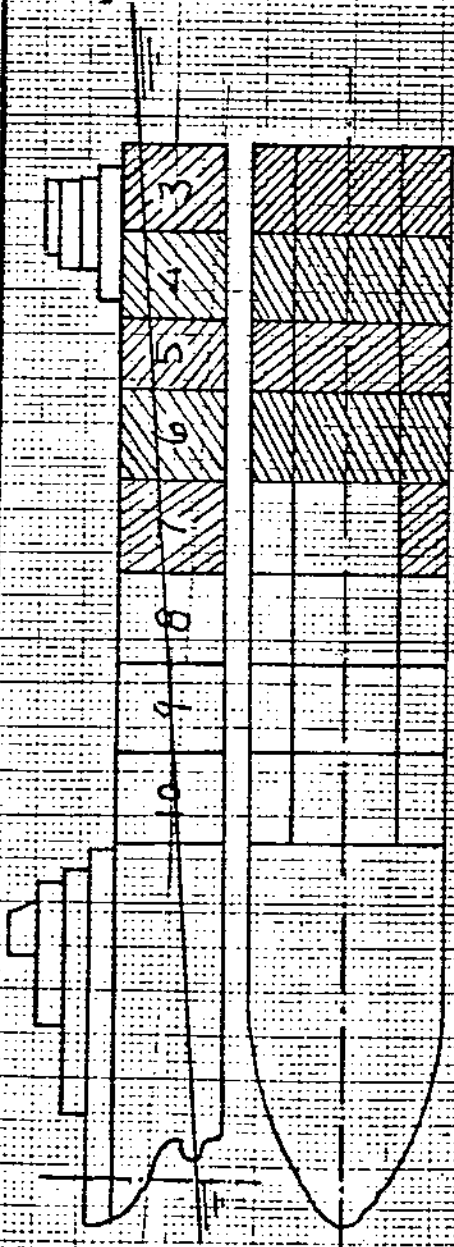
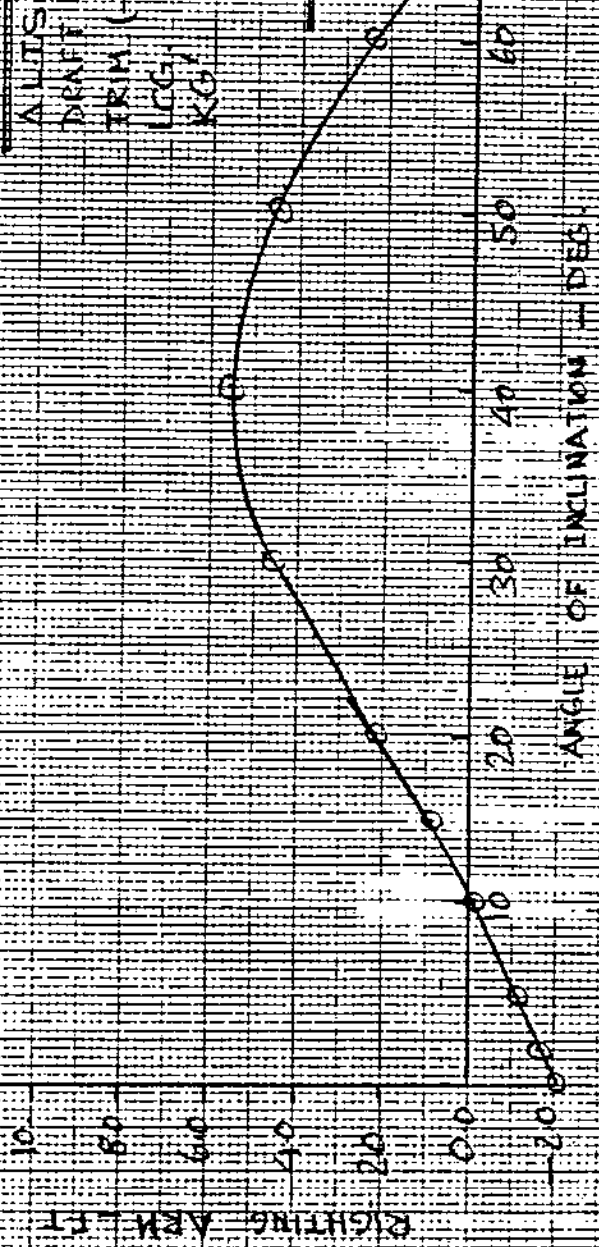
FIG. (13)

DAMAGE COND. (II)

BEFORE DAMAGE	
ALTS W.	9972.05
DRAFT Φ	15.42'
TRIM (H)	23.45' BY ST
LCG	117.04' AFT Φ
KCG	29.73'

AFTER DAMAGE	
DRAFT Φ	21.4'
TRIM (H)	31.0' BY BOW
HEEL TO STRD	10.5°

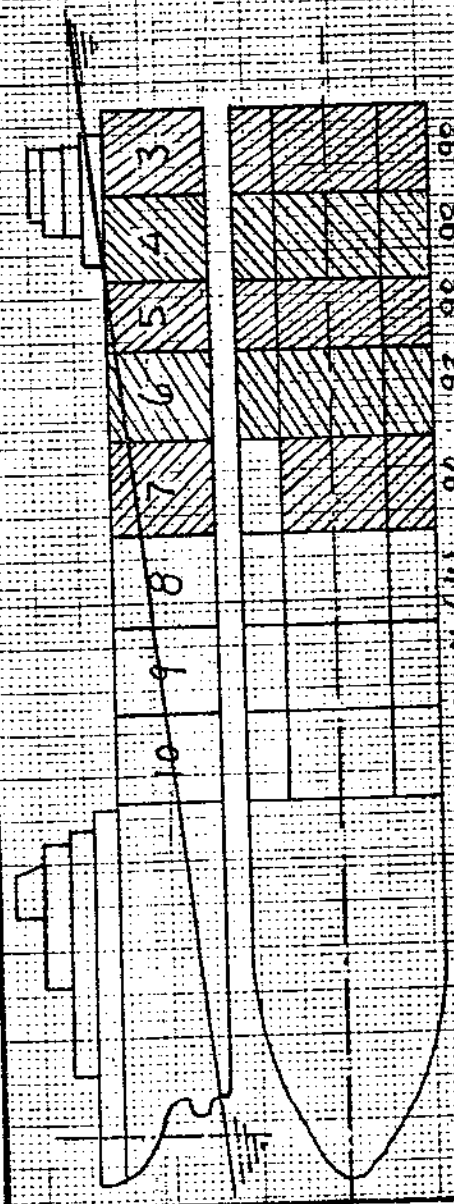
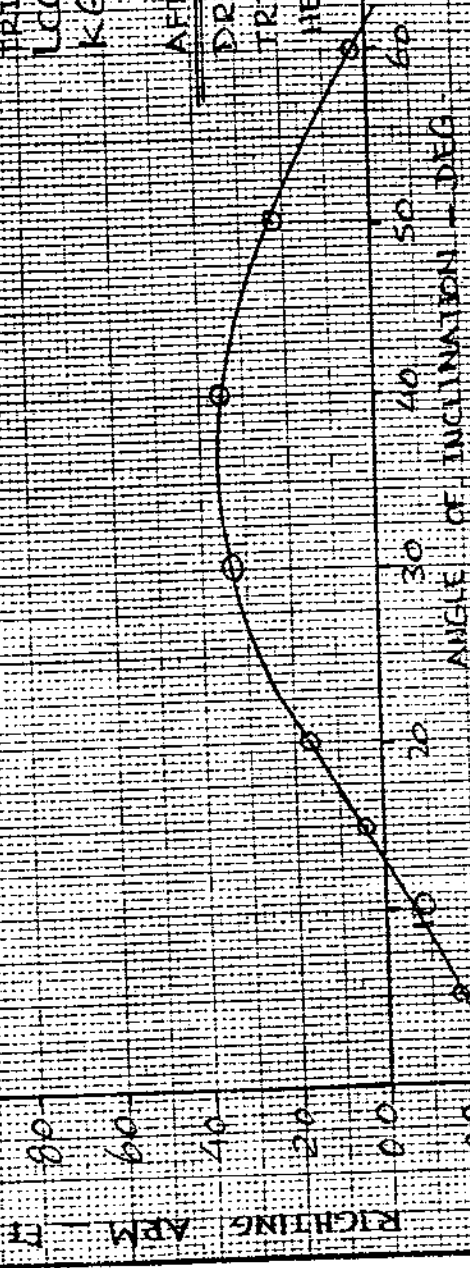
FIG (14)

STERN SECTION
AMERICAN EAGLE
DAMAGE COND. (12)

DRAFT (X)	26.6
TRIM (M)	60.51 BOW
HEEL TO STUD	13.00
