**Worker Injured During Explosion**

**Date of Incident:** 99 04 27

**Type of Incident:** Fatality

## **SUMMARY**

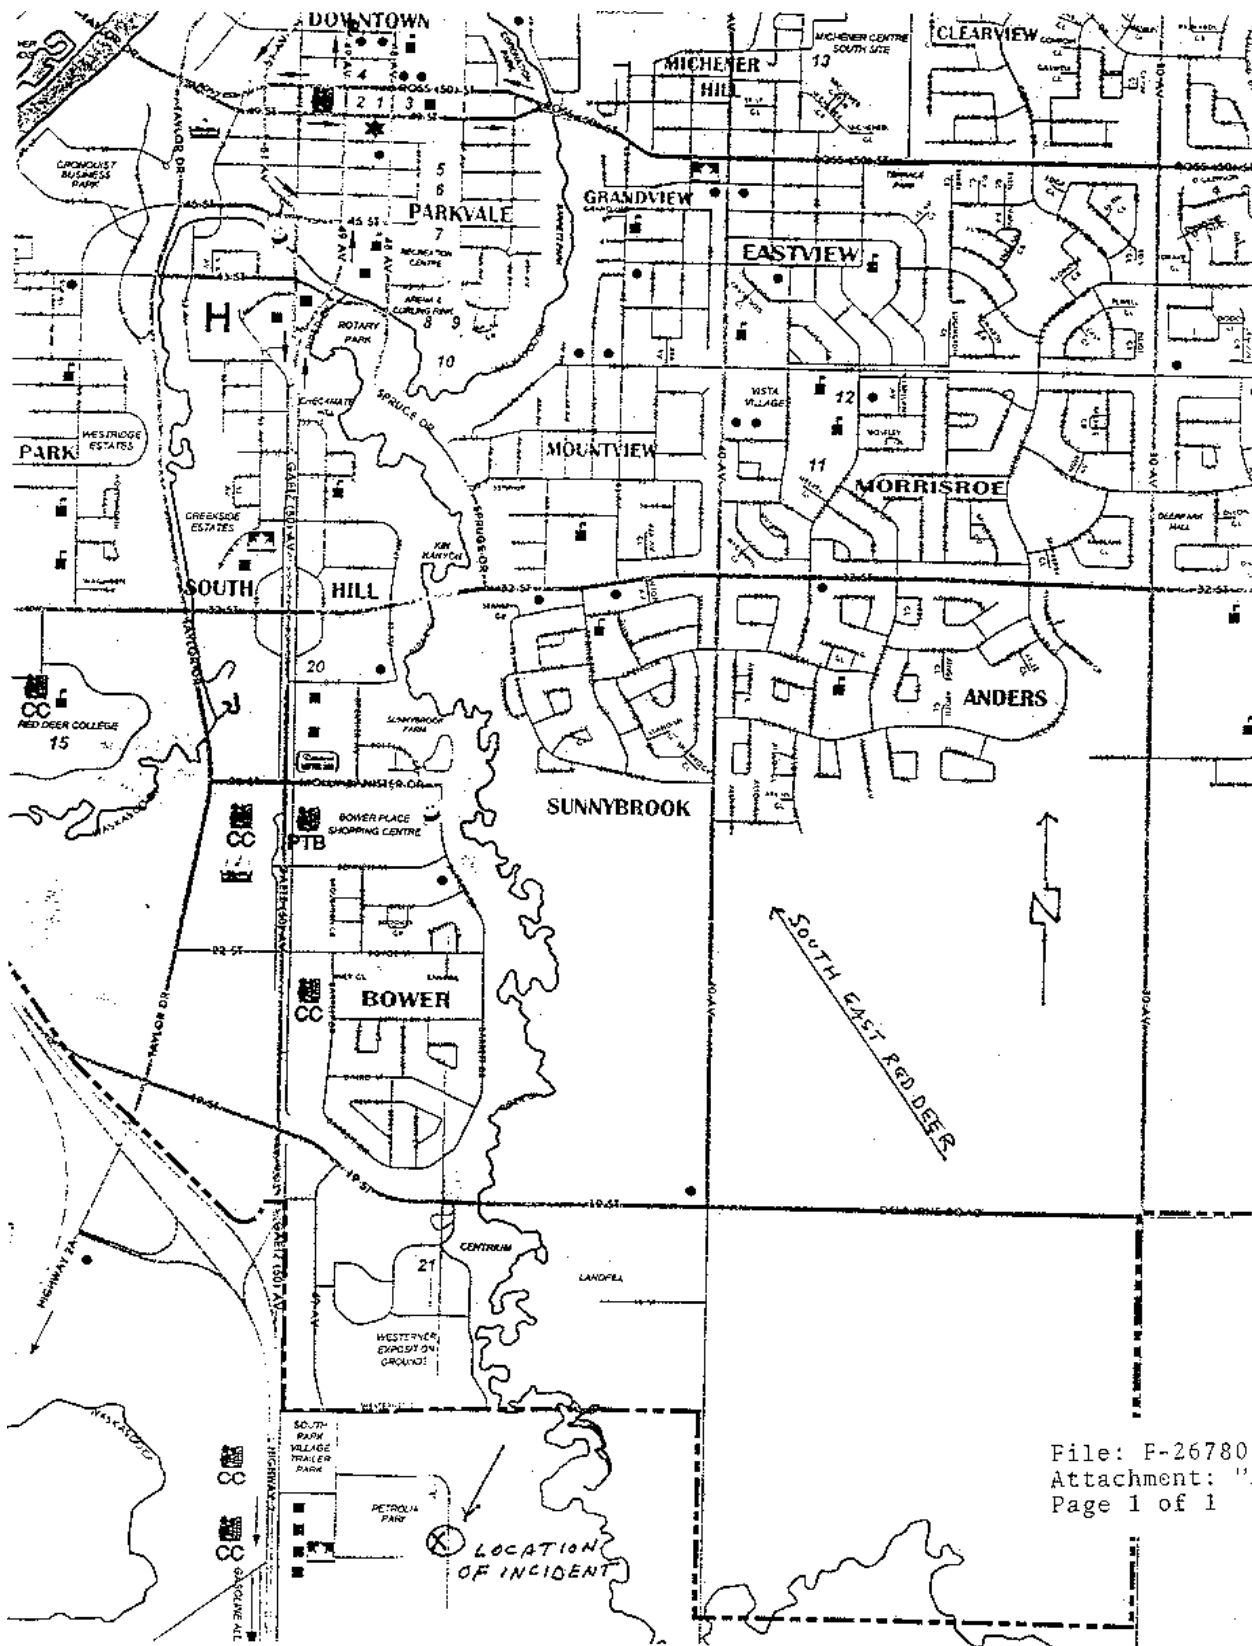
File: F-26780  
 Attachment: "  
 Page 1 of 1

On 99 04 27 a worker was welding a splashguard on a portable tar tank that contained a flammable liquid residue. Welding caused the flammable liquid residue inside the tar tank to ignite and explode. The worker was critically injured when he was struck with a service lid on his facial area. The injured worker was transported to the Red Deer Regional Hospital where he was pronounced dead.

The direct cause of the incident was that the welding was performed on the portable tar tank that contained a flammable liquid residue.

- 14.1.2 The employer had taken the damaged tar tank out of service. The company currently utilises a newly manufactured tank certified by a professional engineer.
